2016 Winton Overpass Piping Project

City of Hayward

Photo Journal by Bert Weiss, Utilities Operation and Maintenance Manager

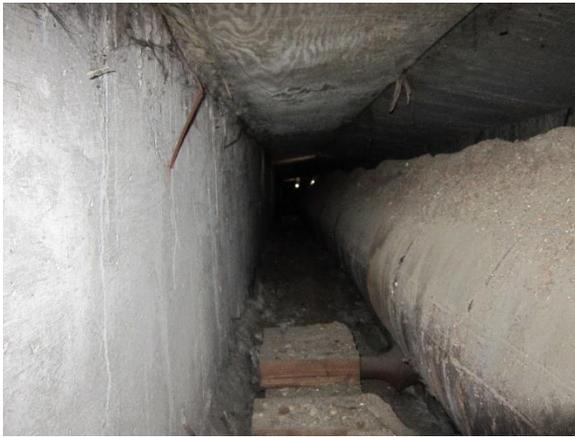
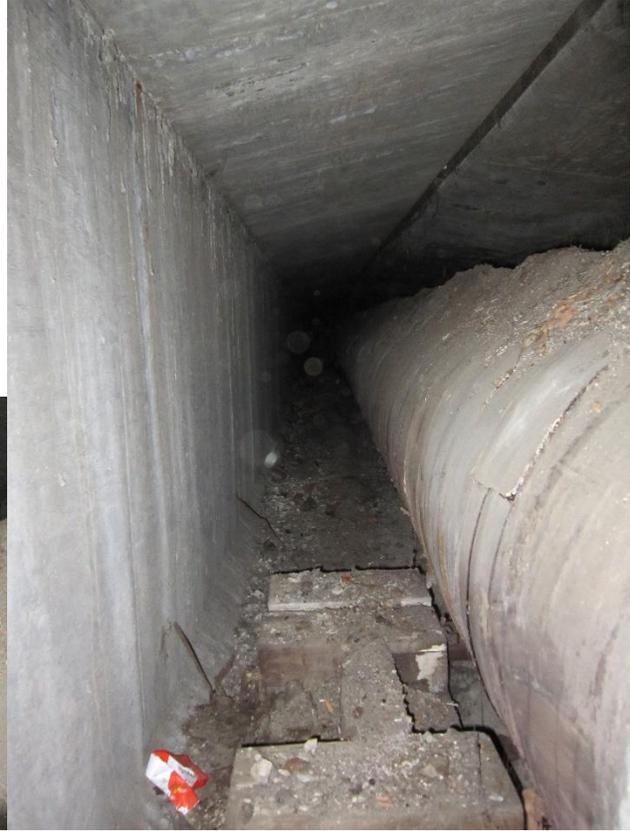
There was a very unceremonious beginning to the project. Our 20 inch pipe in the Winton Street/880 overpass had developed a leak and needed to be replaced. Note the debris that had accumulated over the decades. The first challenge to overcome was how we would clean the interior of the structure. The space was limited and the debris kept clogging the vacuum truck hose. We finally resigned ourselves to having to go in and clean the interior by hand, with dustpans, foxtail brooms, and five gallon buckets.

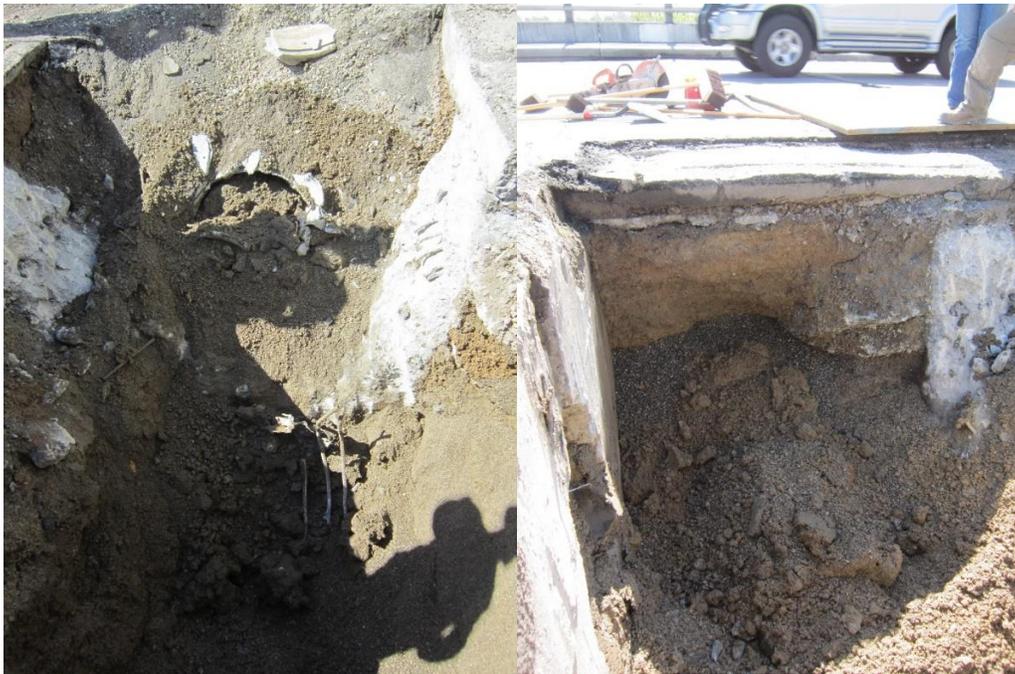
Unfortunately, we didn't get far before encountering the first unexpected revelation. There were large veins of pea gravel near the overpass structure. It started to pour out of the sides of the trench walls and threatened to undermine the very busy West Winton. We immediately had to backfill to prevent that from happening and shifted to Plan B.

Thanks to the expertise of United Trench Safety folks, “Plan B” effectively became driving $\frac{3}{4}$ ” steel plates into the ground with the excavator to keep the pea gravel in place thereby preventing the undermining of the very heavily traveled roadway.

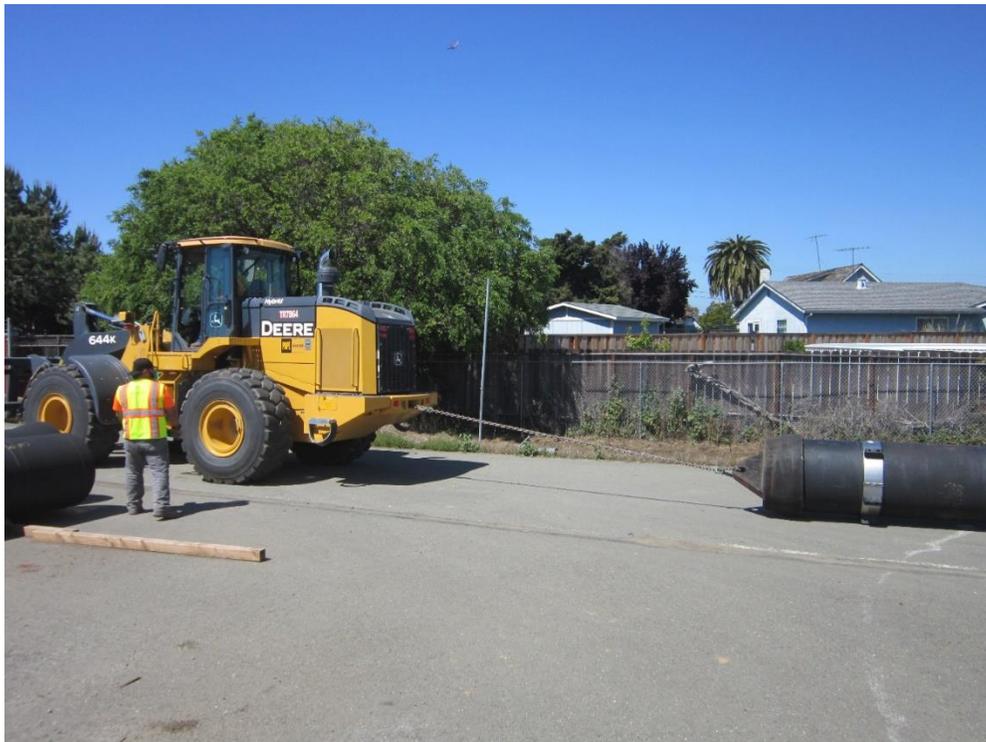
The test was simple. We would drag the pipe behind the front loader to determine the wear rate of the plastic blocks on the insulator bands.

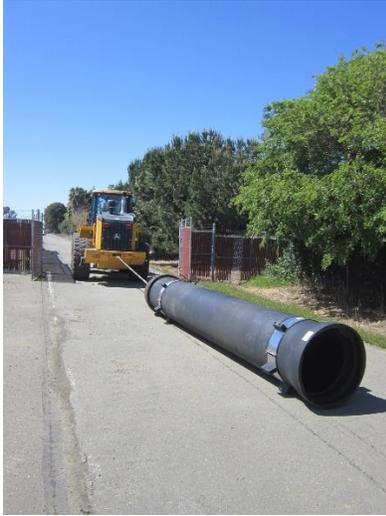
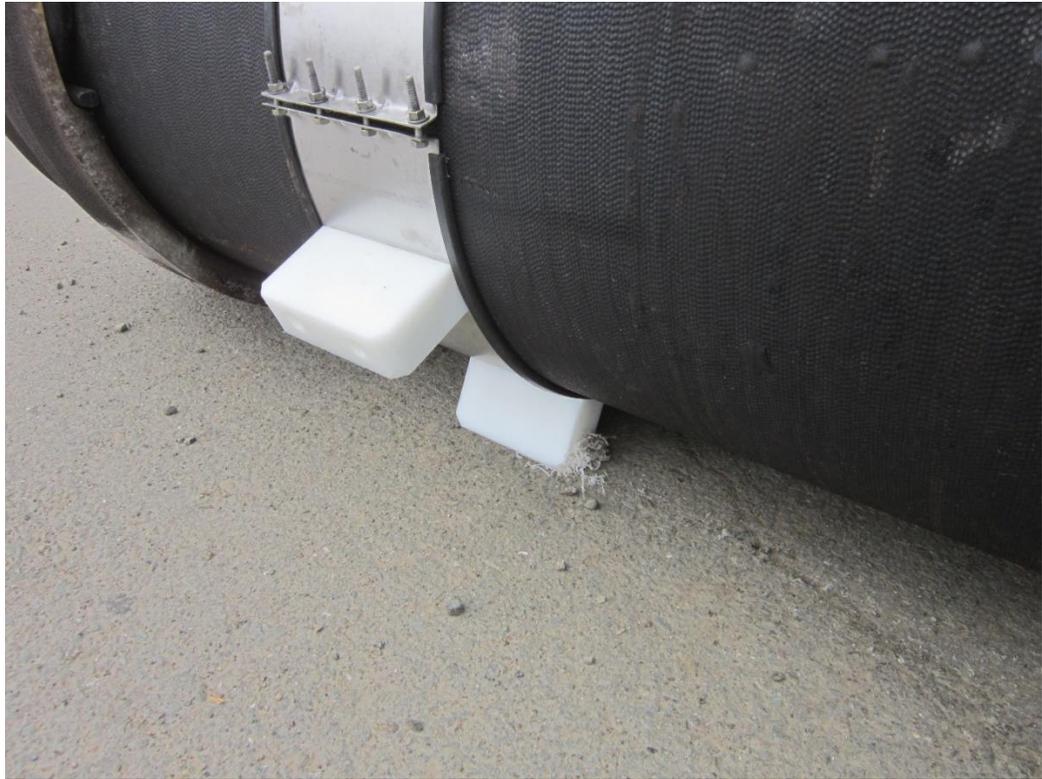
The results of the test were both dismal and very discouraging. One material wore out in 80 feet. The next did slightly better and hit about 120 feet before the wear was so great that the pipe's bell end started to drag on the ground. We had a serious challenge ahead of us to come up with something that could withstand the full pull of 300 feet through the overpass and over the unfinished concrete floor that was much rougher than the asphalt we were dragging the test pipe on. Not only that, but staff decided that it was necessary to be able to make a 600 foot pull, in the event that something went wrong with the hydro test and that the pipe had to be pulled out of the overpass again. We absolutely couldn't afford for the bell ends of the pipe to drag in the gap of the center of the structures, thereby raining spalled chunks of concrete down on the traffic below, if the pipe needed to come out again.

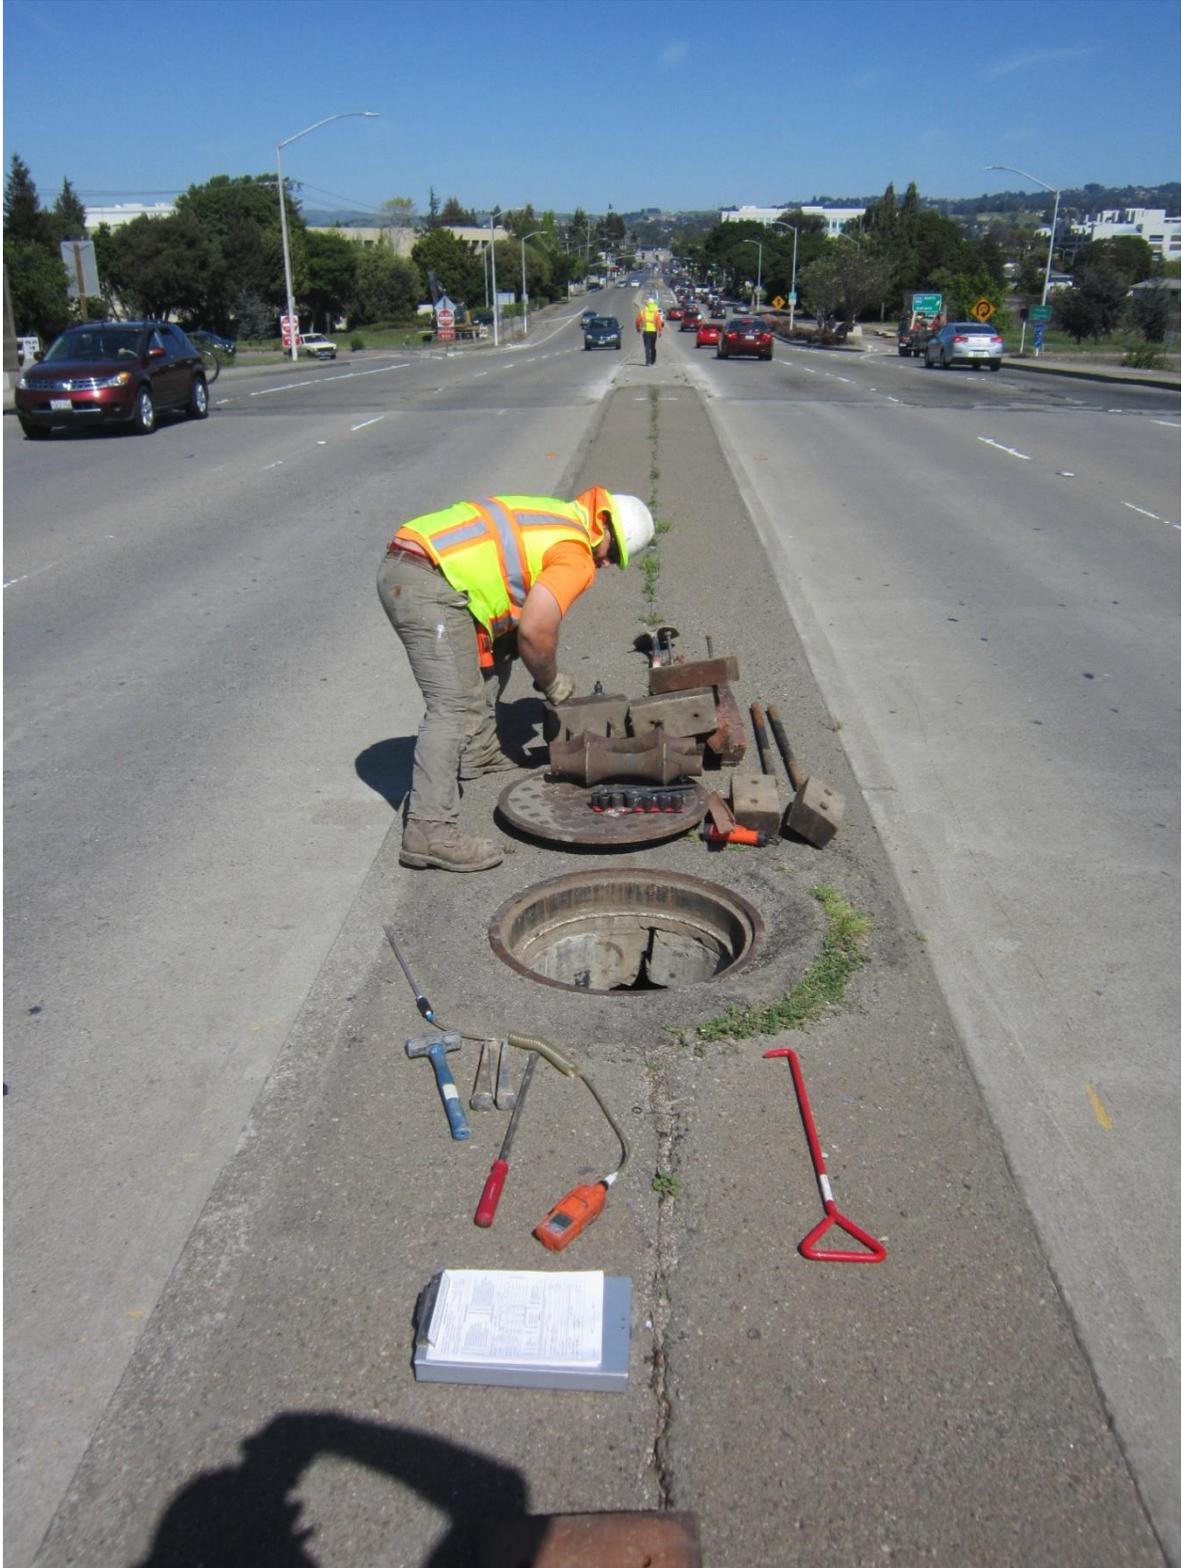
This photo shows the old roller supports coming out of the overpass. Notice the air monitor and the confined space entry permit in the foreground. Safety first!

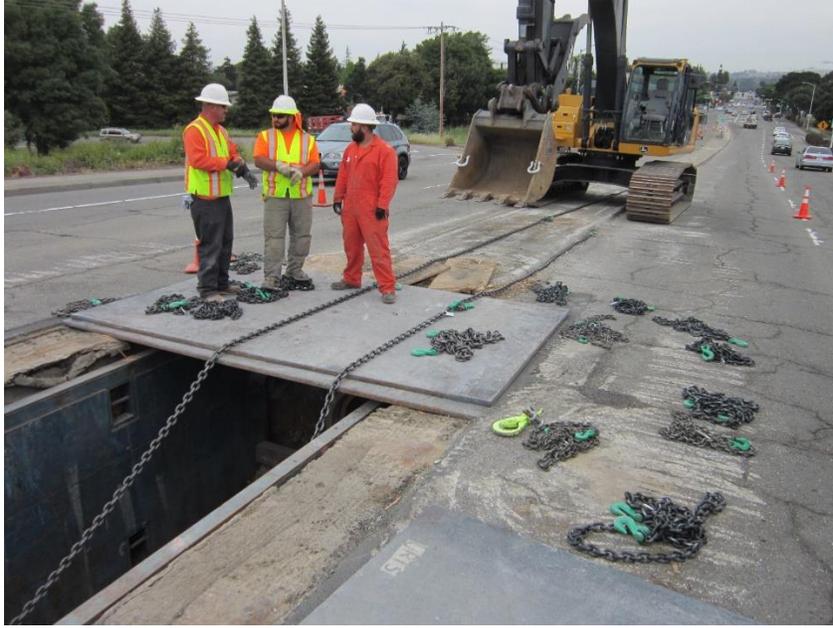
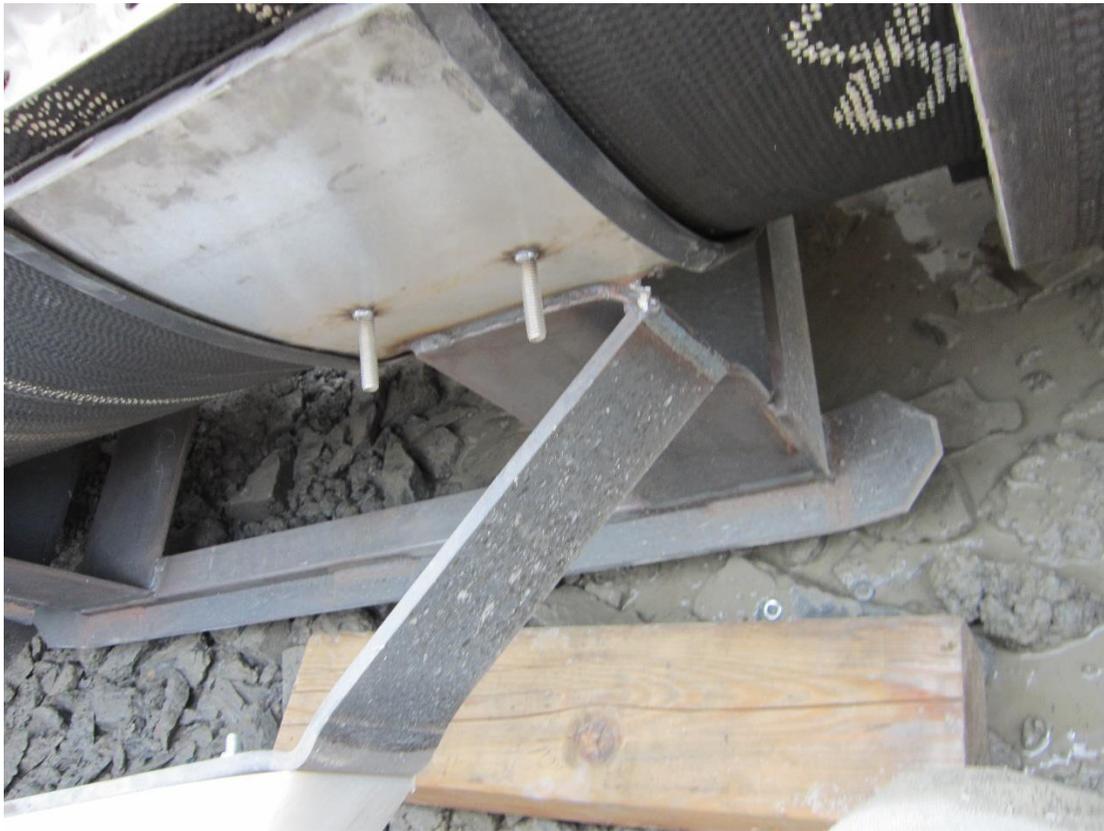
Staff elected to simply pull the pipe through the far side. We knew that the outriggers didn't have the clearance but elected to give the prototypes, that had served us very well, a final destructive test. This would give the welds the acid test. Despite the extreme deformation of the hot roll flat bar, the welds held. The base metal is what ended up finally tearing. The weld procedures employed by RA Metal were beyond reproach, as usual.

The mangled lead sled was removed and inspected one last time. Extremely minor design changes would be incorporated and the order for 47 sleds was immediately placed.

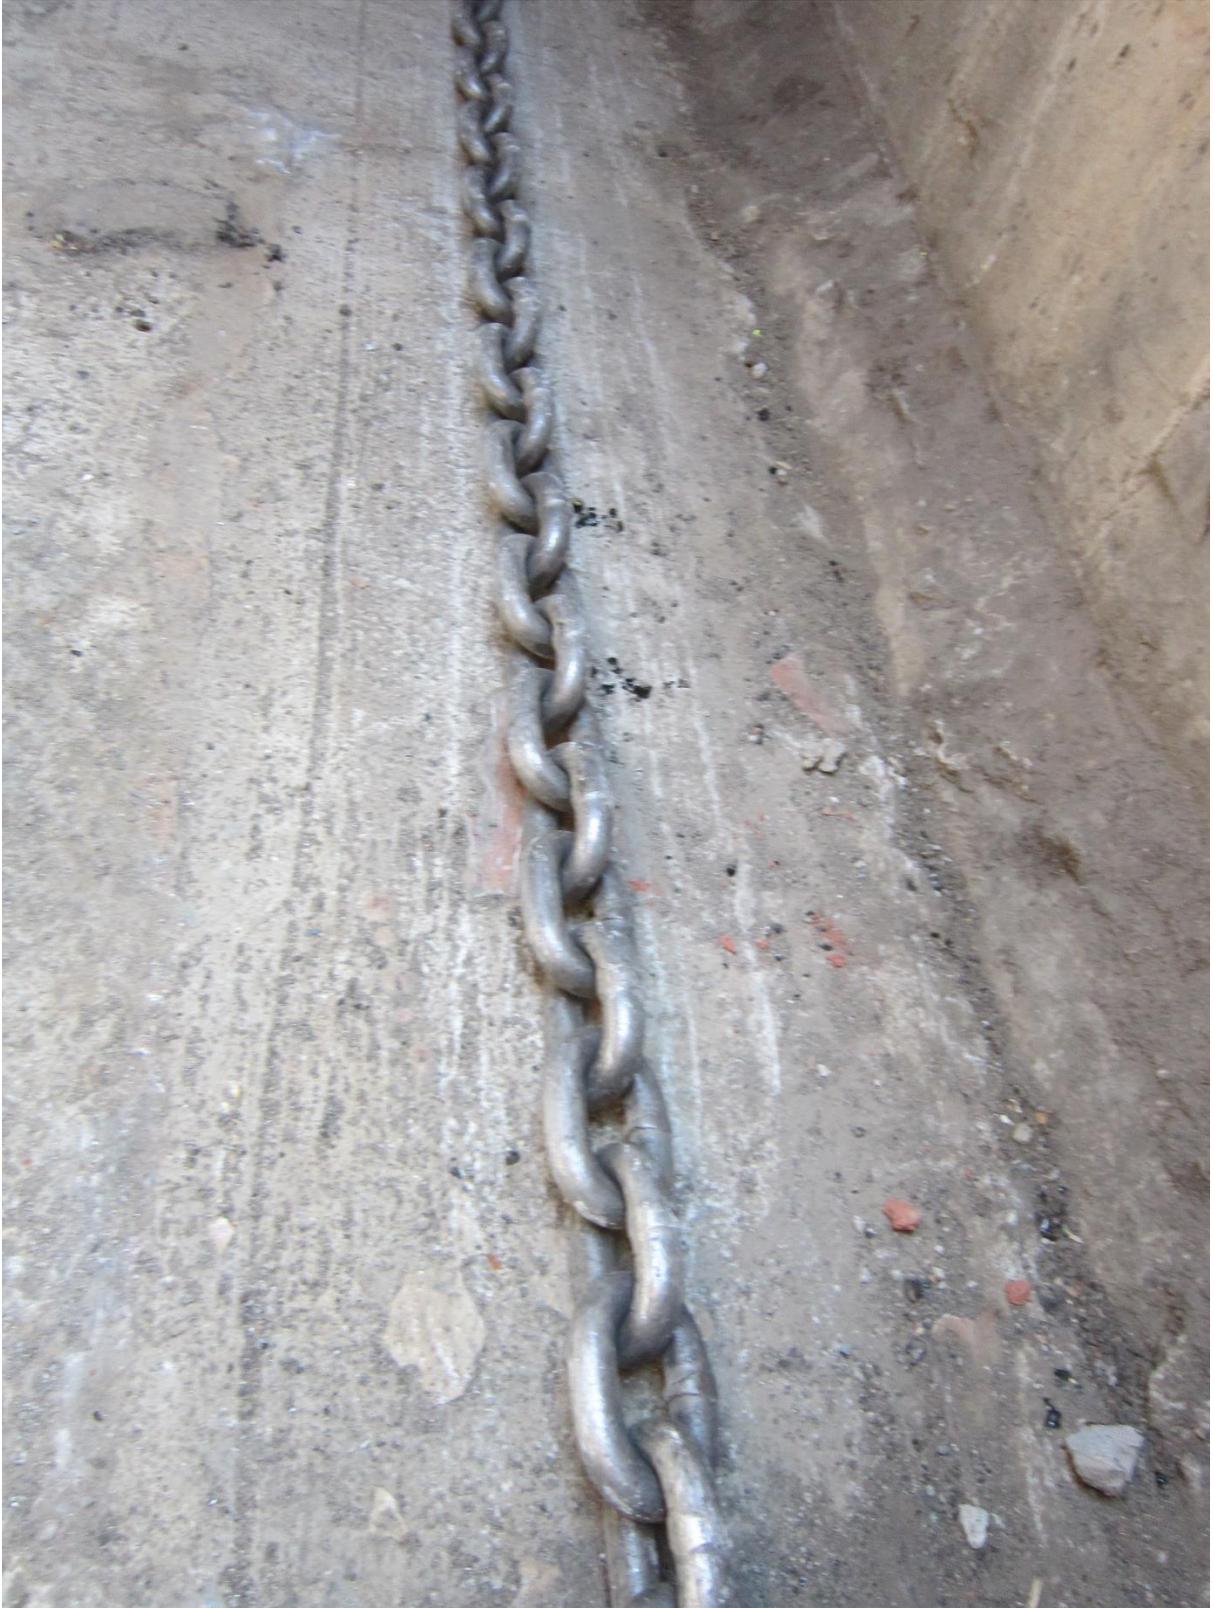
The wear to the floor of the overpass was for all practical purposes, nonexistent.

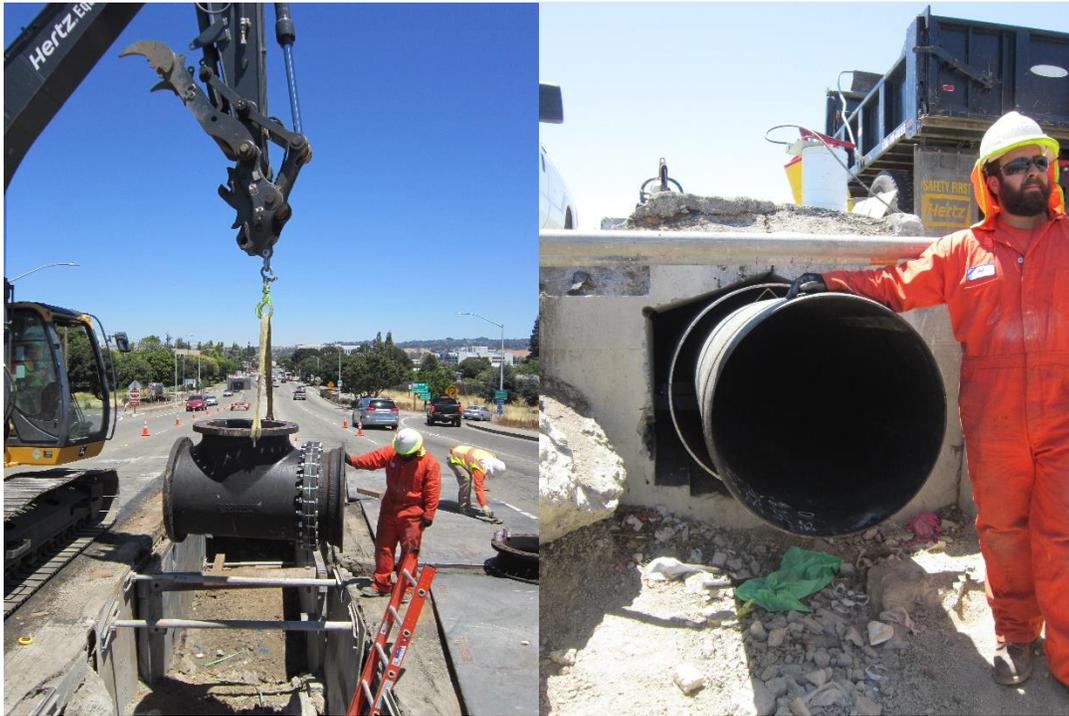
Note the tight clearances between the top of the Tee and the trench plate. This clearance actually dropped to 0.035 inches (the thickness of about 10 human hairs) in certain areas after the upper flange and bolts were installed. The precise dimensional tolerances were yet another challenge throughout the project, but successfully overcoming any challenge thrown our way also made the project fun.
