Audit of the
Calpine Corporation
Russell City Energy Center

Audit Number GA2019-01RC

June 2019

STAFF REPORT

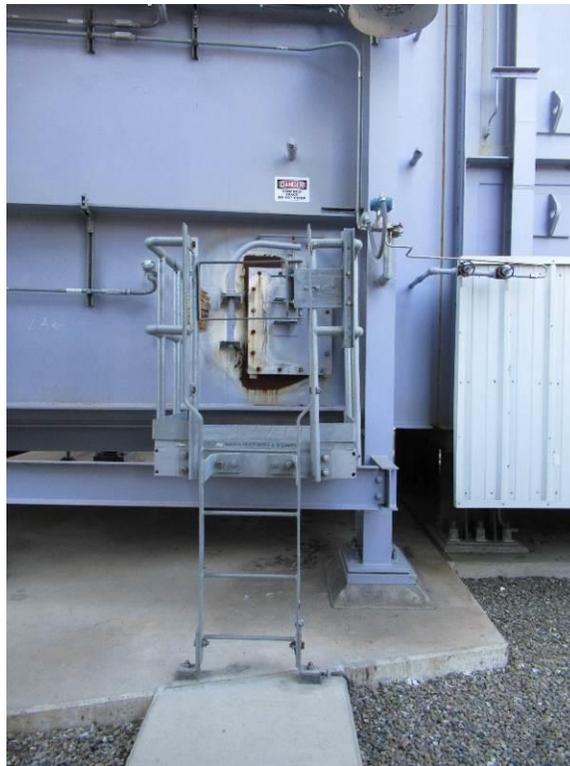
Finding 2: Manway hatch is severely corroded and presents a burn risk for workers.

ESRB observed a severely corroded access hatch on Unit 1’s HRSG. The corroded surface and discoloration surrounding the hatch indicate the area has been subject to high heat flux. This presents a burn risk hazard for workers as the hatch is within reach from ground level.¹ The Plant must take corrective action to mitigate the hazard and repair the defect. While ESRB did not observe similar defect on Unit 2, it recommends the Plant to inspect and assess all HRSG manways to identify and prioritize repairs where appropriate.

Figure 1: Manway hatch is severely corroded and presents a burn risk for workers.

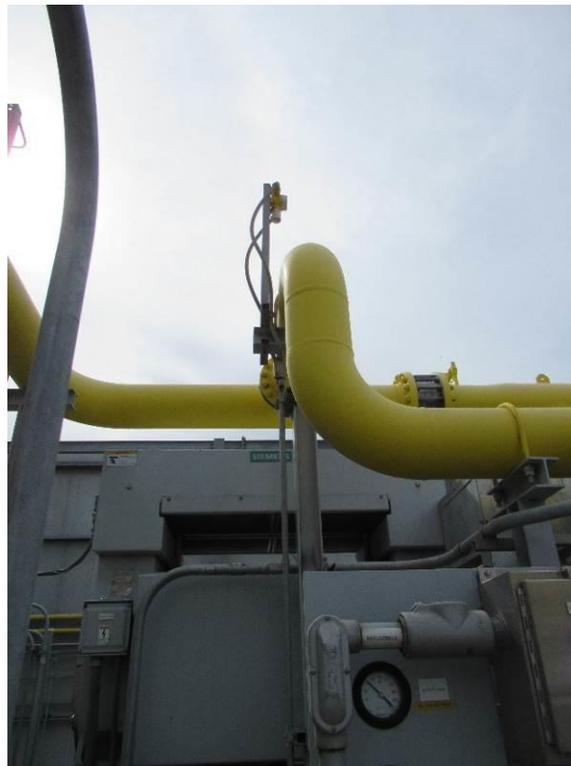
Finding 3: Methane detectors at the fuel gas compressors are defective. Due to the methane sensors at the fuel gas compressors being defective, the compartment currently lacks leak detection capability. There're four methane detectors in the compartment, all of which are not

functioning due to a low or no voltage (i.e. sensors are not receiving their power supply in proper voltage in order to function and detect). ESRB noticed that Russell City created a Level 4 (urgent) work order in Maximo on January 24, 2019.² However, at the time of the audit (March 2019), the Plant still has not yet repaired the defect. Methane sensors are a part of the fire protection system that detect leakage of natural gas which can accumulate in the compartment and lead to a natural gas explosion. The Plant must repair the detectors as soon as possible.

Figure 2: Methane detectors at the gas compressors are defective.

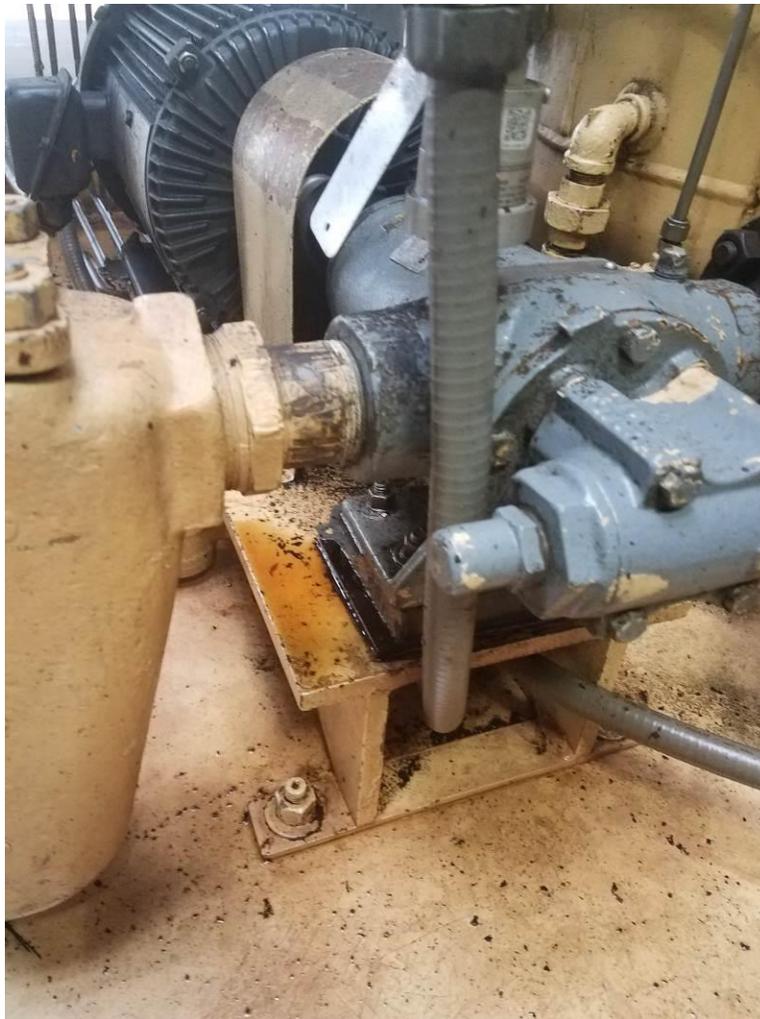
Finding 4: ESRB observed oil leaks at the steam turbine lube oil pump skid. The oil appeared to be leaking from the pump seal. Lube oil is flammable and can catch on fire if it contacts hot bearing or other pump surfaces. The Plant had previously created a work order (#26659485) to repair the leak, but the leak persisted. In response, the Plant generated a new work order (#27404664) and assigned it a priority level 3 to repair the defect. The Plant must repair the leak before it gets worse.

Figure 3: Oil leaks at the steam turbine lube oil pump skid.

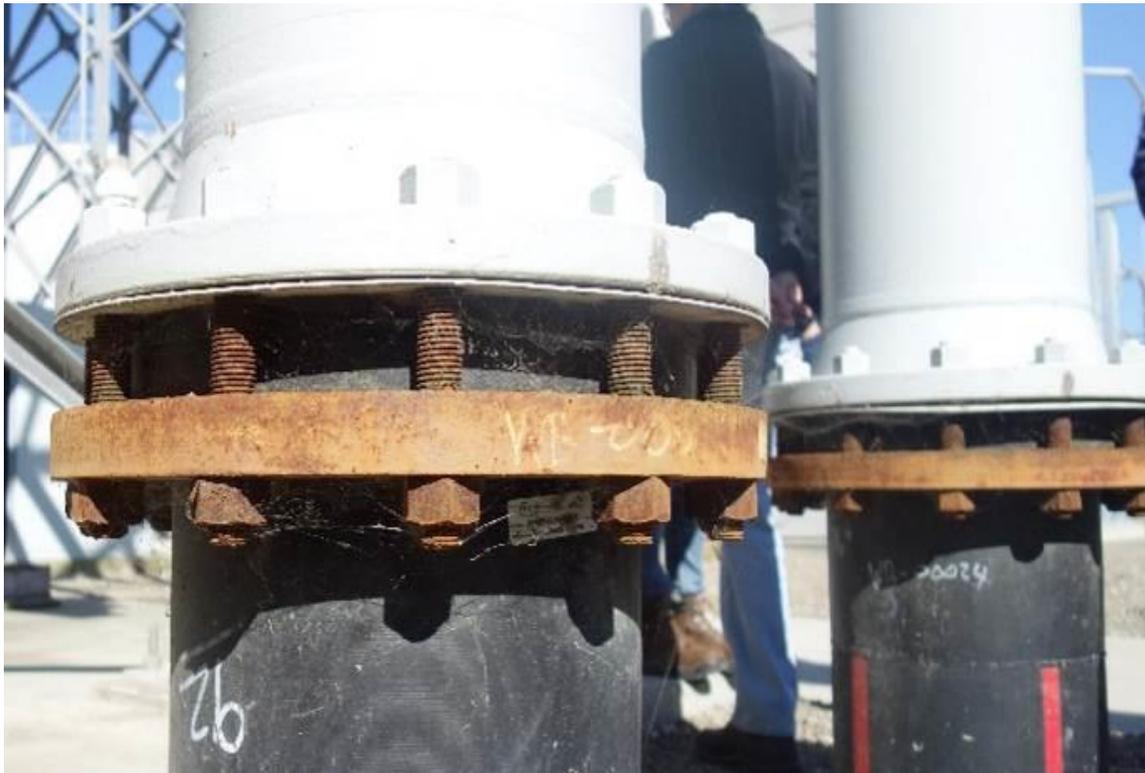
Finding 5: ESRB observed atmospheric corrosion on piping and pipe flanges, particularly on the cooling tower risers, and at the zero-liquid discharge (ZLD) crystallizer (See Figures 4 to 9). The Plant plans to clean and repaint the corroded surfaces and is looking into solutions to abate corrosion. As stated in Finding 1, the Plant is located close to the bay and is exposed to moist and corrosive sea air where corrosion is of concern. The Plant must take proper corrective action to address and mitigate atmospheric corrosion on equipment such as increasing the frequency of inspection and re-coating.

Figure 4. Corroded pipe flange.

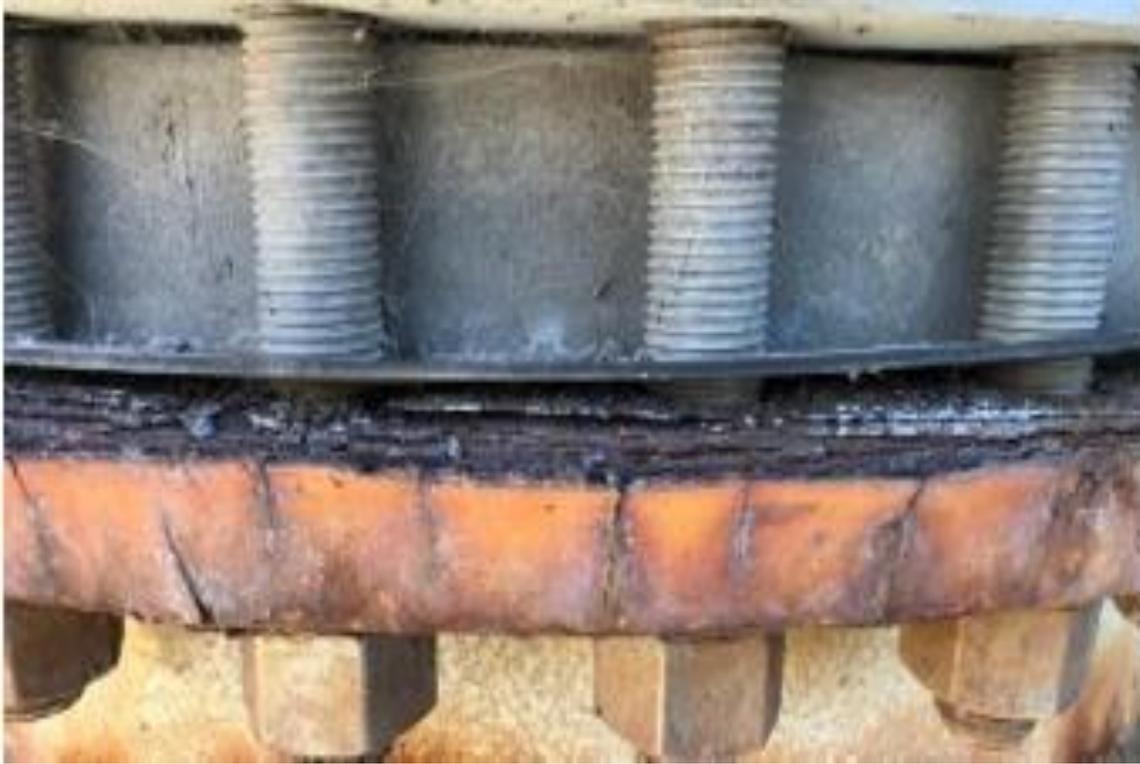
Figure 5. Corroded pipe flange.

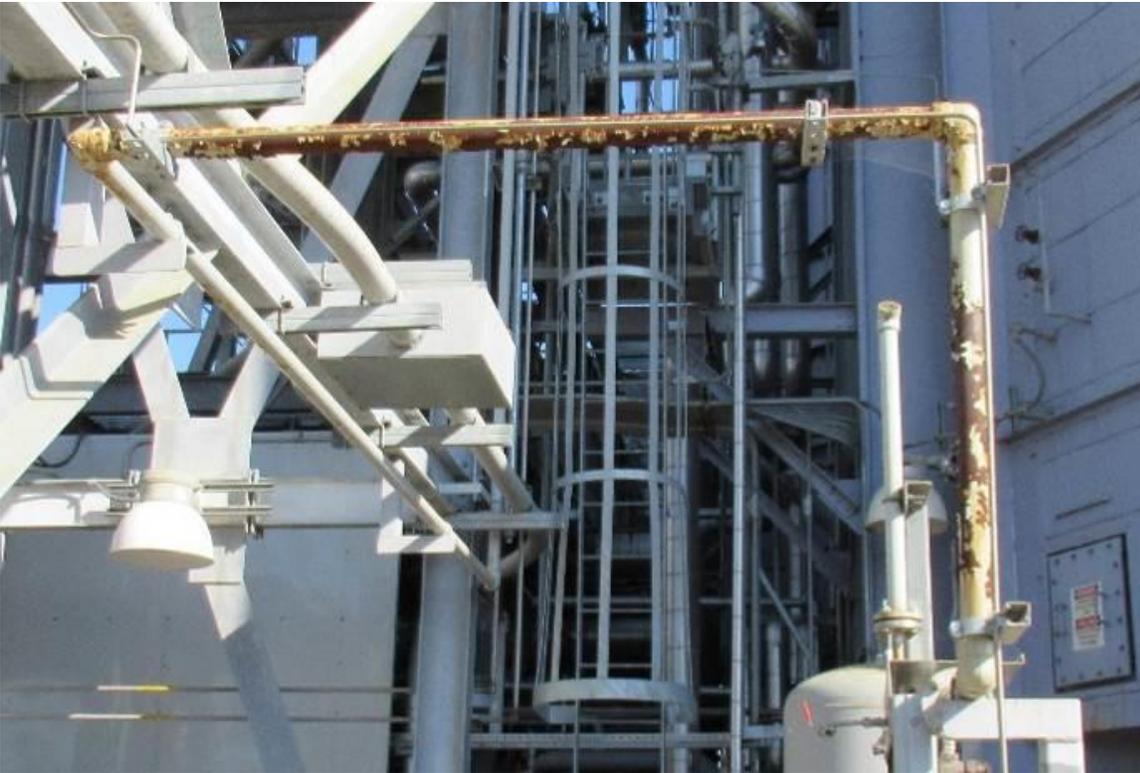
Figure 6. Corroded piping.

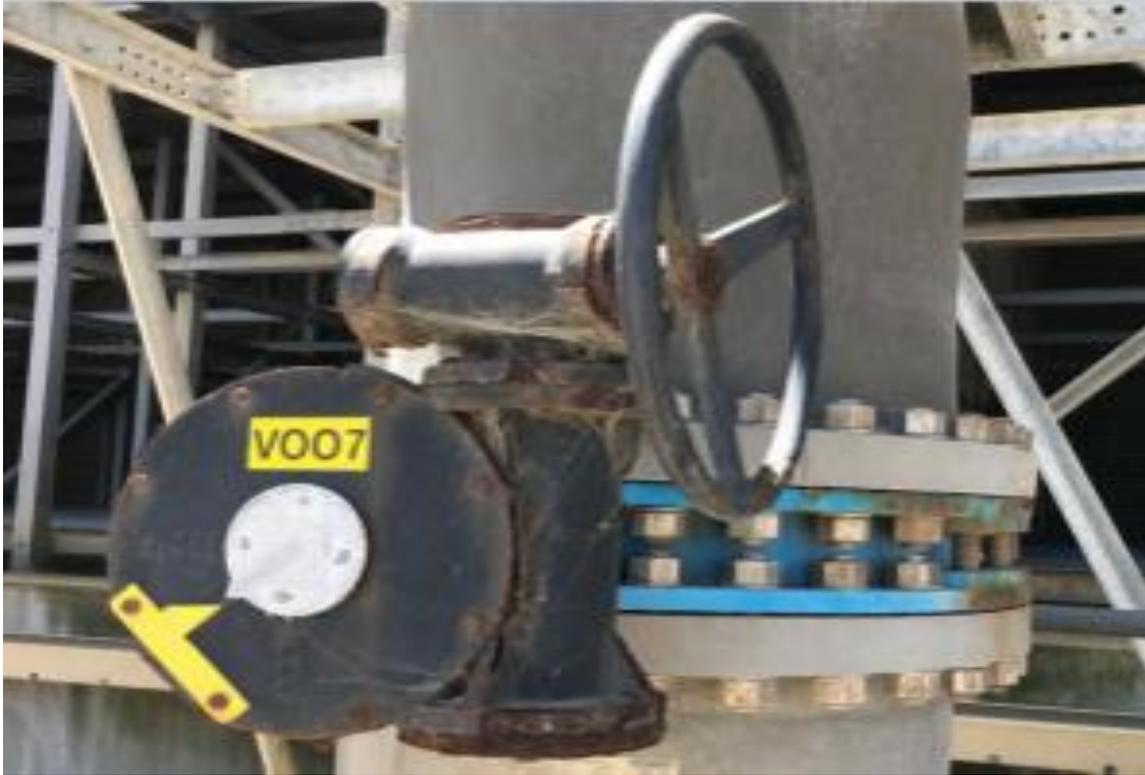
Figure 7. Corroded riser butterfly valve at the cooling tower.

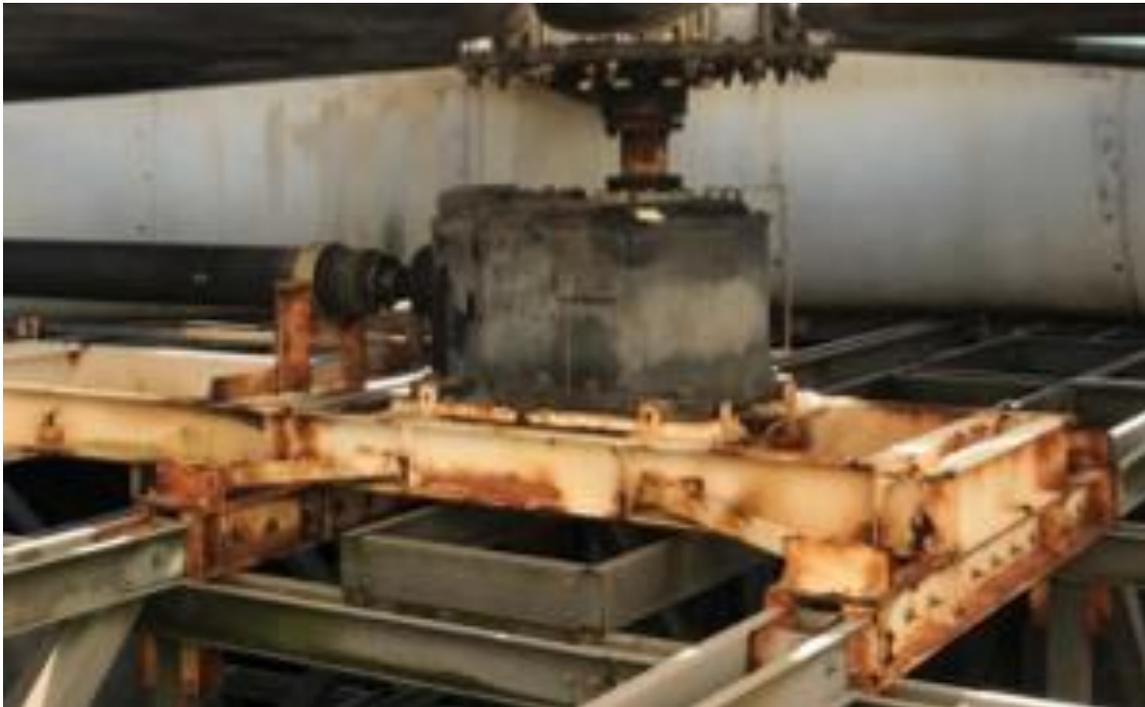
Figure 8. Corroded support braces.

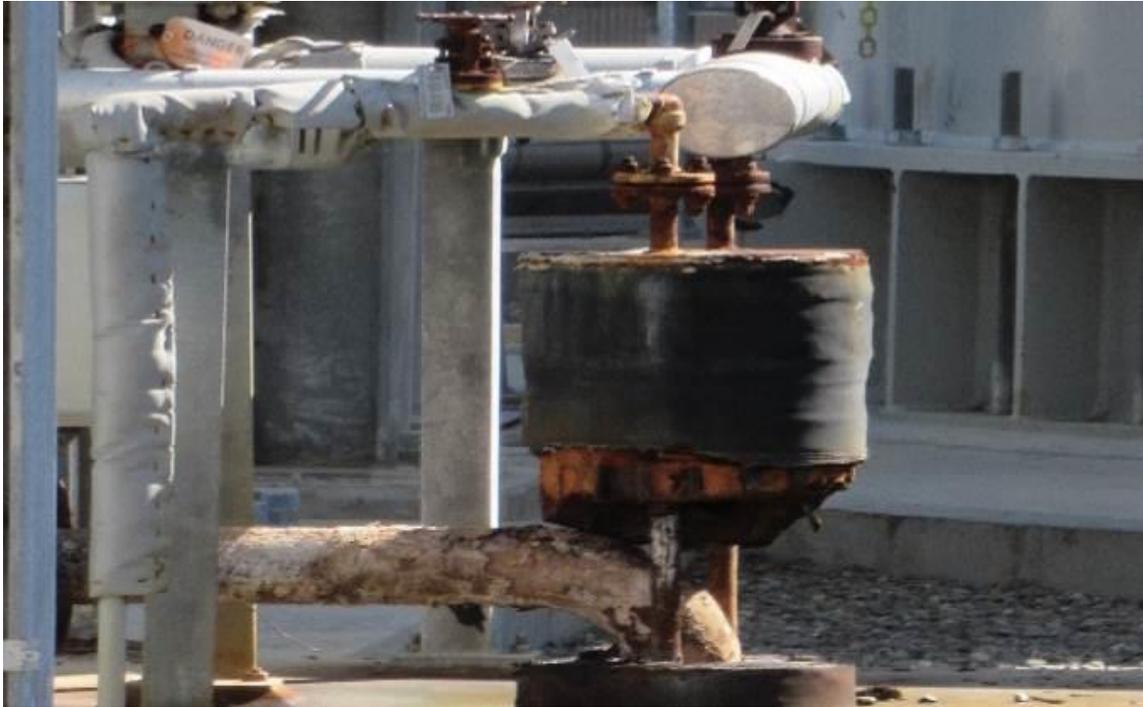
Figure 9. Corroded equipment at the ZLD.

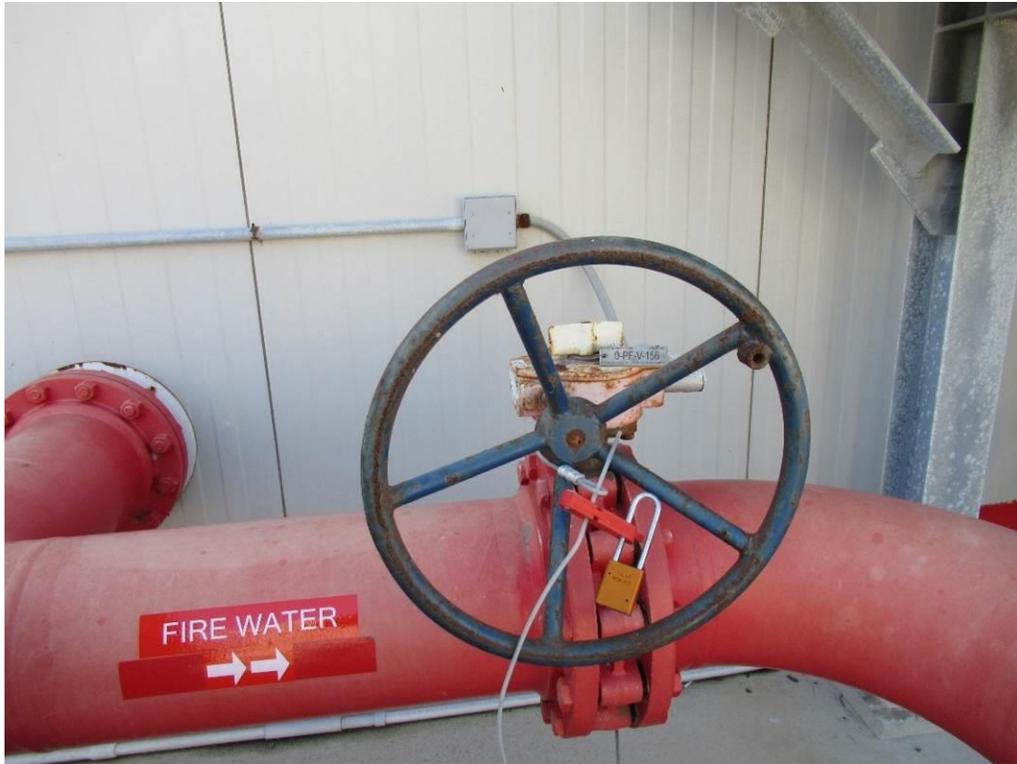
Finding 7: Tamper switches at two control valves outside the fire pump house are defective. Per inspection conducted by ORR Protection, two flow control valves next to the fire pump house had defective tamper switches. The Plant confirmed it has not repaired or replaced the switches. While the valves are currently locked open by chain, the tamper switches provide a secondary measure against inadvertent closure of the valves. Water flow to hydrants and sprinklers deluge systems is crucial in the event of a fire. The Plant must repair the defective switches to prevent tampering or accidental closure that would shut off the fire water supply.

Figure 10: Tamper switches at two control valves outside the fire pump house are defective.

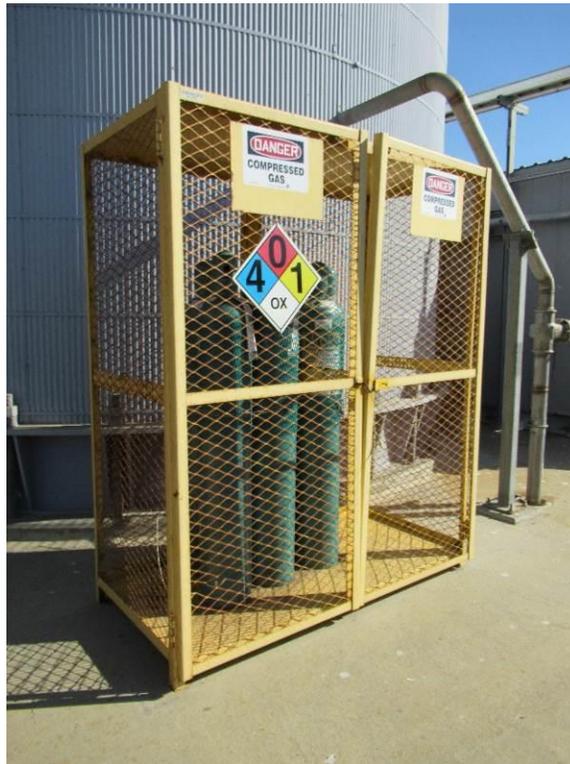
Finding 10: Compressed gas cylinders are not being secured properly. ESRB observed improper storage of compressed gas cylinders by the CEMS shack. The high-pressure gas cylinders are loosely held by a single chain with no secondary support, and are otherwise, freestanding. While the Plant stores the tanks inside a metal cage, ESRB observed the cage doors are not secured. General Industry Standard requires compressed gas cylinders to be stored in a manner to prevent hazards by tipping, falling, or rolling.³ Russell City is located near the Hayward Fault and the area is prone to seismic activities and minor quakes. The Plant must properly secure compressed gas cylinders to prevent tip-overs.

Figure 11: Compressed gas cylinders are not being secured properly.

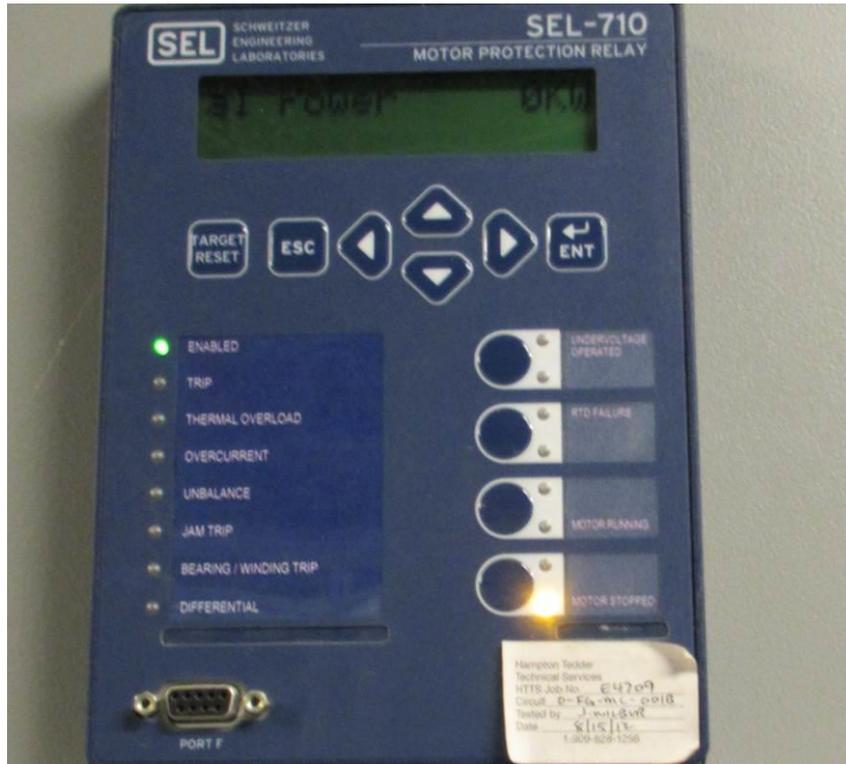
Finding 11: Calibration stickers are not kept up-to-date. ESRB observed outdated calibration stickers on breaker relays in the 4160V load center. Similarly, online analyzers in the Sampling Water Analysis Shack also have out-of-date stickers. Outside operators routinely take readings off of these instruments. Without up-to-date stickers, operators may get confused as to whether or not the instrument reading is reliable, which may lead to operational error. While the Plant may track calibrations separately in a database, stickers at the instrument location (point of reading) is an effective and inexpensive way to communicate to the operator regarding the instrument’s calibration status.

Figure 12: Calibration stickers are not kept up-to-date.

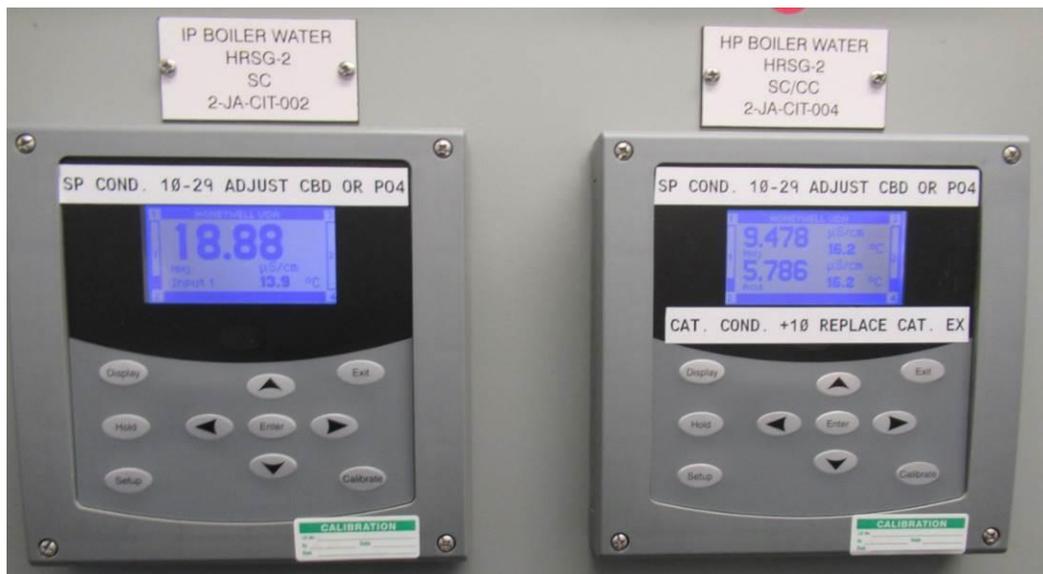
Figure 13: Calibration stickers are not kept up-to-date.

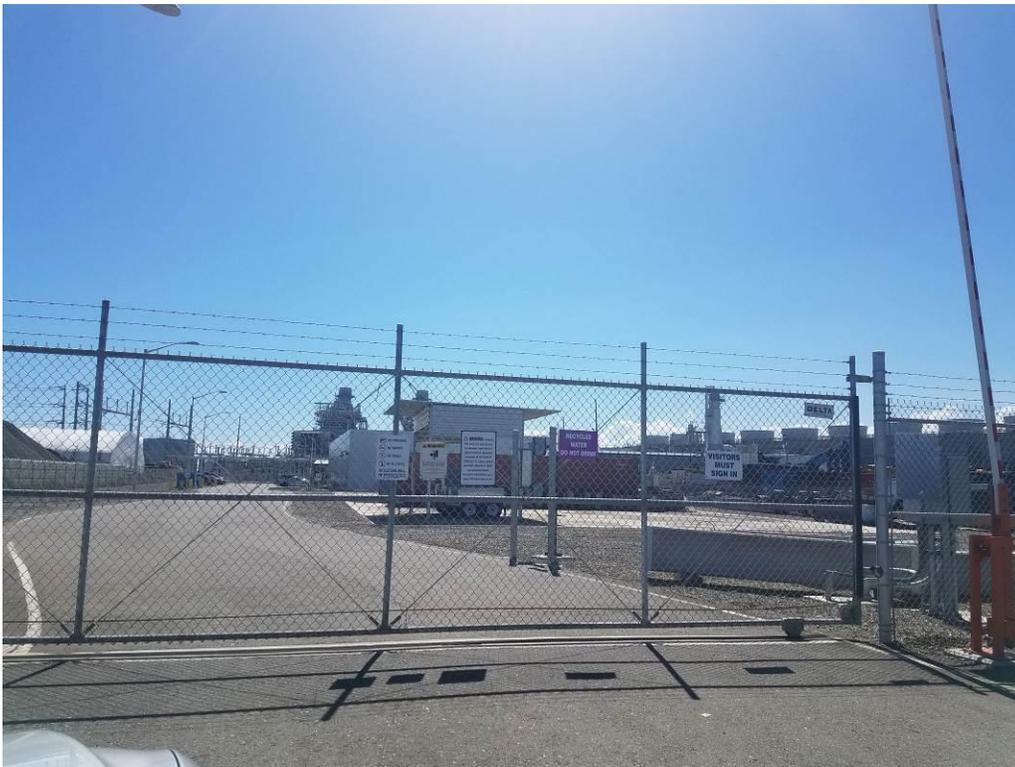
Finding 12: Missing NFPA Placard on main gate. ESRB observed that the Plant’s main gate did not have a National Fire Protection Association (NFPA) 704 warning placard. The Plant

stockpiles and uses hazardous chemicals as part of its normal operation, including ammonia for emission controls, sodium hypochlorite, pH adjuster, and oxygen scavenger for feedwater controls. NFPA 704 is a standard system for identifying hazards of materials for emergency response. The posting of an NFPA placard on the main gate is a common industry practice so first responders can quickly and easily identify the risks posed by a facility's hazardous materials. This helps emergency personnel to determine what safety gear and precautions to use and how best to respond in emergency situations. In response, the Plant installed a placard on the main gate. Therefore, the Plant does not need to take further corrective action.

Figure 14: Missing NFPA Placard on main gate.

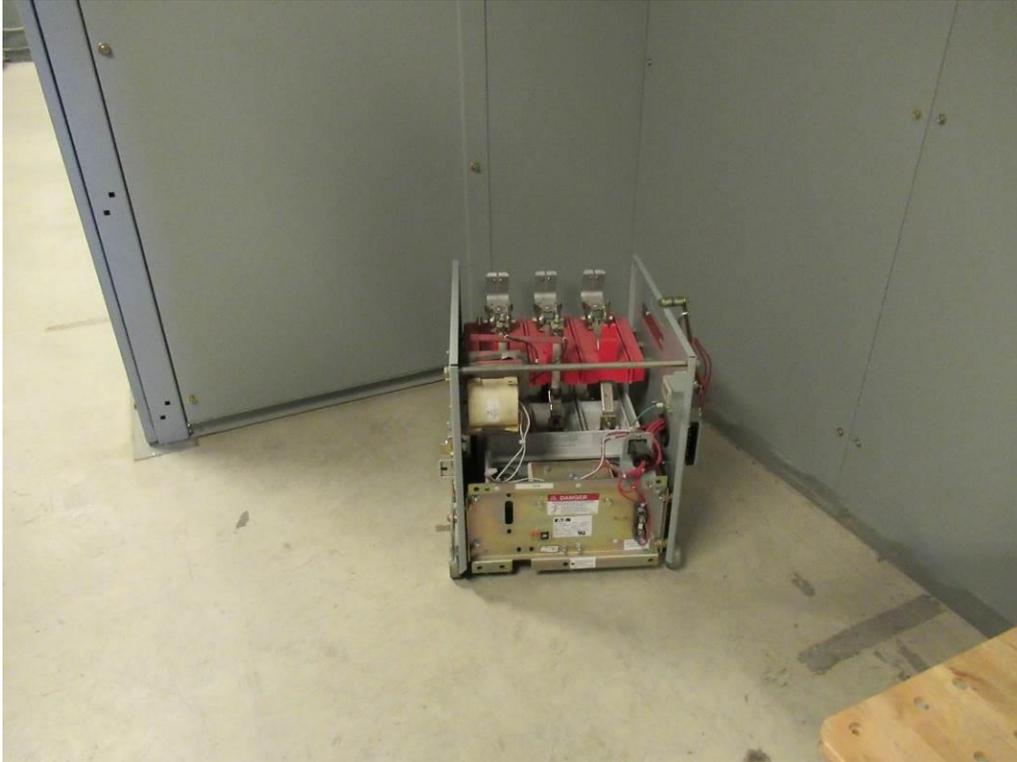
Finding 14: Improper storage of spare component. ESRB observed a metal-clad breaker being precariously stored in the 4160V load center. The Plant should store spare components in the warehouse where they’re properly tracked and inventoried. In response, the Plant relocated the spare part back into proper storage in the warehouse. Therefore, the Plant does not need to take further corrective action.

Figure 15: Improper storage of spare component.

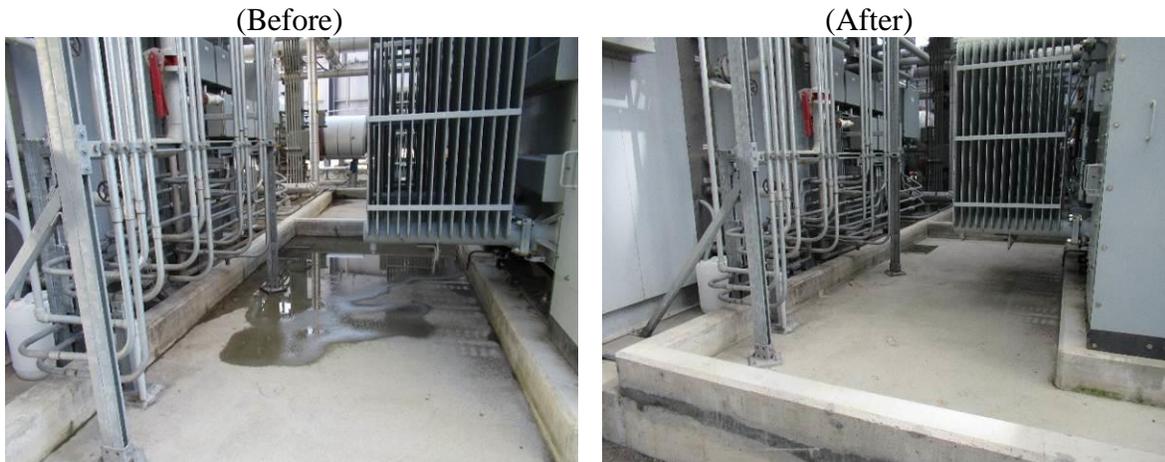
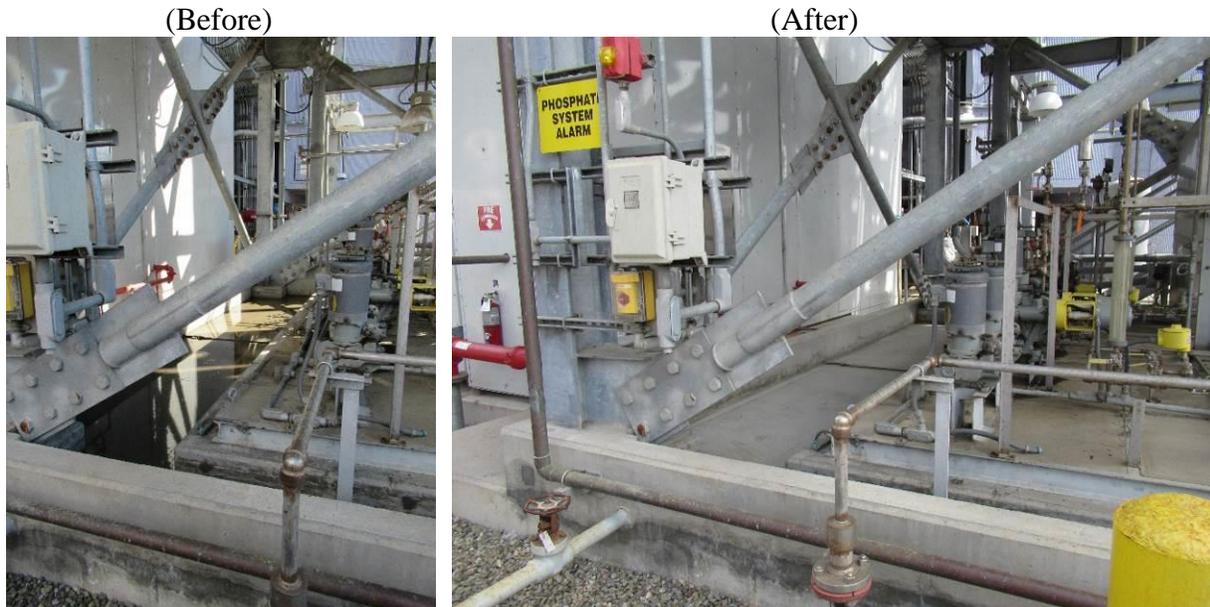
Observation 1: Water ponding in secondary containments. ESRB observed water ponding in secondary containments of Unit 1’s station transformer and phosphate storage tank. Due to recent storms, rainwater had accumulated in the containment. In response, the Plant tested the water with pH strips (confirming it was indeed storm water) prior to draining the water out of the containment. Containments are designed to hold certain fixed volume per the equipment in the event of a leak. Allowing water to pond in the containment displaces its design volume and defeats its purpose. While the amount of water in the containment did not appear to significantly lower the catch volume, ESRB nonetheless recommends the Plant to follow good industry practice to drain containments after major storms.

Figure 16: Before and after photos of water ponding in secondary containments.
