**Route 238 Bypass – Group 6**  
Hayward, California

**PRELIMINARY GEOTECHNICAL EXPLORATION**

January 9, 2017

**Project No.**  
12843.000.000

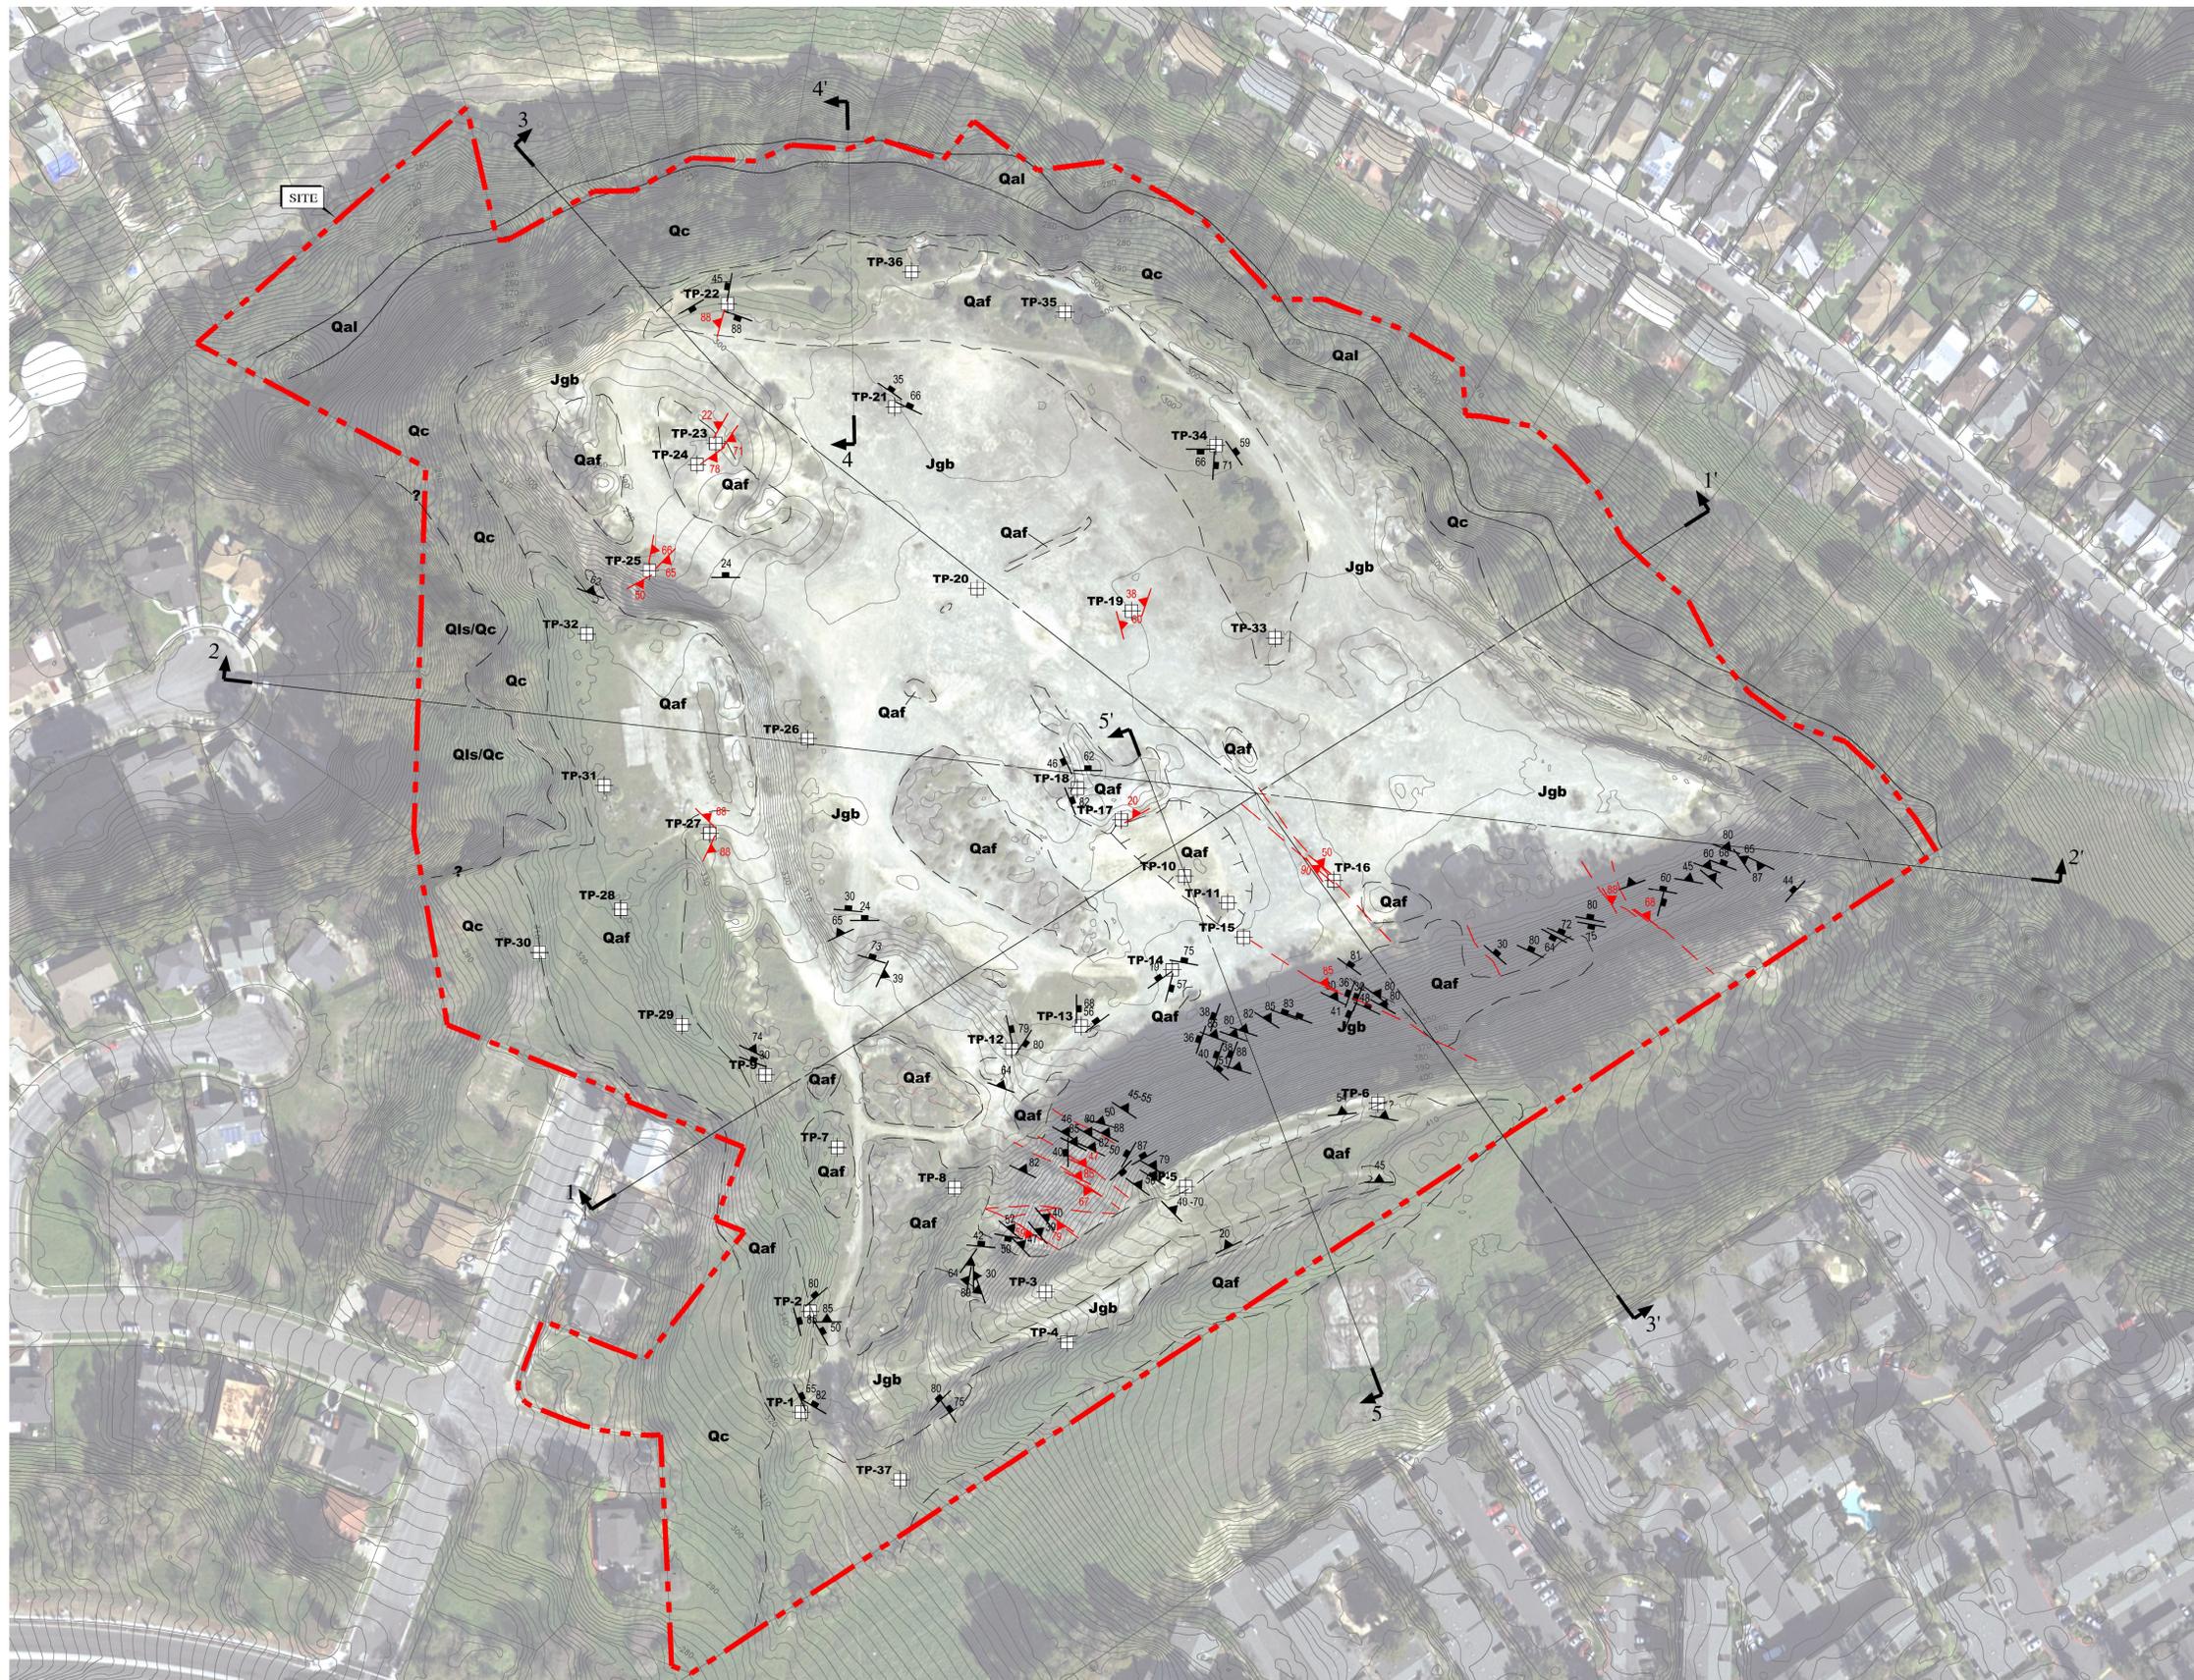
A steep-sided slope exhibiting earthflow/slide mass accumulation is located in the western portion of the site (Figure 3). This earthflow/slide mass comprises silty clayey sand and we estimate it is approximately 15 to 20 feet thick. This area is also shown on the map by Nilsen (1975) as well as CGS (2003; Figure 3). The earthflow does not appear to exhibit signs of recent activity, such as cracking or displacement near the head scarp or sloughing of surficial soils. This steep slope is located immediately up slope of residential homes located at the end of Redstone Place, and in our opinion poses a slope stability hazard to the existing homes.

The deepest depths to bedrock were encountered in Test Pits TP-31 and TP-33 at approximately 13½ feet below the ground surface and 15½ feet below the ground surface, respectively. TP-31 was located on the western edge of the site likely where a fill pad was created above native colluvium. We observed the thickest surficial material consisting of fill and colluvium at the western portion of the site and may be susceptible to slope movements. TP-33 was located on the floor of the quarry in the northern portion of the site. The relatively deep depth to bedrock suggests that there may have been some kind of cut at this location that was infilled at some later date.

Consult Figure 3 and the boring and test pit logs for specific subsurface conditions at each location. We include our exploration logs in Appendix A. The logs describe the soil type, color, consistency, and visual classification in general accordance with the Unified Soil Classification System (USCS). The logs graphically depict the subsurface conditions encountered at the time of the exploration.

As discussed in the Geologic Mapping section, there is a likely landslide located at the western edge of the site. This landslide mass is located precariously uphill from the over-steepened quarry slope on the western edge of the site with a residential community located in close proximity downslope. From inspection, this slope should be graded to mitigate the risk to downslope residences. We recommend in Section 5 below that this slide mass be removed and the upper portion of the slope be re-graded to a shallower inclination.

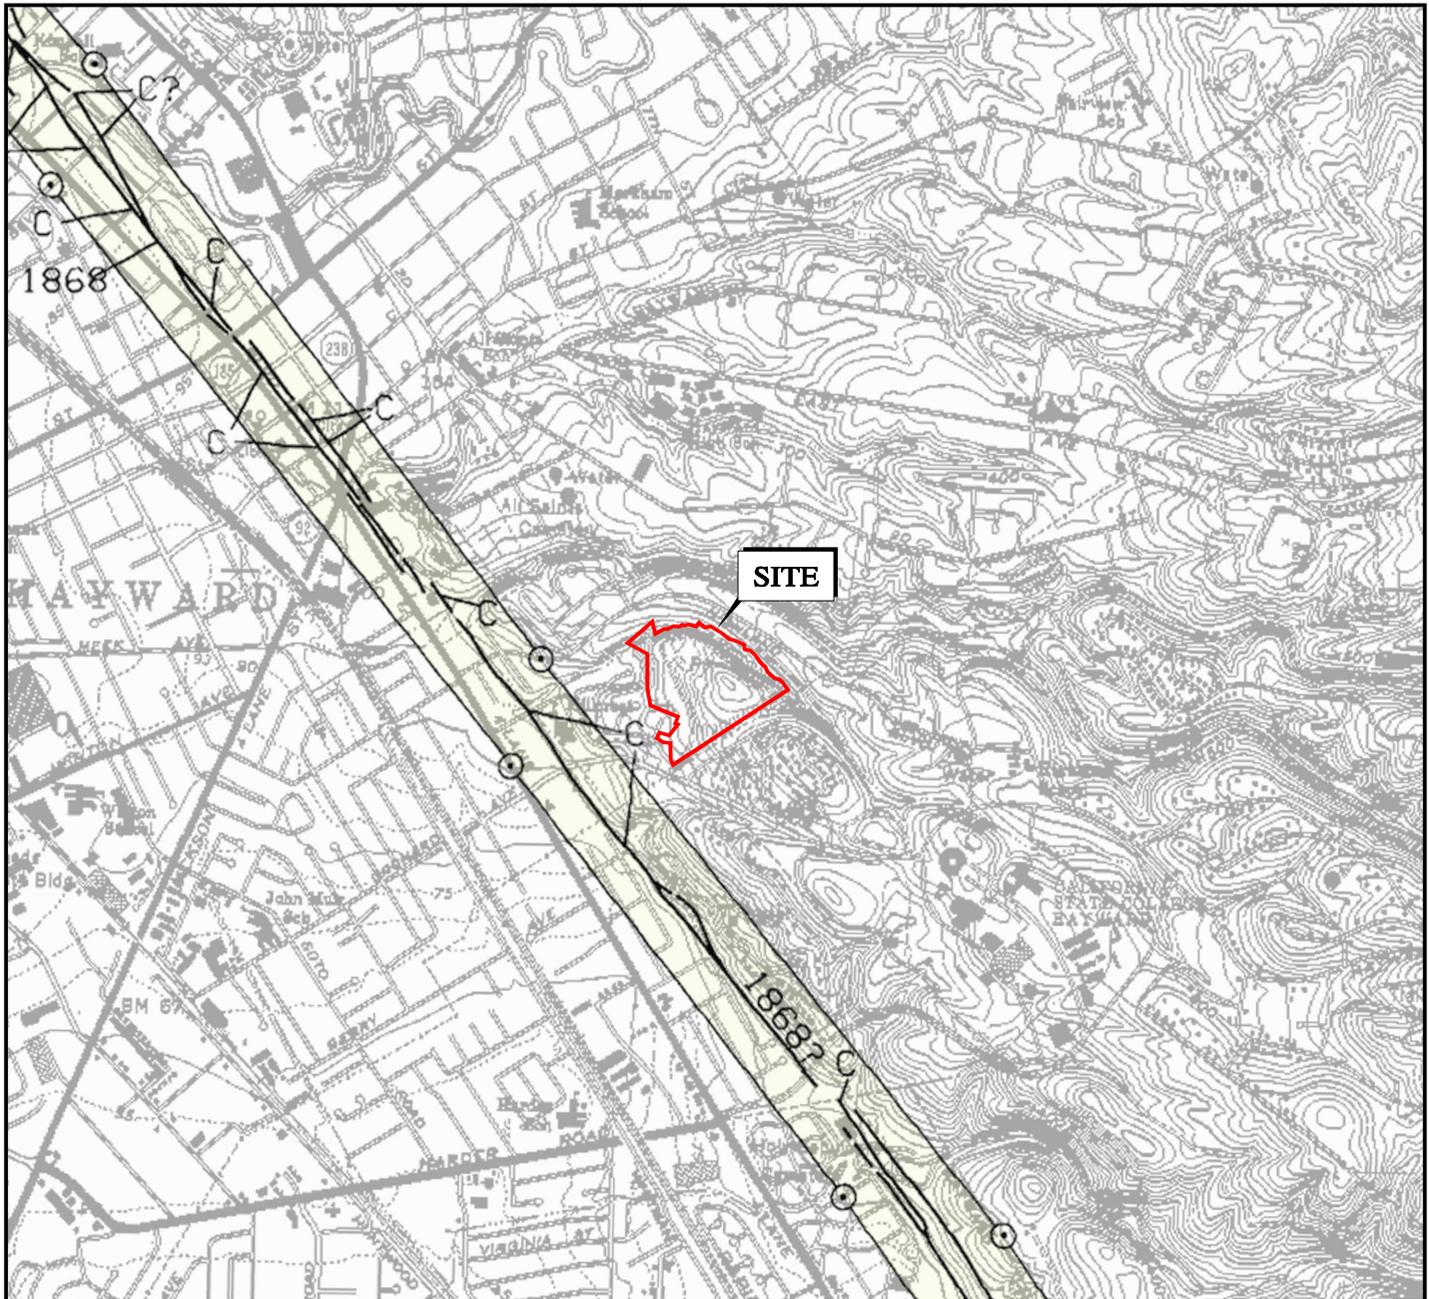
FIGURE NO.  
**5**

The site is located adjacent to the Hayward fault zone; however, the property lies outside of the designated State of California Earthquake Fault Zone (Figure 5). The Hayward fault is considered an active fault with a general right-lateral sense of movement. The Hayward fault is a creeping fault that displays evidence (off-set curbs, en-echelon cracks within pavements, etc.) of fault creep along various segments.

As previously discussed, the site is not located within a State of California Earthquake Fault Zone. Based on our field mapping, review of aerial photographs and the results of our field exploration, it is our opinion that fault-related ground rupture is unlikely at the subject property.
