**Fire Station #6
and Training Center**
Initial Study and Mitigated Negative
Declaration (IS/MND)

September 2018

**City of Hayward
Capital Improvement Project**

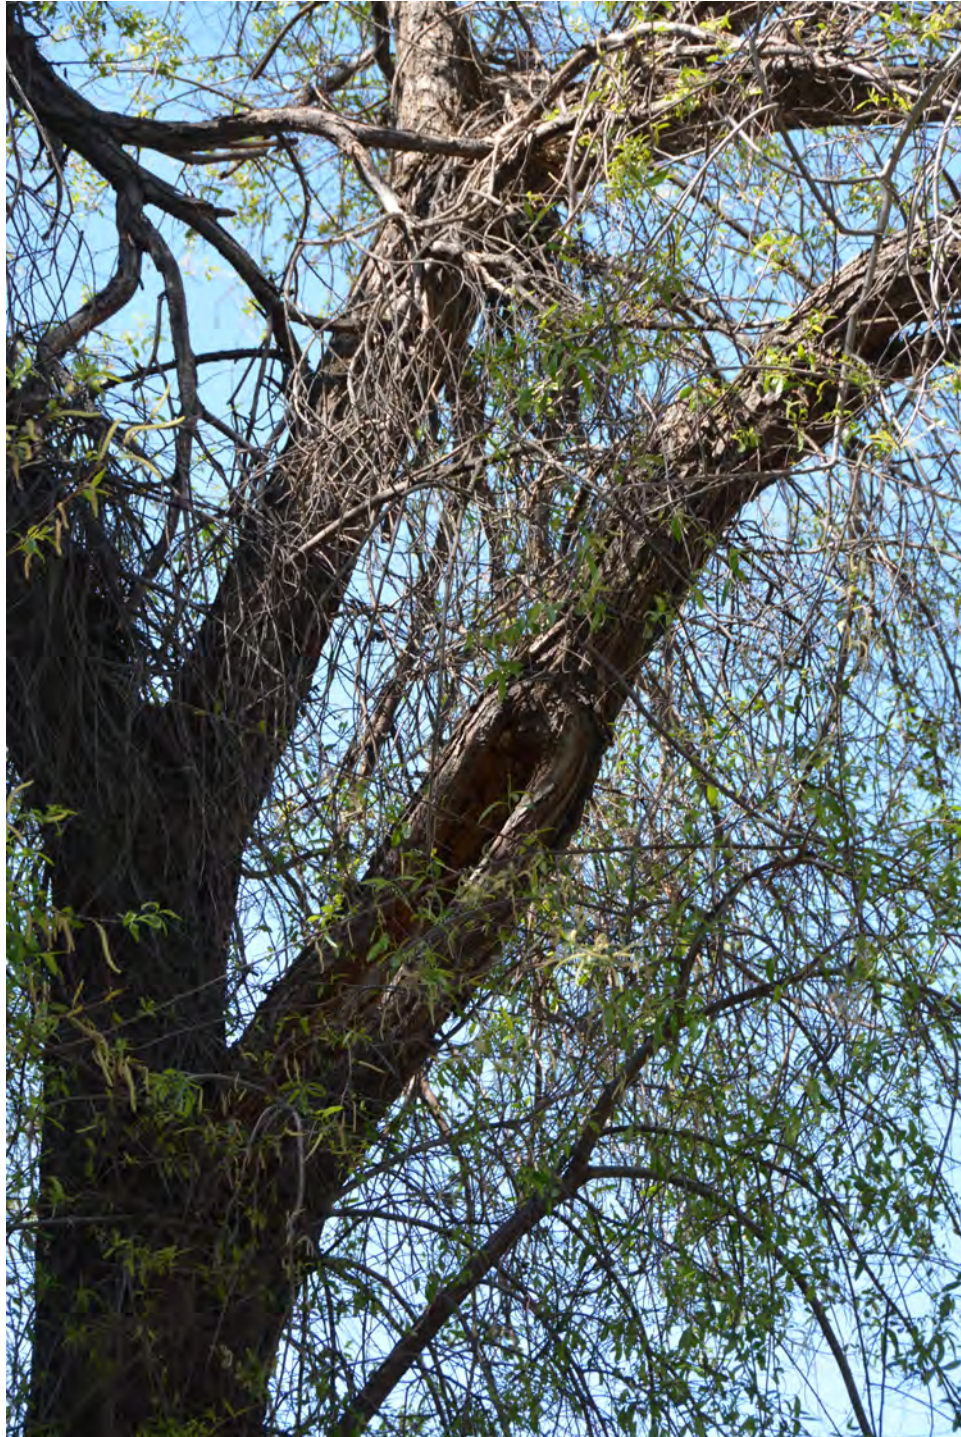
Willows along property line (#7 and #8)

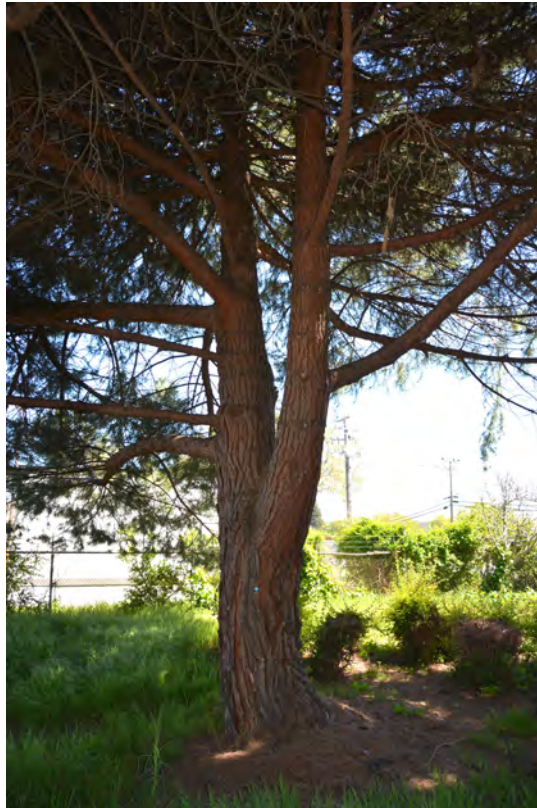
Defective, included, co-dominant trunks on Italian stone pine.

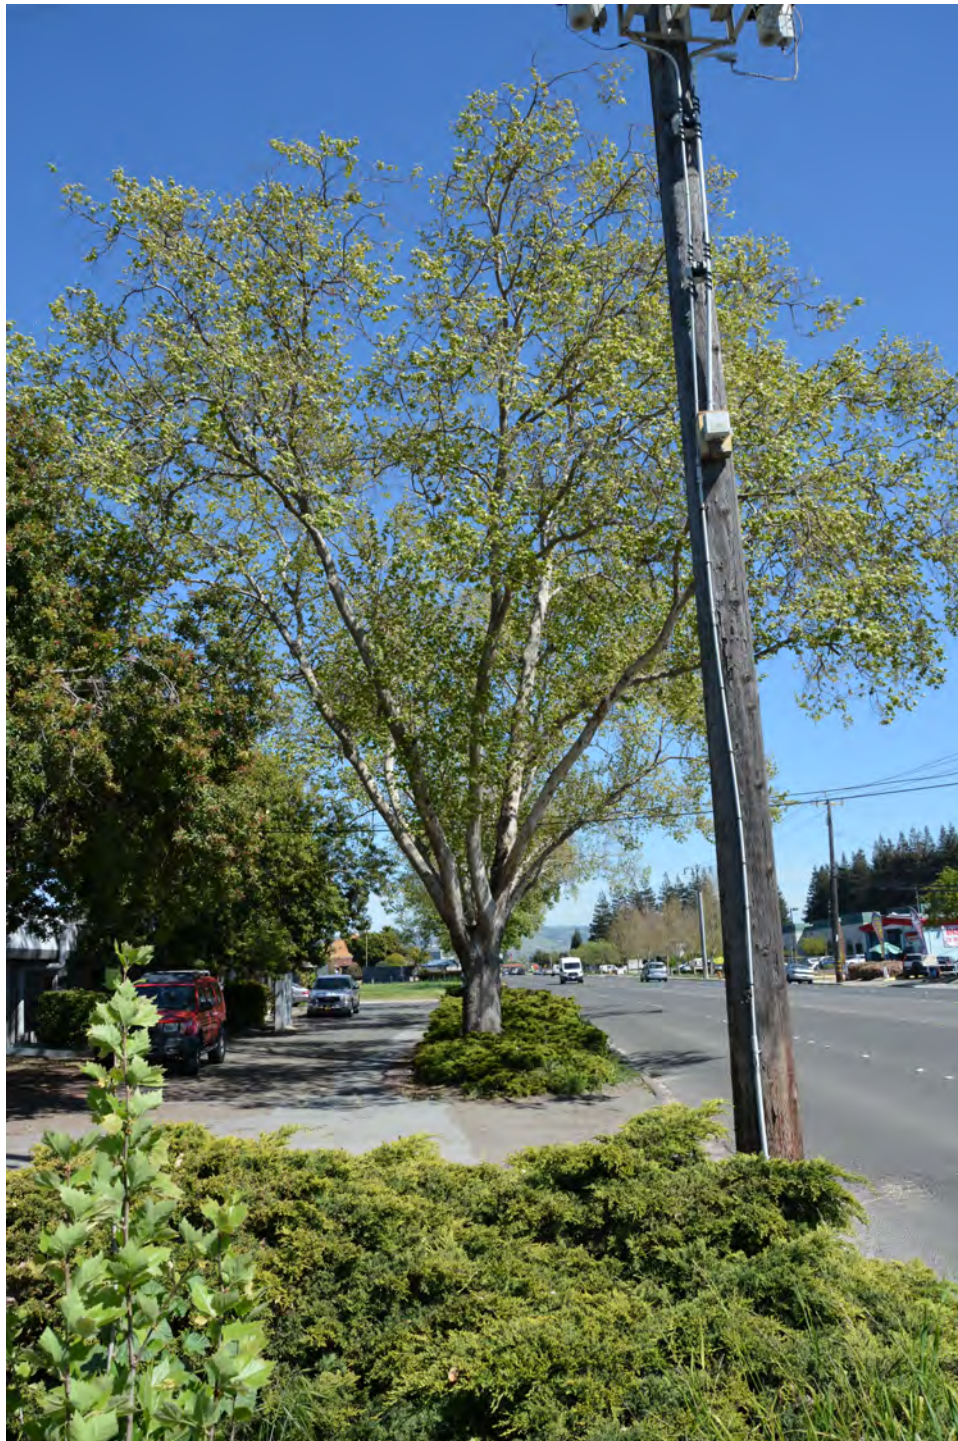
London plane tree in very poor condition (tree #18)

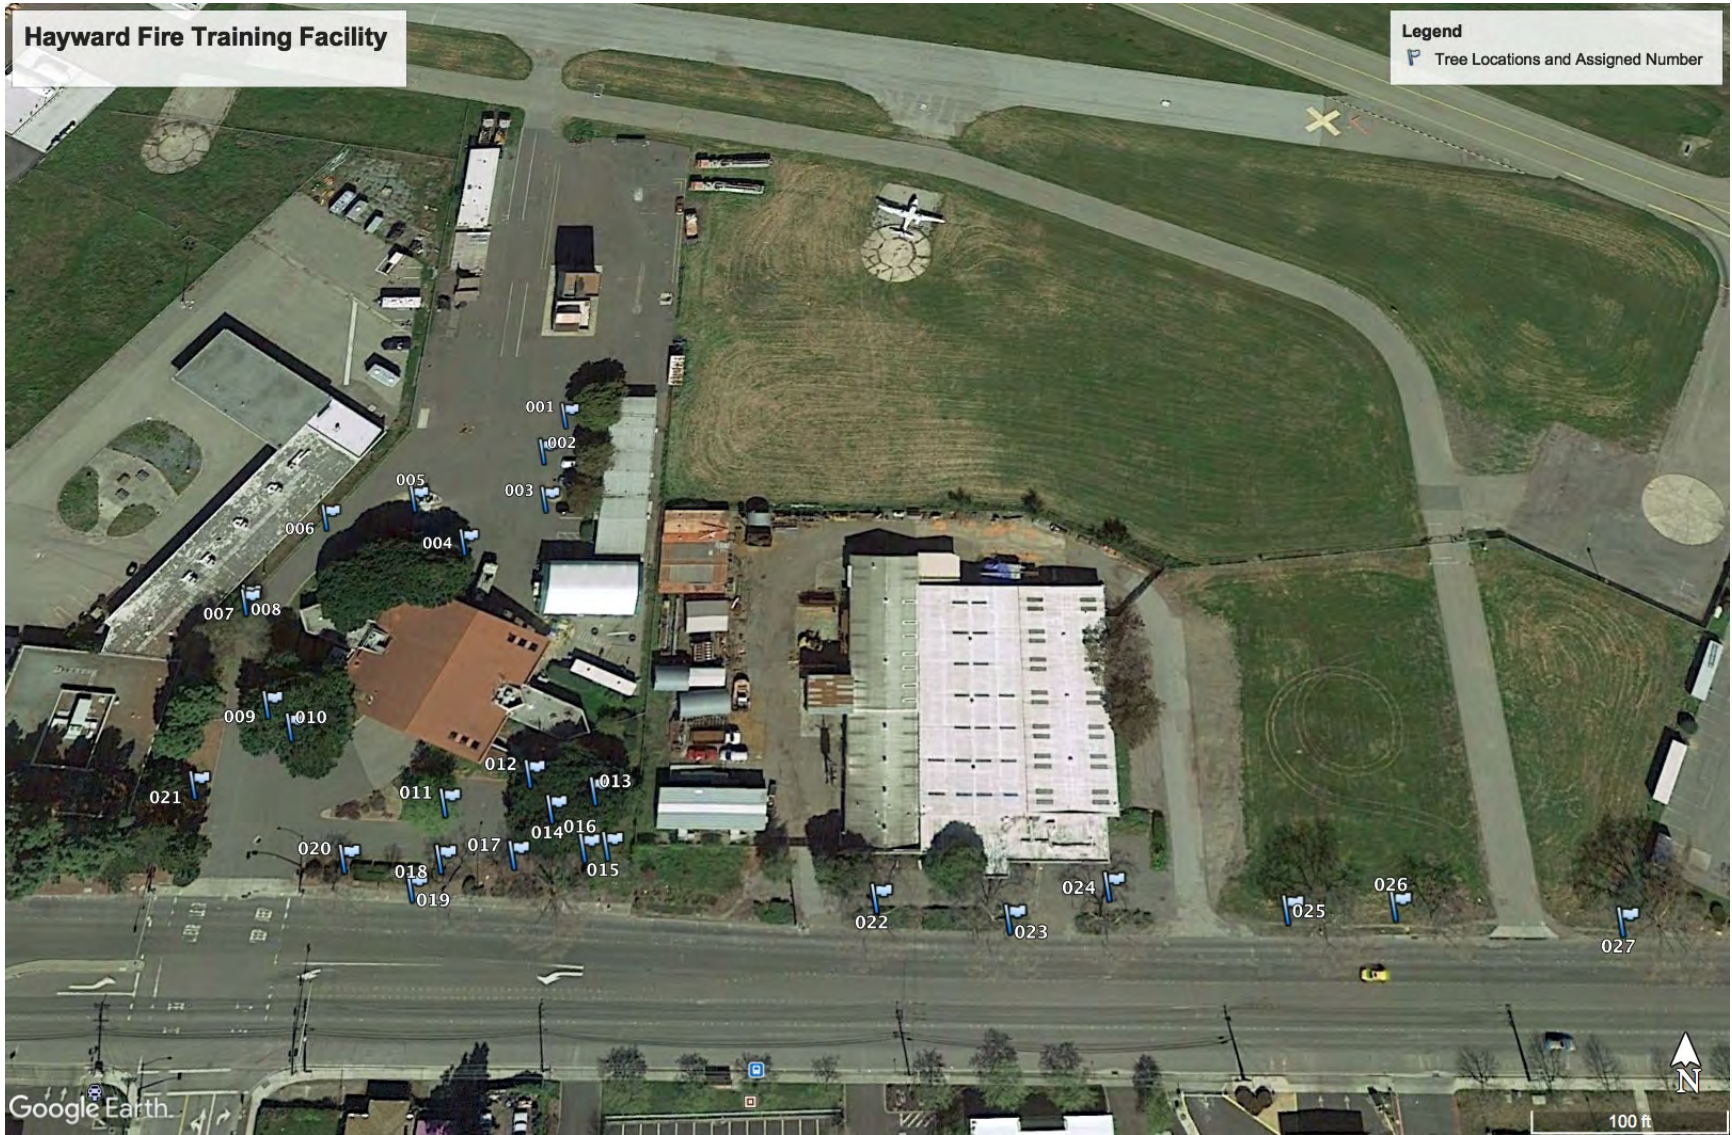
Hayward Fire Training Facility
Tree Location and Numbering Aerial

Aerial showing tree locations and assigned tree numbers.

An Arborist Report was prepared by MacNair & Associates, dated September 14, 2017, evaluated and assessed the health, structural conditions, and value of the existing twenty-seven (27) trees on-site and has been attached to this document as **Appendix B**. According to the arborist report, the 27 trees consist of seven different species including bronze loquat (*Eriobotrya deflexa*), English walnut (*Juglans regia*), ginkgo (*Ginkgo biloba*), Italian stone pine (*Pinus pinea*), London plane tree (*Platanus x acerifolia* 'Bloodgood'), Shamel ash (*Fraxinus uhdei*), and willows (*Salix laevigata*). Pursuant to Chapter 10, Article 15 (Tree Preservation Ordinance) of the Hayward Municipal Code¹⁰, all of the existing trees on-site meet the criteria and definition of a “protected tree” and cannot be removed without a permit based on their minimum trunk diameters of four-inches for native trees and eight-inches for all other trees measured 54-inches above ground.

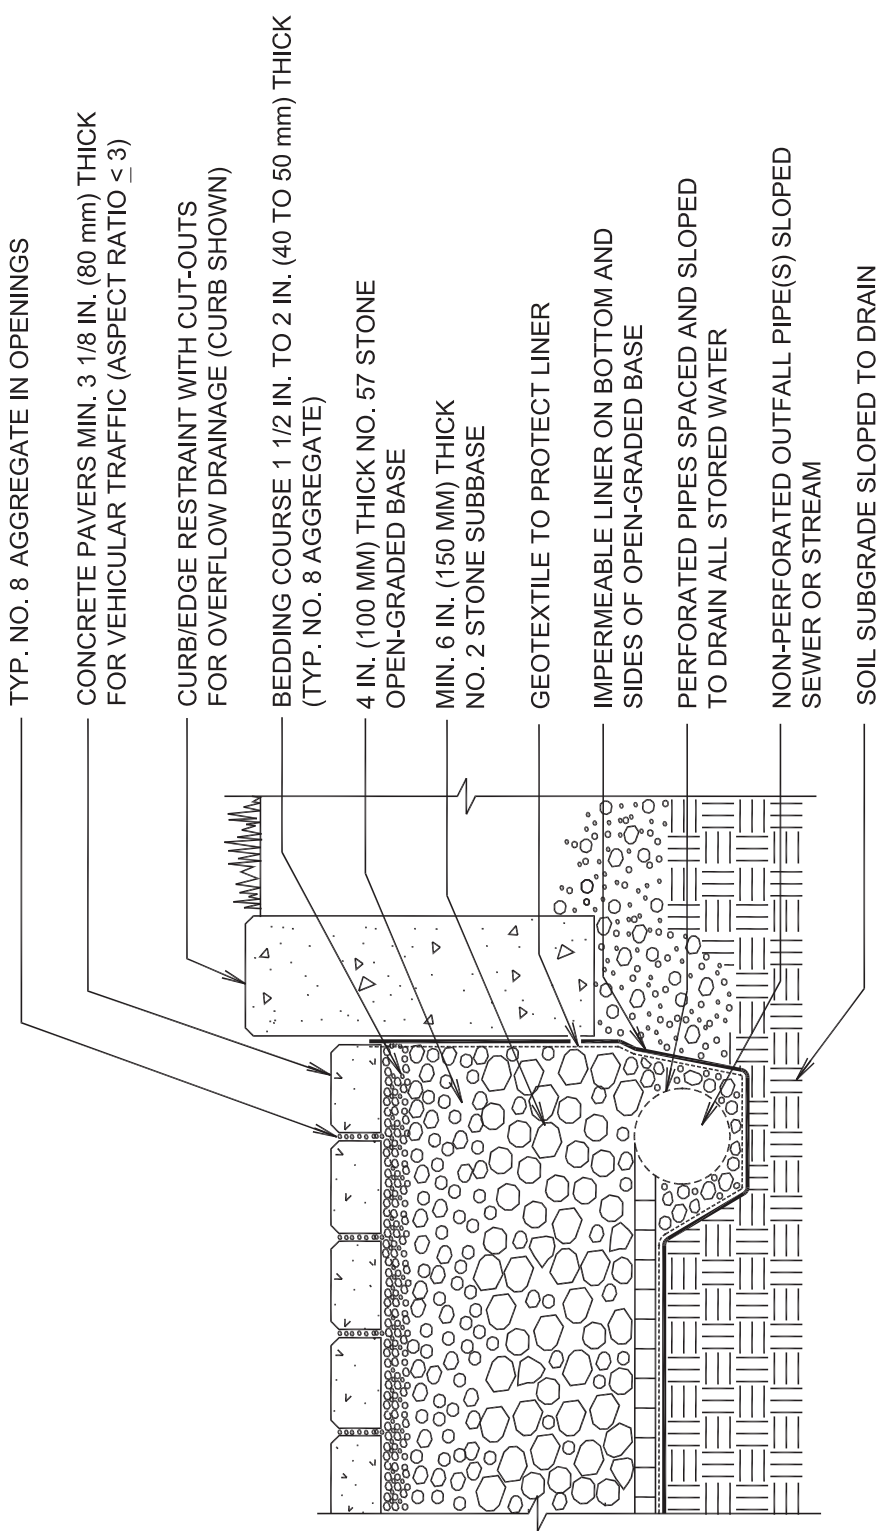
1. NO. 2 STONE SUBBASE THICKNESS VARIES WITH DESIGN. CONSULT ICPI PERMEABLE INTERLOCKING CONCRETE PAVEMENT MANUAL.
2. PERFORATED PIPES MAY BE RAISED FOR WATER STORAGE FROM LARGE RAIN EVENTS WITH OUTLET(S) AT LINER BOTTOM TO DRAIN SMALL RAIN EVENTS.

- The installation of 4,217 square-feet of permeable pavers within the parking lot, pedestrian, and entry areas that will include pavers, 2-inch thick aggregate base, 4-inch thick stone for proper infiltration into the soil;

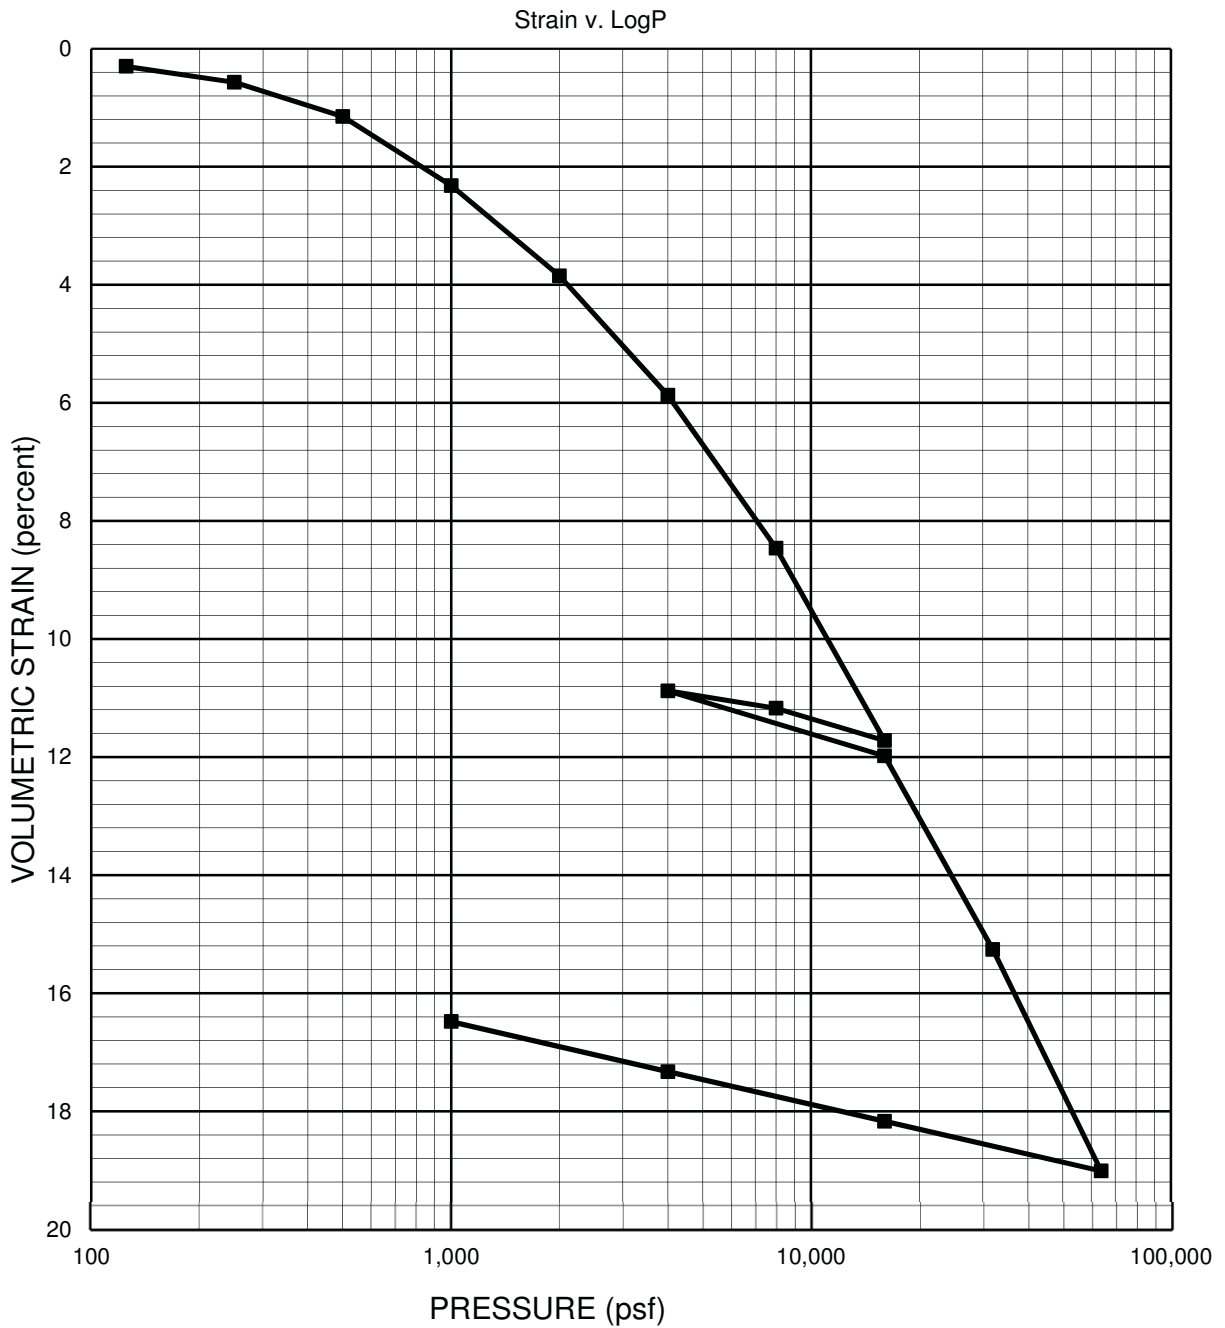
Date 04/29/17 Project No. 15-919B Figure C-1

Sampler Type: Shelby Tube		Condition		Before Test		After Test	
Diameter (in)	2.42	Height (in)	1.00	Water Content	w_o 28.7 %	w_f	20.2 %
Overburden Pressure, p_o	2,000 psf	Void Ratio		e_o	0.86	e_f	0.55
Preconsol. Pressure, p_c	4,000 psf	Saturation		S_o	91.9 %	S_f	100 %
Compression Ratio, C_{ec}	0.12	Dry Density		γ_d	92 pcf	γ_d	111 pcf
Recompression Ratio, C_{er}	0.019	LL		PL		PI	
					G_s 2.75		(assumed)

Source: B-1 at 26.0 feet
 Description: CLAY with SAND (CL), light gray

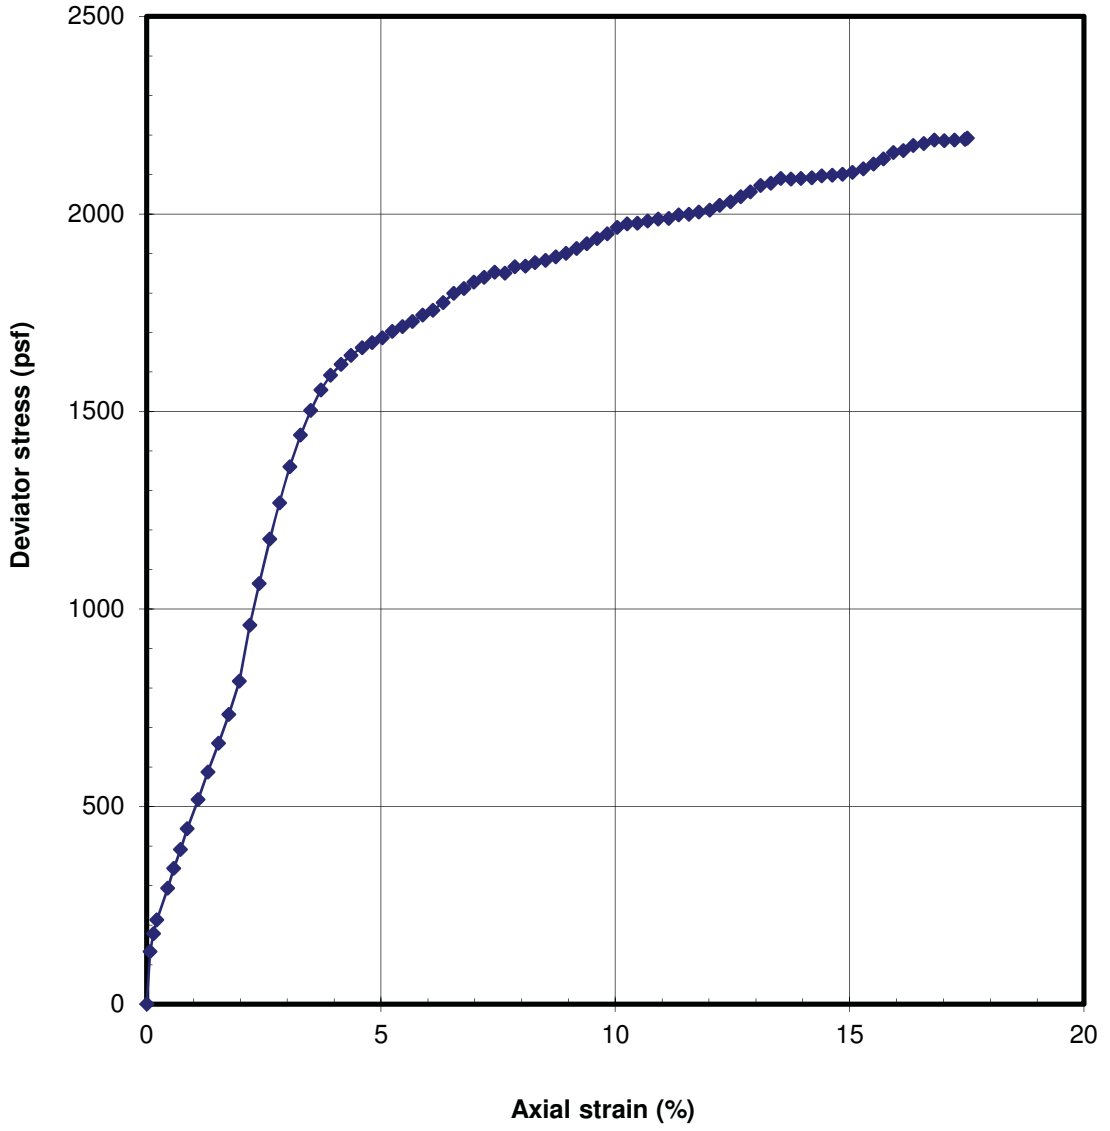
Date: 05/01/17		Project No. 15-919B	Figure C-2

Sampler Type: Shelby Tube		Shear Strength:	1,100 psf
Diameter (in): 2.81	Height (in): 6.51	Strain at Failure:	17.5%
Moisture Content: 28.7 %		Confining Pressure:	2,500 psf
Dry Density: 92 pcf		Strain Rate:	1%/min
Source: B-1 at 25.5 feet			
Description: CLAY with SAND (CL), light gray			
HAYWARD FIRE STATION #6 & FIRE TRAINING CENTER 1401 WEST WINTON AVENUE Hayward, California		UNCONSOLIDATED-UNDRAINED TRIAxIAL COMPRESSION TEST

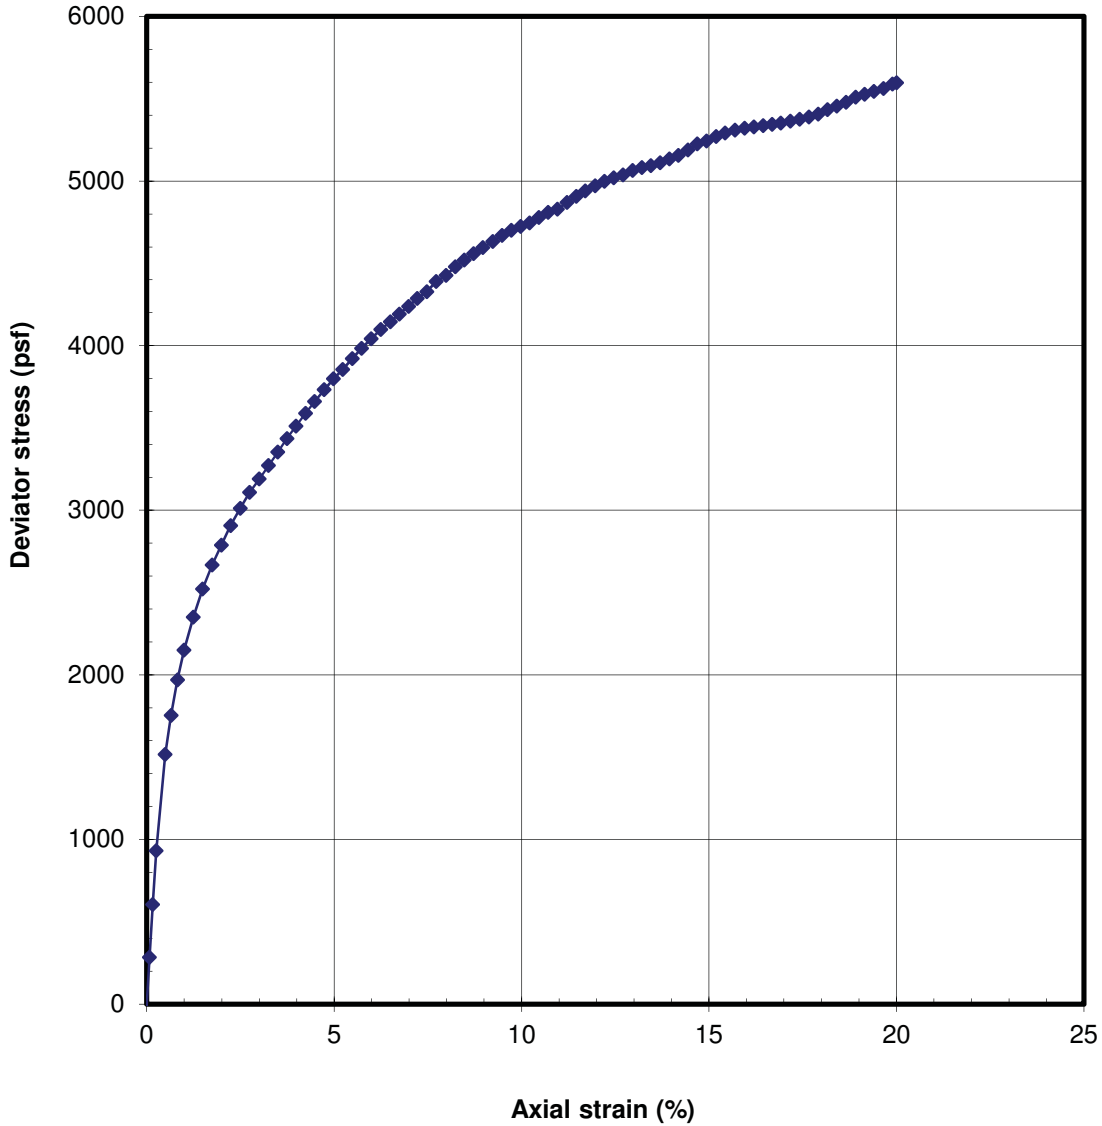
Date: 05/01/17	Project No. 15-919B	Figure C-3

Sampler Type: Sprague & Henwood (S&H)		Shear Strength:	2,800 psf
Diameter (in): 2.39	Height (in): 5.98	Strain at Failure:	20.0%
Moisture Content:	22.6 %	Confining Pressure:	3,000 psf
Dry Density:	106 pcf	Strain Rate:	1%/min
Source: B-2 at 35.5 feet			
Description: CLAY with SAND (CL), green-gray			
HAYWARD FIRE STATION #6 & FIRE TRAINING CENTER 1401 WEST WINTON AVENUE Hayward, California		UNCONSOLIDATED-UNDRAINED TRIAxIAL COMPRESSION TEST

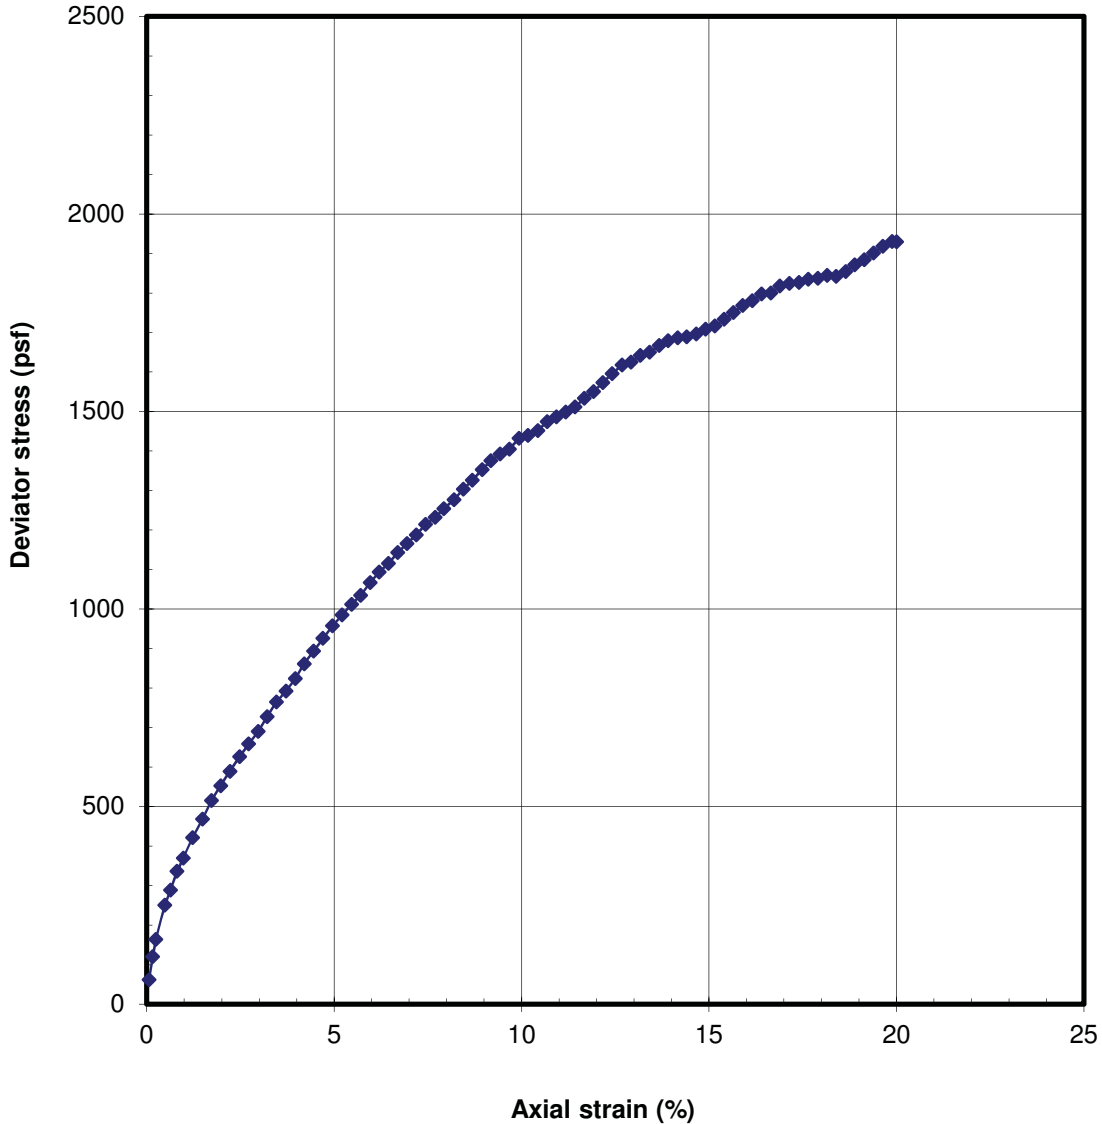
Sampler Type: Sprague & Henwood (S&H)		Shear Strength:	975 psf
Diameter (in): 2.39	Height (in): 5.66	Strain at Failure:	20.0%
Moisture Content:	29.7 %	Confining Pressure:	2,000 psf
Dry Density:	93 pcf	Strain Rate:	1%/min
Source: B-3 at 20.5 feet			
Description: CLAY (CL) yellow-brown with dark brown mottling			
HAYWARD FIRE STATION #6 & FIRE TRAINING CENTER 1401 WEST WINTON AVENUE Hayward, California		UNCONSOLIDATED-UNDRAINED TRIAxIAL COMPRESSION TEST

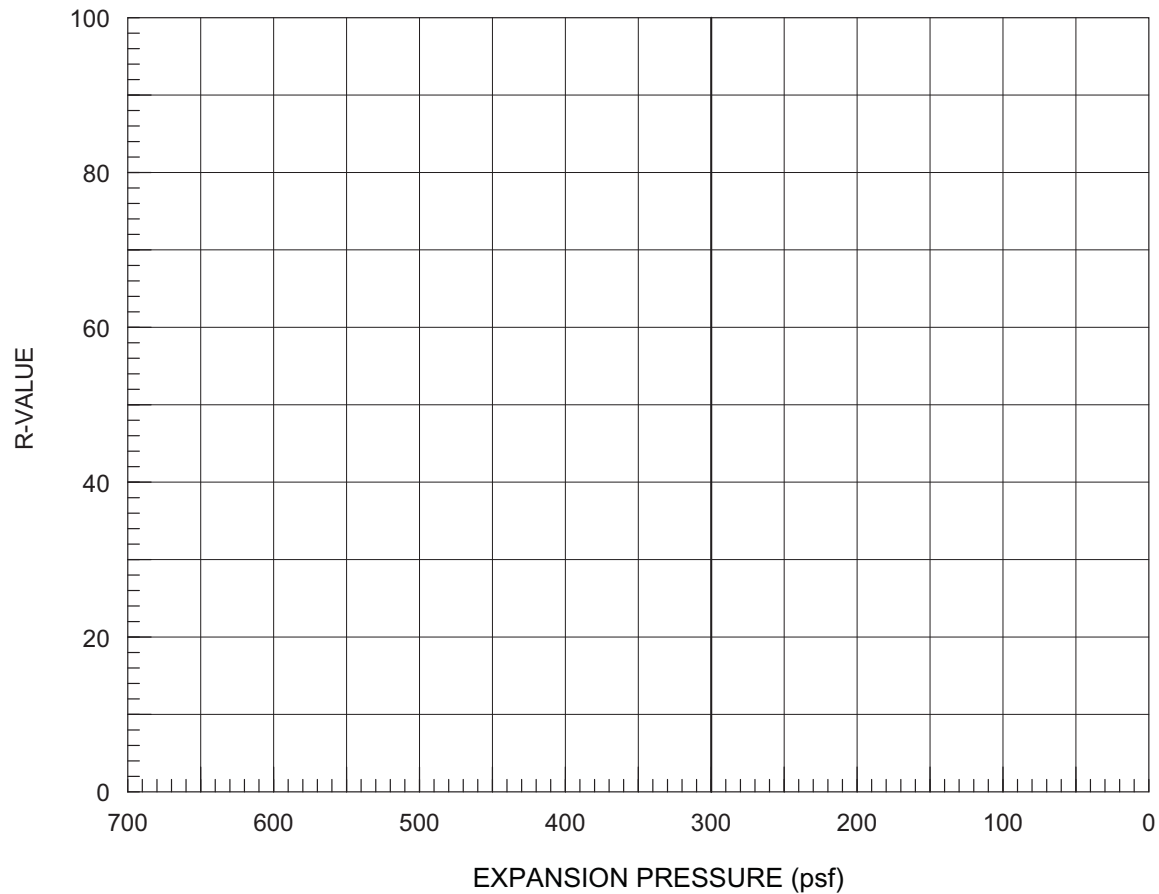
Resistance R-Value and Expansion Pressure - Cal Test 301

No.	Compact. Pressure psi	Density pcf	Moist. %	Expansion Pressure psi	Horizontal Press. psi @ 160 psi	Sample Height in.	Exud. Pressure psi	R Value	R Value Corr.
1	120		22.5					<5

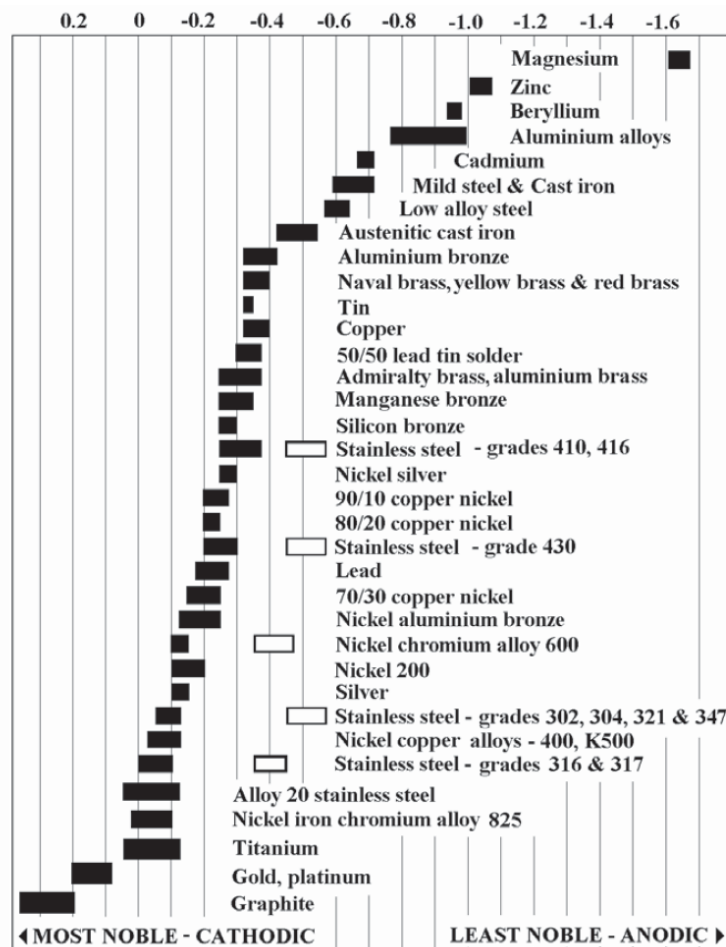
Figure 2 - Galvanic series of metals relative to CSE half cell.

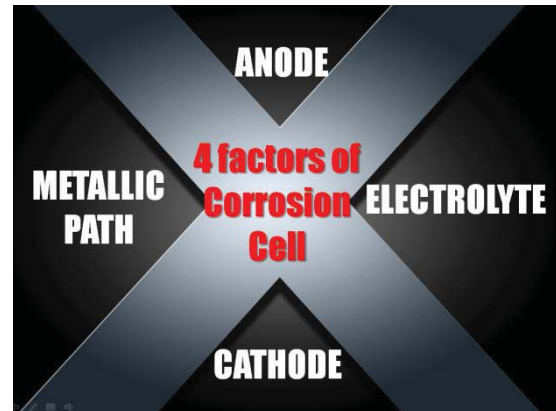
In order for corrosion to occur, four factors must be present. (1) The anode (2) the cathode (3) the electrolyte and (4) the metallic or conductive path joining the anode and the cathode. If any one of these is removed, corrosion activity will stop. This is how a simple battery produces electricity. An example of a non-metallic yet conductive material is graphite. Graphite is similar in nobility to gold. Do not connect graphite to anything in moist environments.

The anode is where the corrosion occurs, and the cathode is the corrosion free material. Sometimes the anode and cathode are different materials connected by a wire or union. Sometimes the anode and cathode are on the same pipe with one area of the pipe in a low oxygen zone while the other part of the pipe is in a high oxygen zone. A good example of this is a post in the ocean that is repeatedly splashed. Deep underwater, corrosion is minimal, but at the splash zone, the corrosion rate is greatest. Low oxygen zones and crevices can also harbor corrosive bacteria which in moist environments will lead to corrosion. This is why pipes are laid on backfill instead of directly on native cut soil in a trench. Filling a trench slightly with backfill before installing pipe then finishing the backfill creates a uniform environment around the entire surface of the pipe.

The electrolyte is generally water, seawater, or moist soil which allows for the transfer of ions and electrical current. Pure water itself is not very conductive. It is when salts and minerals dissolve into pure water that it becomes a good conductor of electricity and chemical reactions. Metal ores are turned into metal alloys which we use in construction. They naturally want to return to their natural metal ore state but it requires energy to return to it. The corrosion cell, creates the energy needed to return a metal to its natural ore state.

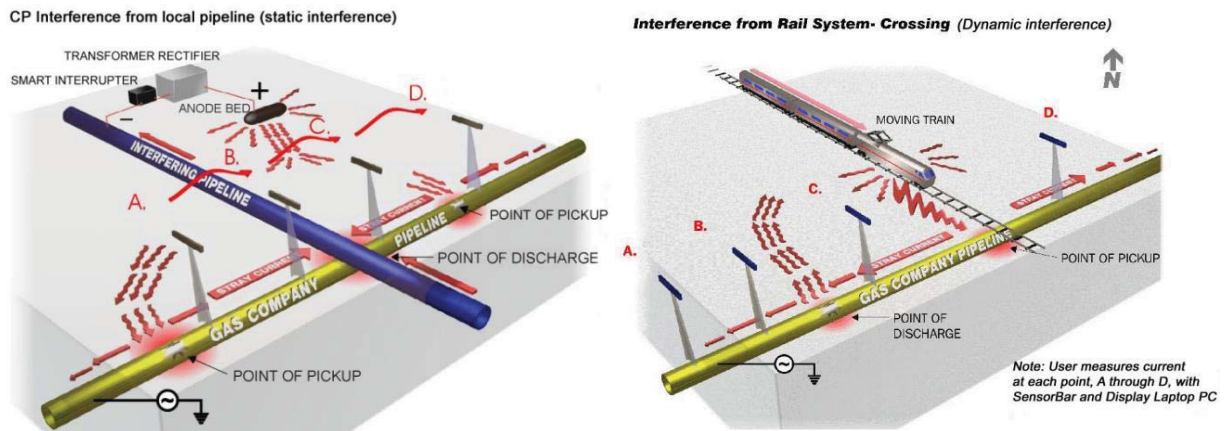
However, stray current strengths may be much higher than those produced by galvanic cells and, as a consequence, corrosion may be much more rapid. Another difference between galvanic-type currents and stray currents is that the latter are more likely to operate over long distances since the anode and cathode are more likely to be remotely separated from one another. Seeking the path of least resistance, the stray current from a foreign installation may travel along a pipeline causing severe corrosion where it leaves the line. Knowing when stray currents are present becomes highly important when remedial measures are undertaken since a simple sacrificial anode system is likely to be ineffectual in preventing corrosion under such circumstances.¹⁰ Stray currents can be avoided by installing proper electrical shielding, installation of isolation joints, or installation of sacrificial jump off anodes at crossings near protected structures such as metal gas pipelines or electrical feeders

Figure 3 Examples of Stray Current¹¹

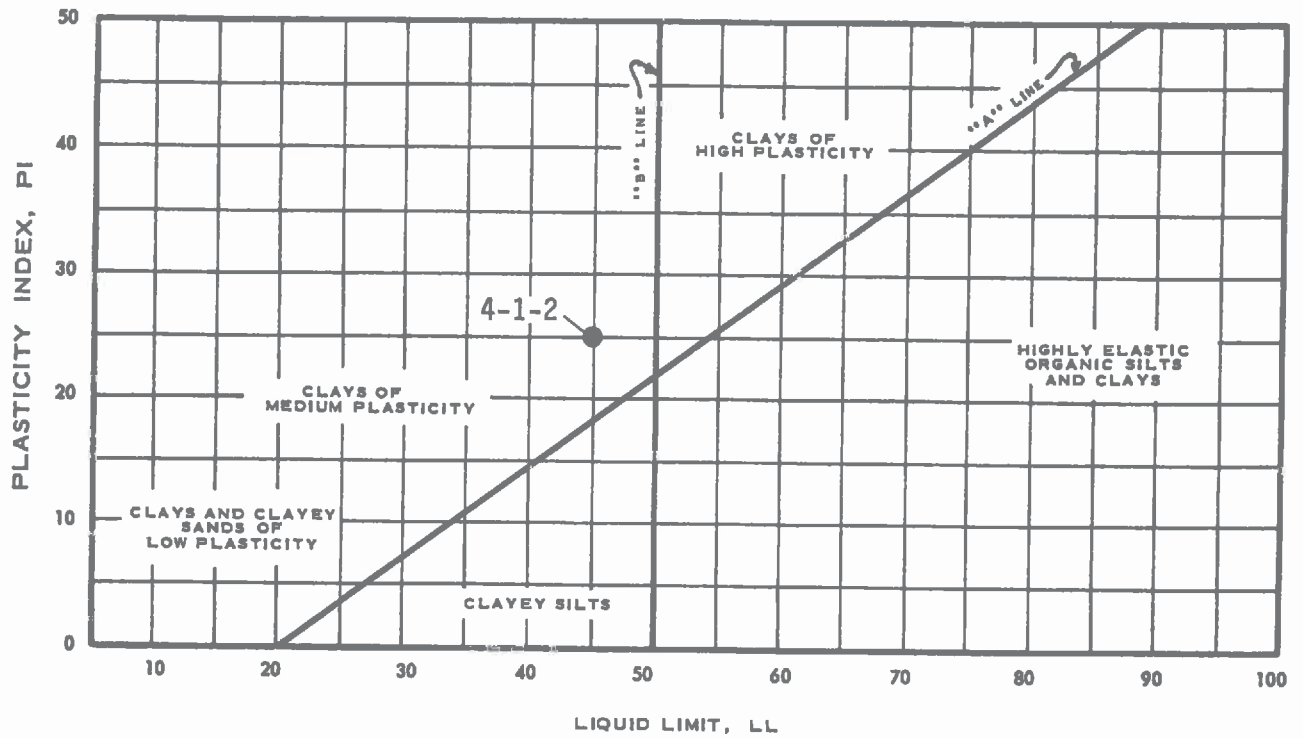
CLASSIFICATION TEST RESULTS								
SAMPLE IDENTIFICATION		ATTERBERG LIMITS			GRAIN SIZES - % DRY WEIGHT			
SAMPLE NO.	LETTER DESIGNATION	LIQUID LIMIT	PLASTICITY INDEX	SHRINKAGE LIMIT	SAND	SILT	CLAY	COLLOIDAL
4-1-2	--	45	25	--	9	43	48	32

SAMPLE NO. 4-1-2	SYMBOL --	DEPTH 3'	LL 45	PI 25	UNIFIED CLASSIFICATION (CL-CH)
-------------------------	------------------	-----------------	--------------	--------------	---------------------------------------

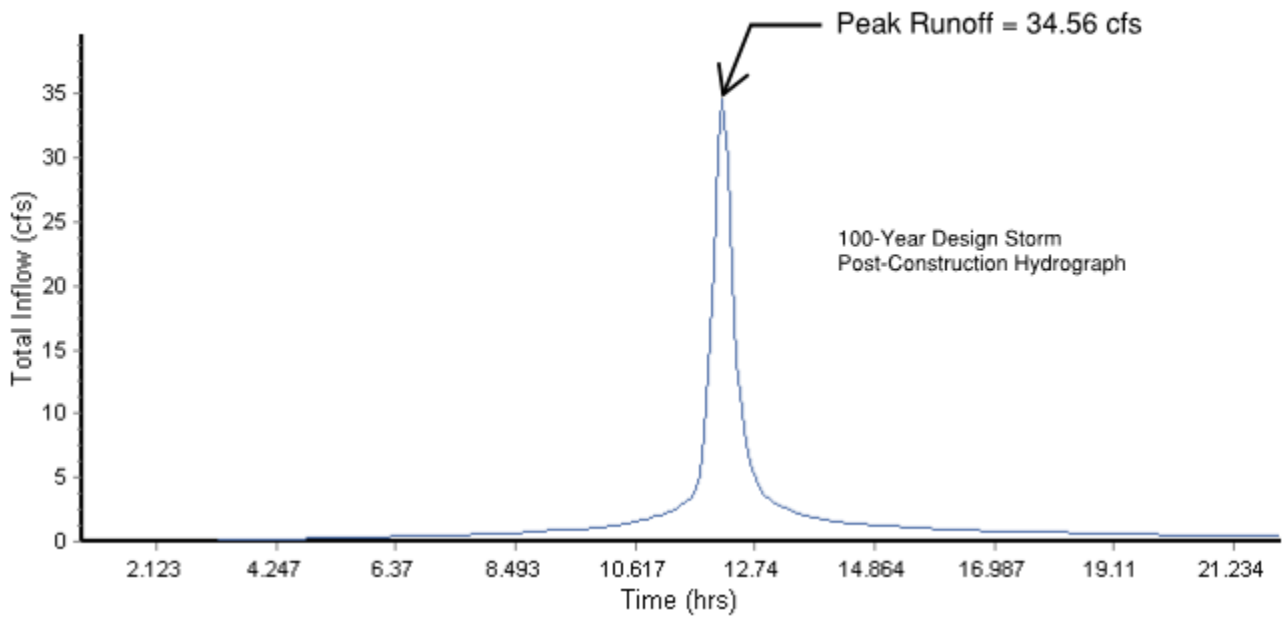
Figure 2: 100-Year Post-Construction Hydrograph

In the post-construction conditions, stormwater runoff is conveyed through a combination of channel flow (within proposed driveway swales) and sheet flow. The post-construction hydrograph for the 100-year design storm is below:
