2016 Winton Overpass Piping Project

City of Hayward

Photo Journal by Bert Weiss, Utilities Operation and Maintenance Manager

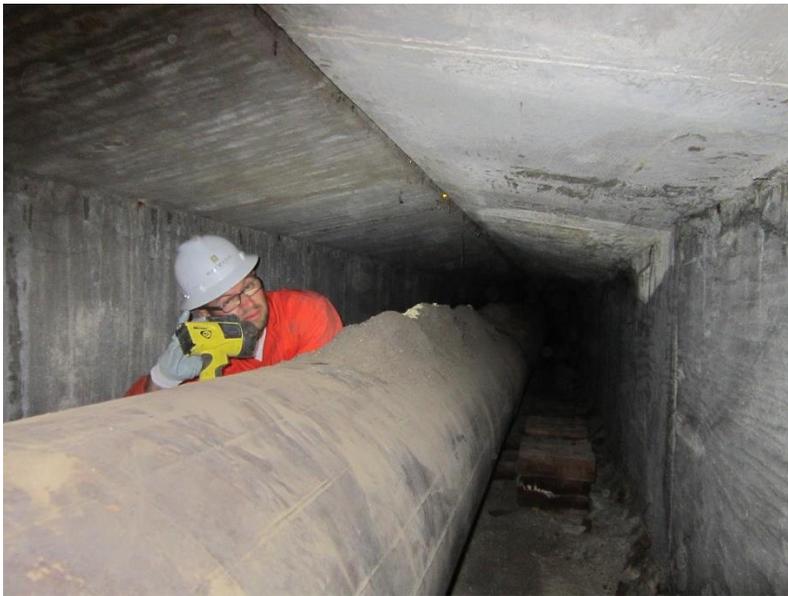
There was a very unceremonious beginning to the project. Our 20 inch pipe in the Winton Street/880 overpass had developed a leak and needed to be replaced. Note the debris that had accumulated over the decades. The first challenge to overcome was how we would clean the interior of the structure. The space was limited and the debris kept clogging the vacuum truck hose. We finally resigned ourselves to having to go in and clean the interior by hand, with dustpans, foxtail brooms, and five gallon buckets.

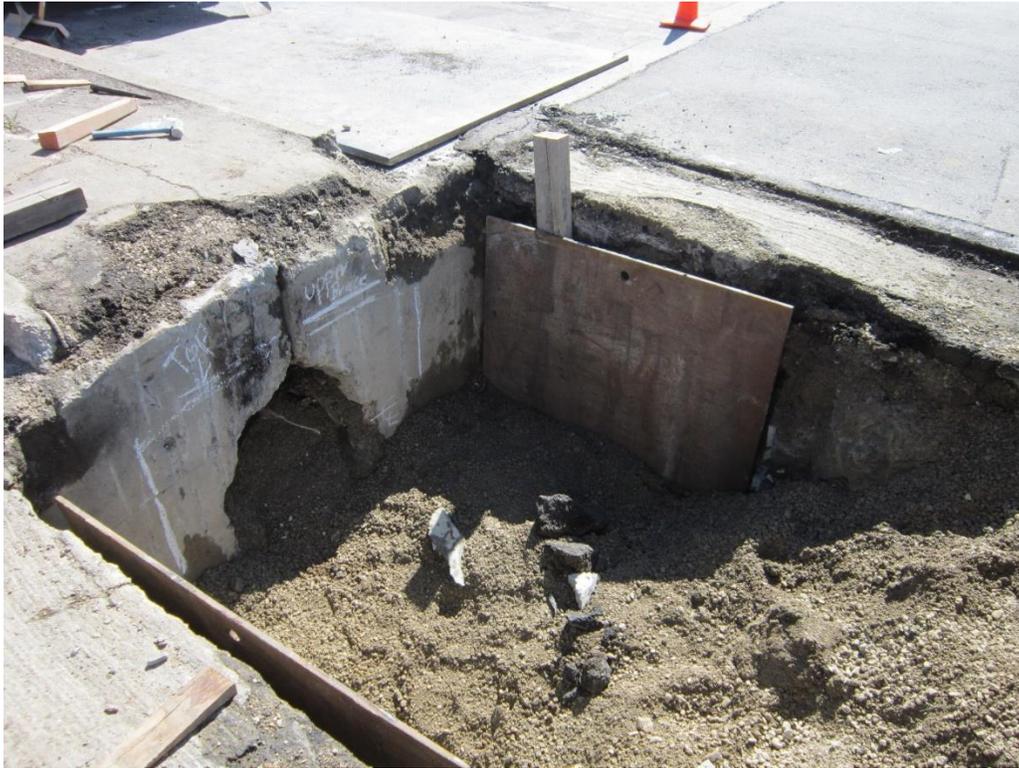
Unfortunately, we didn't get far before encountering the first unexpected revelation. There were large veins of pea gravel near the overpass structure. It started to pour out of the sides of the trench walls and threatened to undermine the very busy West Winton. We immediately had to backfill to prevent that from happening and shifted to Plan B.

Thanks to the expertise of United Trench Safety folks, “Plan B” effectively became driving $\frac{3}{4}$ ” steel plates into the ground with the excavator to keep the pea gravel in place thereby preventing the undermining of the very heavily traveled roadway.

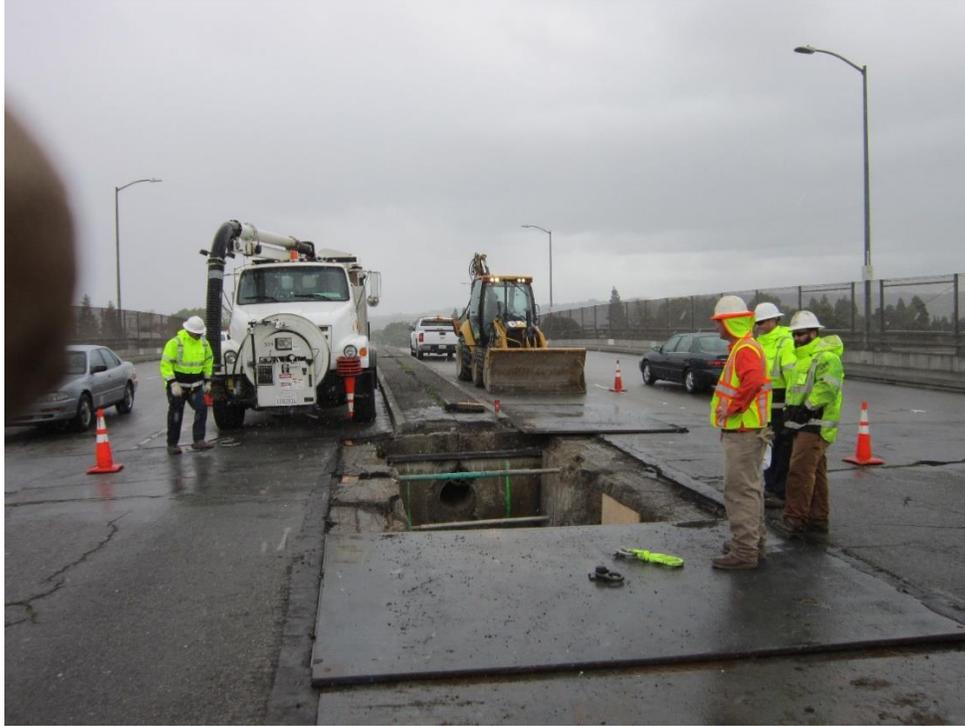
In the transition area from 30 inch to 20 inch, a substantial reinforced concrete wall was poured over the transition coupling. It took staff three days to break through the wall with a backhoe mounted breaker and concrete chainsaws. While no one was thrilled with the work, staff attacked it with a vengeance.

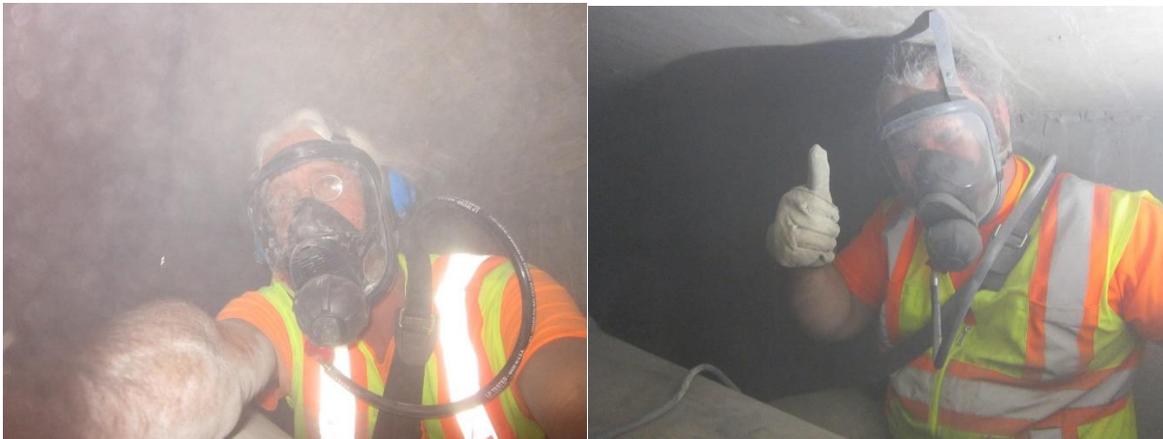
The next challenge was cutting the asphaltic coated, welded steel and mortar lined 20 inch pipe. Things got smoky and dusty in the overpass and required the use of forced-air respirators. This had to be done because the overpass end walls were formed around the pipe. In order for us to remove the wire sawed concrete plug that surrounded the pipe, we had to cut the pipe in the interior of the overpass.

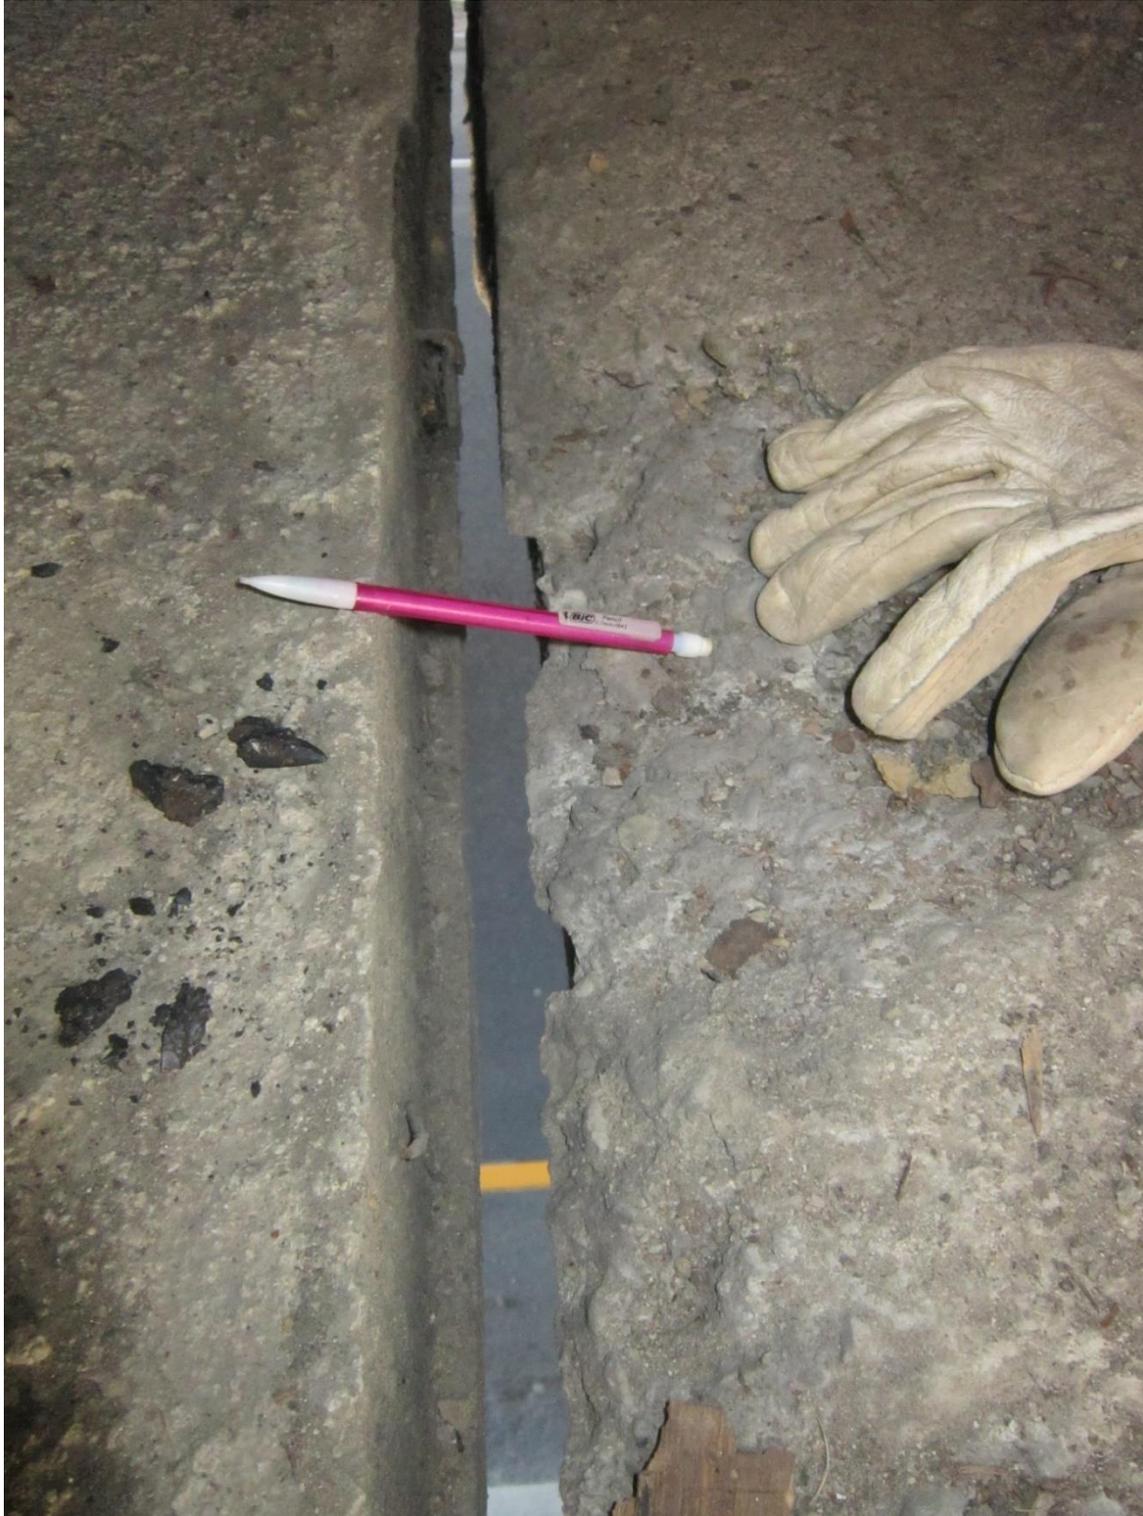
This is a good picture of the freeway below, as seen through the gap. The pencil and glove are included for scale to show both the width of the gap and the roughness of the floor of the overpass. That floor roughness would ultimately prove to be one of the bigger challenges that we had to overcome with this project.

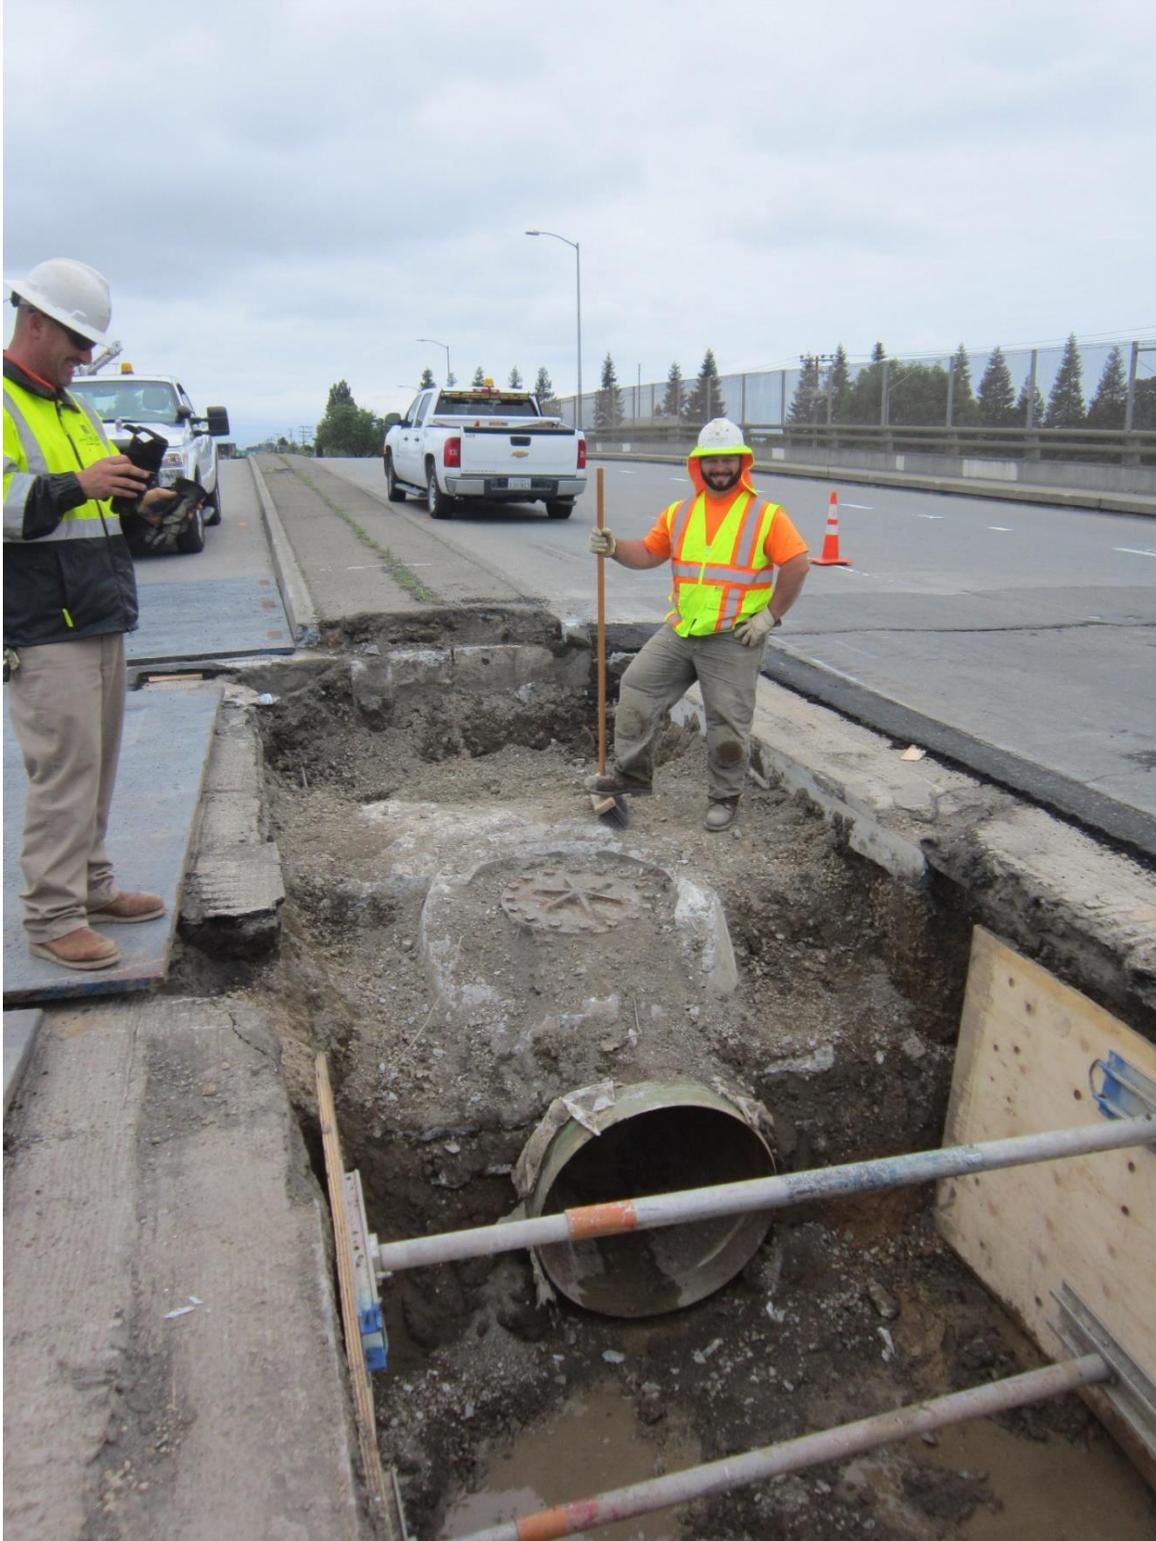
...and this time when an even larger wall of reinforced concrete was revealed, it was all smiles because we had a Plan B. There would be **NO** backhoe mounted breaker and the concrete chain-sawing would be kept to an absolute minimum...

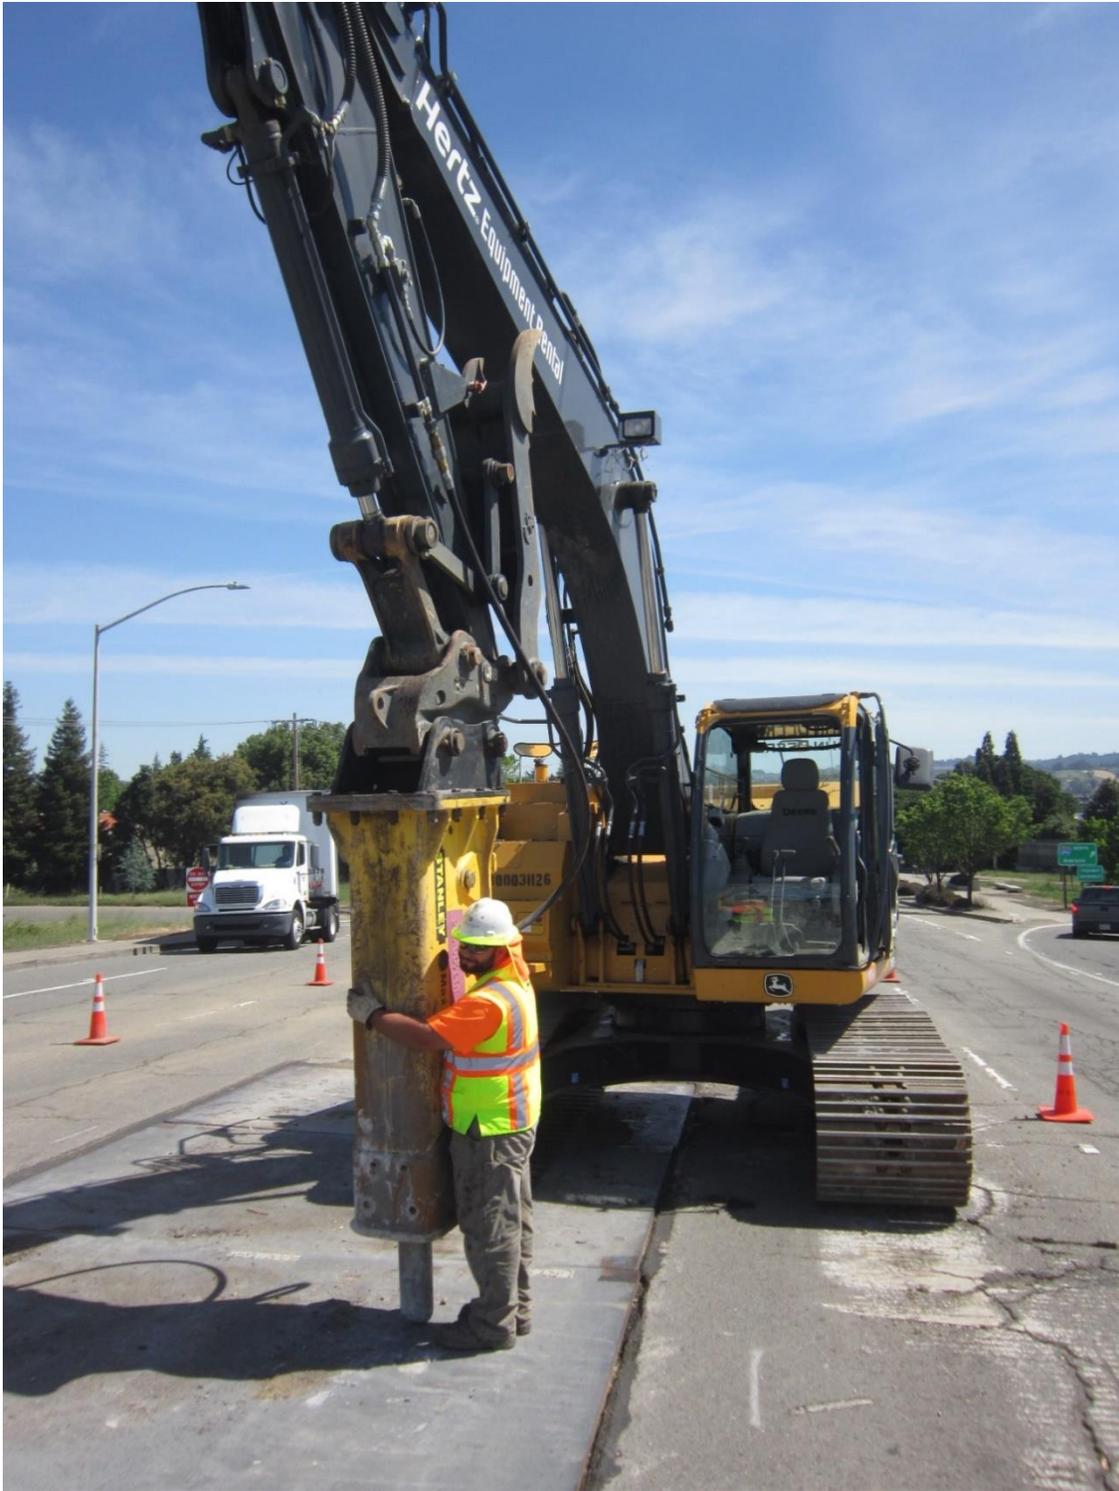
...and this was “getting through the latest concrete wall Plan B.” A 5,000-pound breaker for our rental Deere 245. Staff came to love “Plan B” after one “thunk, thunk, thunk” blow caused a 24 inch chunk off concrete to blow off of the reinforced concrete wall. The progress made with one trigger pull took the backhoe mounted breaker hours to accomplish on the west side. The crew was very impressed!

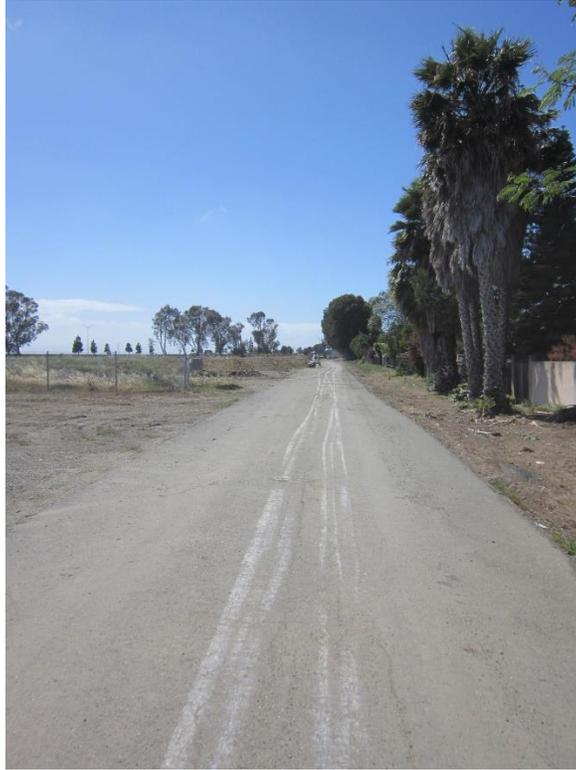
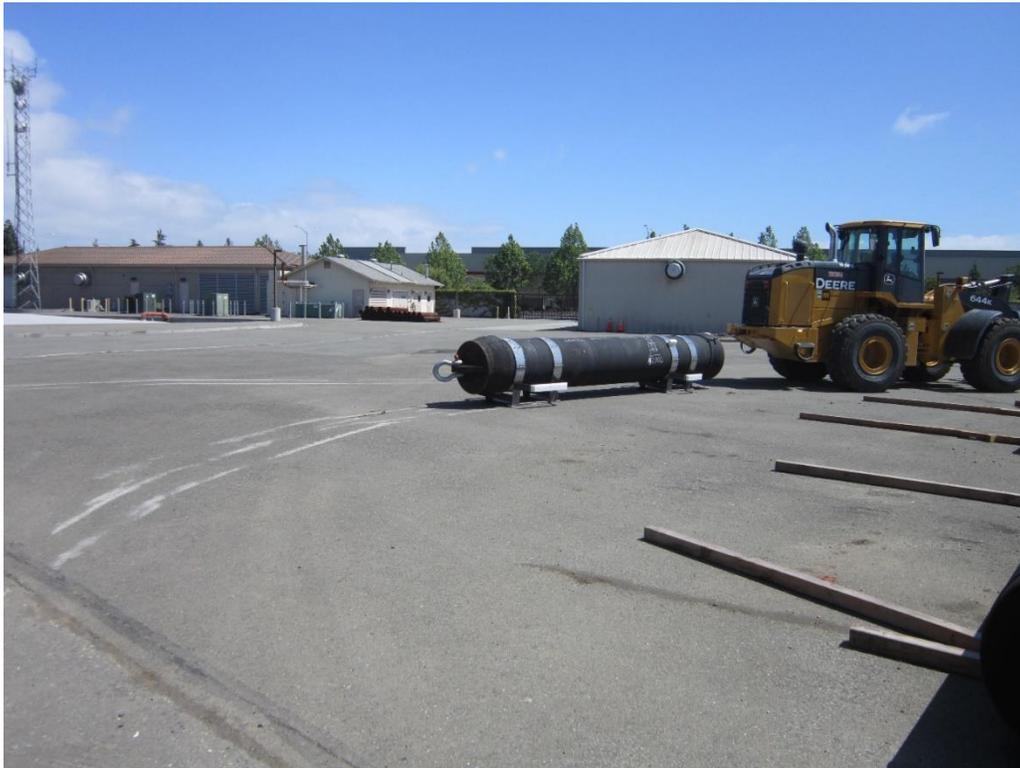
...and finally through a turn, back to the place where the sleds had been bolted to the pipe – all without incident! When all was said and done, there was no visible wear to the runners and, while very warm, they could still be touched with a bare hand!!!

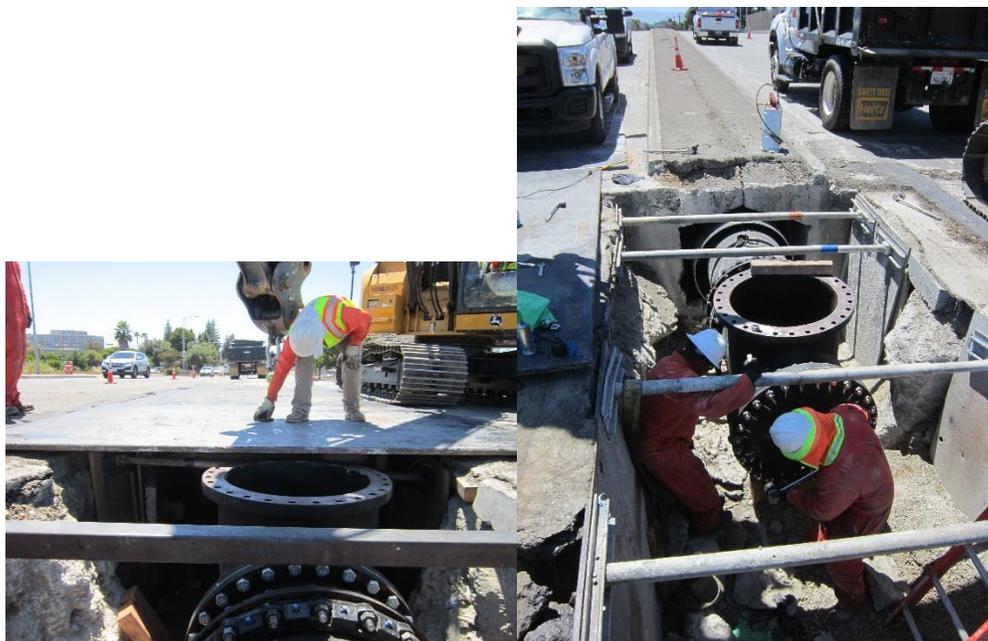
Note the tight clearances between the top of the Tee and the trench plate. This clearance actually dropped to 0.035 inches (the thickness of about 10 human hairs) in certain areas after the upper flange and bolts were installed. The precise dimensional tolerances were yet another challenge throughout the project, but successfully overcoming any challenge thrown our way also made the project fun.

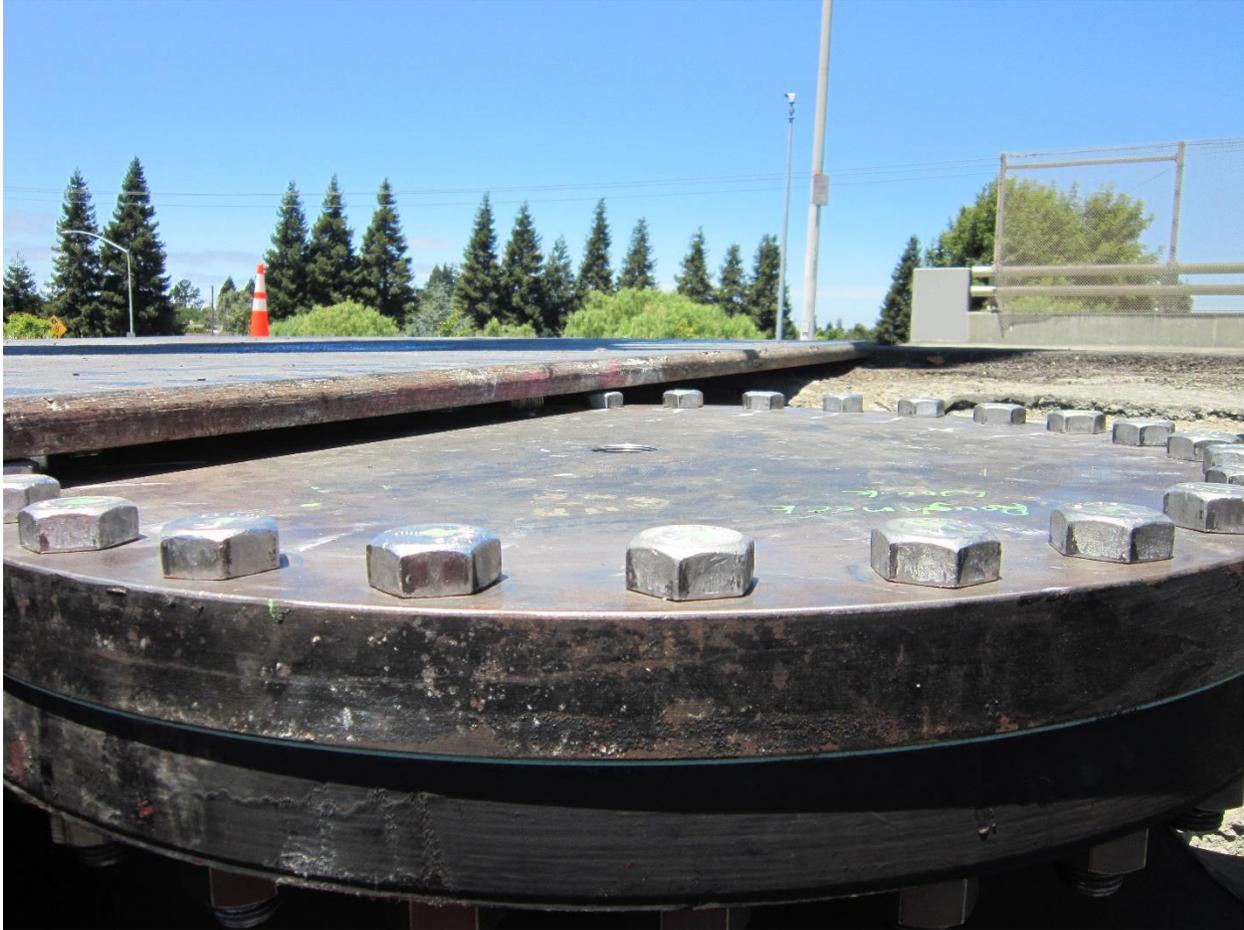
This was one of the aforementioned tighter clearance locations. By good fortune, this fitting is actually located in the raised center divide section. If it was located in the street, staff would have had no option but to rotate the tee 90 degrees and provide access to the pipe from the side, but that would also disrupt a lane of traffic, if this feature was to be utilized.
