# GEOTECHNICAL FEASIBILITY REPORT

ROUTE 238 BYPASS – GROUP 5  
HAYWARD, CALIFORNIA

**March 18, 2016**

## **GEOTECHNICAL FEASIBILITY REPORT**

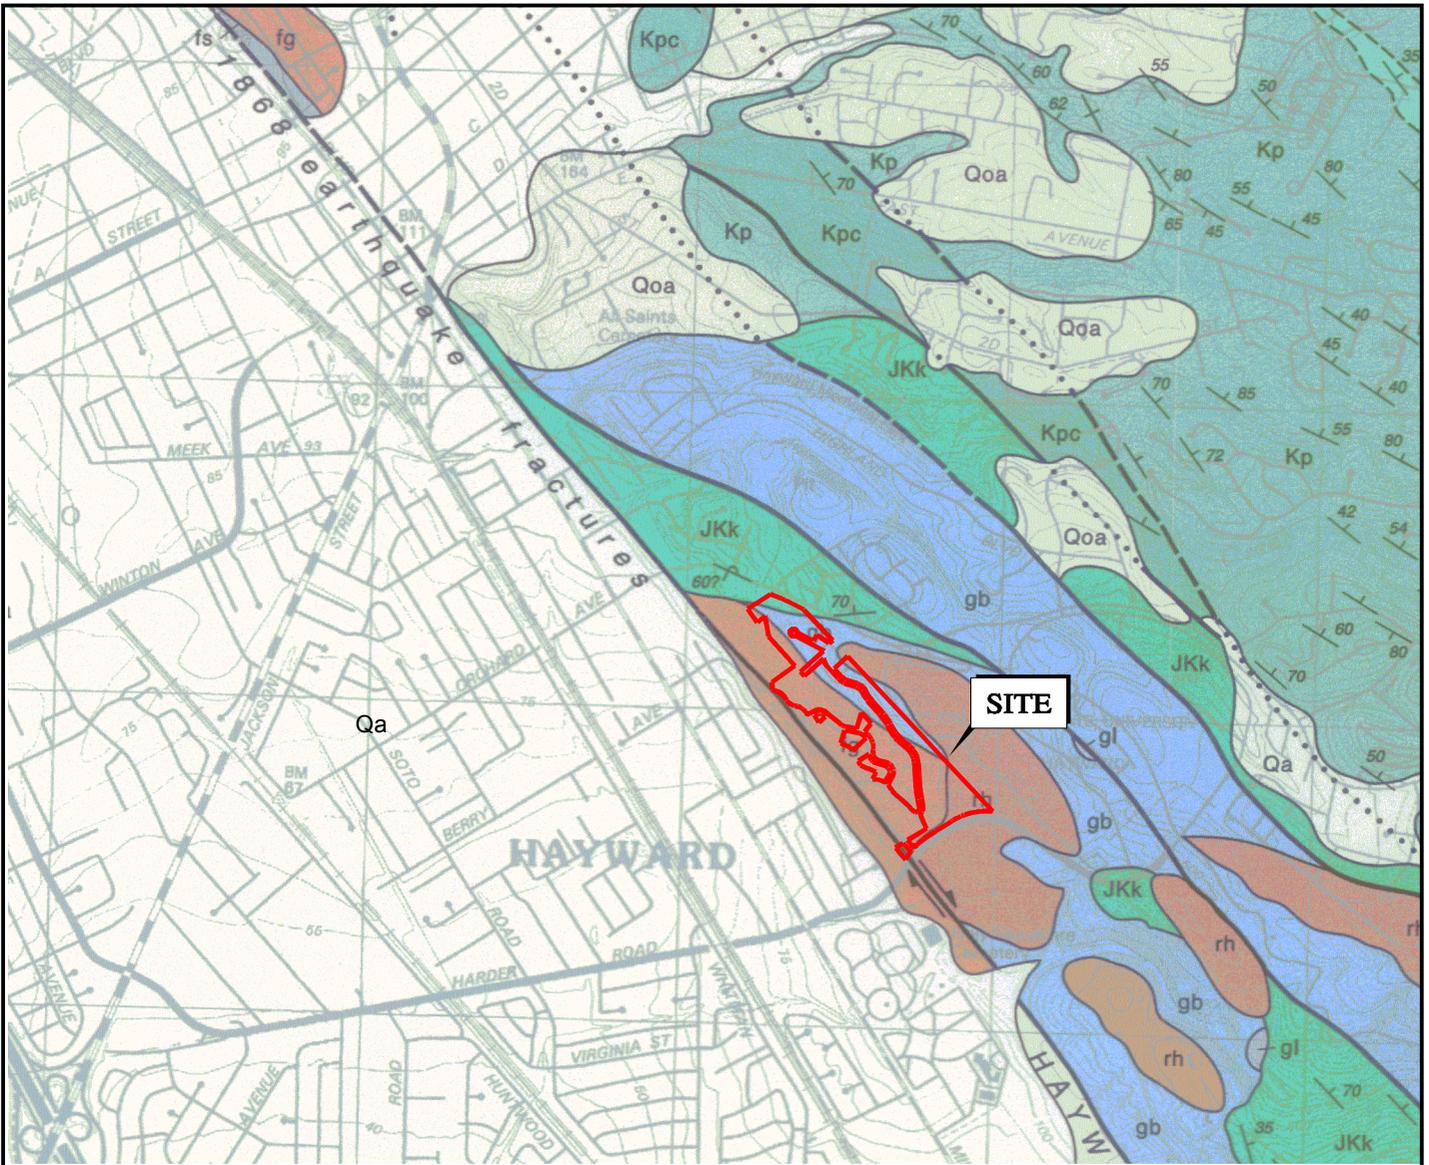
REGIONAL GEOLOGIC MAP	PROJECT NO.: 12843.000.000	FIGURE NO.
	ROUTE 238 BYPASS - GROUP 5	SCALE: AS SHOWN	3
	HAYWARD, CALIFORNIA	DRAWN BY: LL	CHECKED BY: JJT

--- GEOLOGIC CONTACT-DASHED WHERE GRADATIONAL OR APPROXIMATELY LOCATED

According to published maps covering the site by Dibblee (1980) and Crane (1988), the majority of the site is underlain by greenstone of the Franciscan Complex (Figure 3). The greenstone (metabasalt) is dark gray to black, massive, aphanitic, and can locally be slightly serpentinized. This unit is associated with the Franciscan assemblage and makes up much of the southwest portion of the property. The Franciscan assemblage is Late Jurassic to Cretaceous in age and is composed of submetamorphosed marine sedimentary and mafic igneous rocks (Dibblee, 2005). Dibblee (2005) also maps the bedrock in the northern most extent of the site as Knoxville Formation – marine clastic, lithified, clay shale and conglomerates from the late Jurassic to early Cretaceous (based on fossil evidence). This particular unit on site is the clay shale unit – a dark brownish gray, bedded, micaceous clay shale which includes thin interbeds of olive brown fine-grained graywacke, sandstone, and brown dolomite. The eastern portion of the site is underlain by Leona Rhyolite and gabbro-diorite of the Coast Range Ophiolite Complex – an igneous complex which is probably intrusive, from the late Jurassic. The Leona Rhyolite (Lawson, 1914), was formerly interpreted as late Cenozoic, but has since been radiometrically dated as late Jurassic. The gabbro-diorite is black, medium to fine-grained, massive, of mafic minerals and aged as late Jurassic.

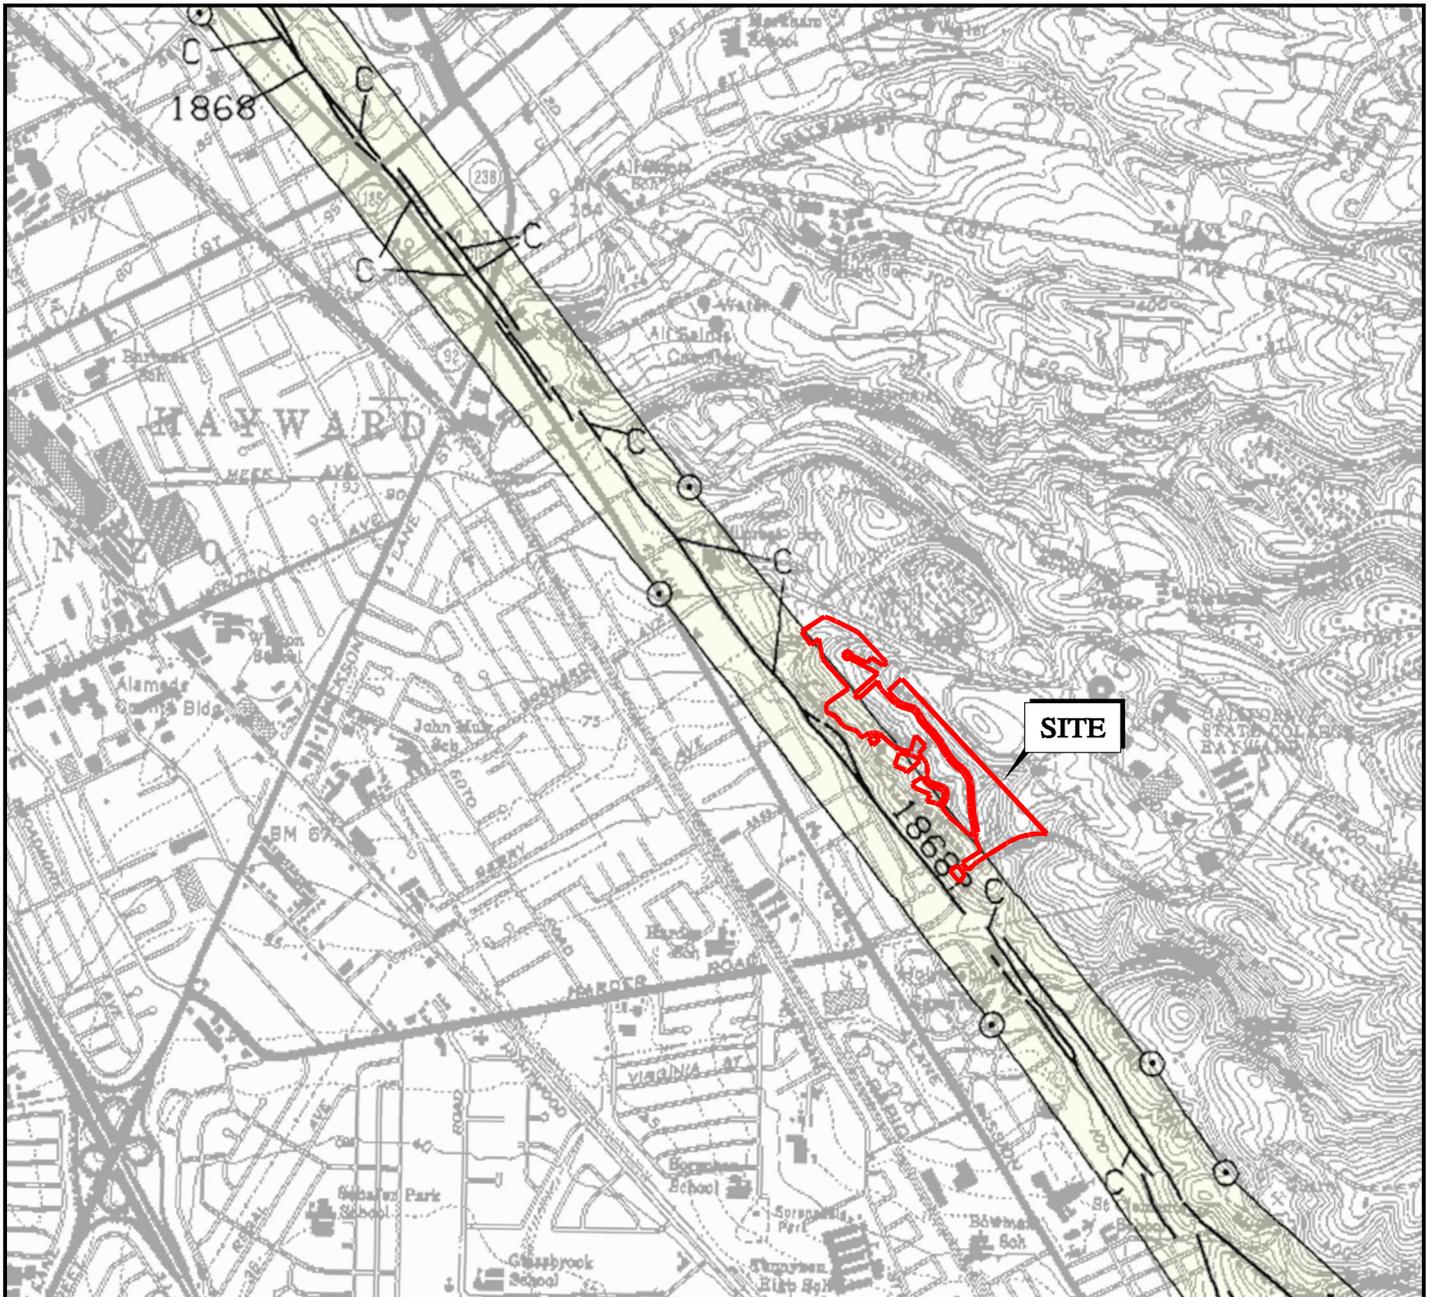
FIGURE NO.  
**5**

- 1906 C FAULTS CONSIDERED TO HAVE BEEN ACTIVE DURING HOLOCENE TIME AND TO HAVE A RELATIVELY HIGH POTENTIAL FOR SURFACE RUPTURE; SOLID LINE WHERE ACCURATELY LOCATED, LONG DASH WHERE APPROXIMATELY LOCATED, SHORT DASH WHERE INFERRED, DOTTED WHERE CONCEALED; QUERY (?) INDICATES ADDITIONAL UNCERTAINTY. EVIDENCE OF HISTORIC OFFSET INDICATED BY YEAR OF EARTHQUAKE-ASSOCIATED EVENT OR C FOR DISPLACEMENT CAUSED BY CREEP OR POSSIBLE CREEP
- EARTHQUAKE FAULT ZONE BOUNDARIES; DELINEATED AS STRAIGHT-LINE SEGMENTS THAT CONNECT ENCIRCLED TURNING POINTS SO AS TO DEFINE EARTHQUAKE FAULT ZONE SEGMENTS

The site is located adjacent to the Hayward fault zone, and portions of the property lie within a designated State of California Earthquake Fault Zone (Figure 5). The Hayward fault is considered an active right lateral fault and continues to creep along various segments. It is likely that fault related surface rupture will occur along the Hayward fault in the vicinity of the property.

The site is partially located within a State of California Earthquake Fault Hazard Zone and splays of the Hayward fault are potentially traversing parts of the property (Figure 5). Per Special Publication 42, any future project that falls under the Alquist-Priolo Earthquake Fault Zoning Act, and lies within the portions of the property located within a State of California Earthquake Fault Hazard Zone, would require future subsurface exploration (e.g. excavation of fault trenches) to assess the potential for fault surface rupture. Building exclusion zones and fault setbacks along active fault traces should be anticipated at the site.

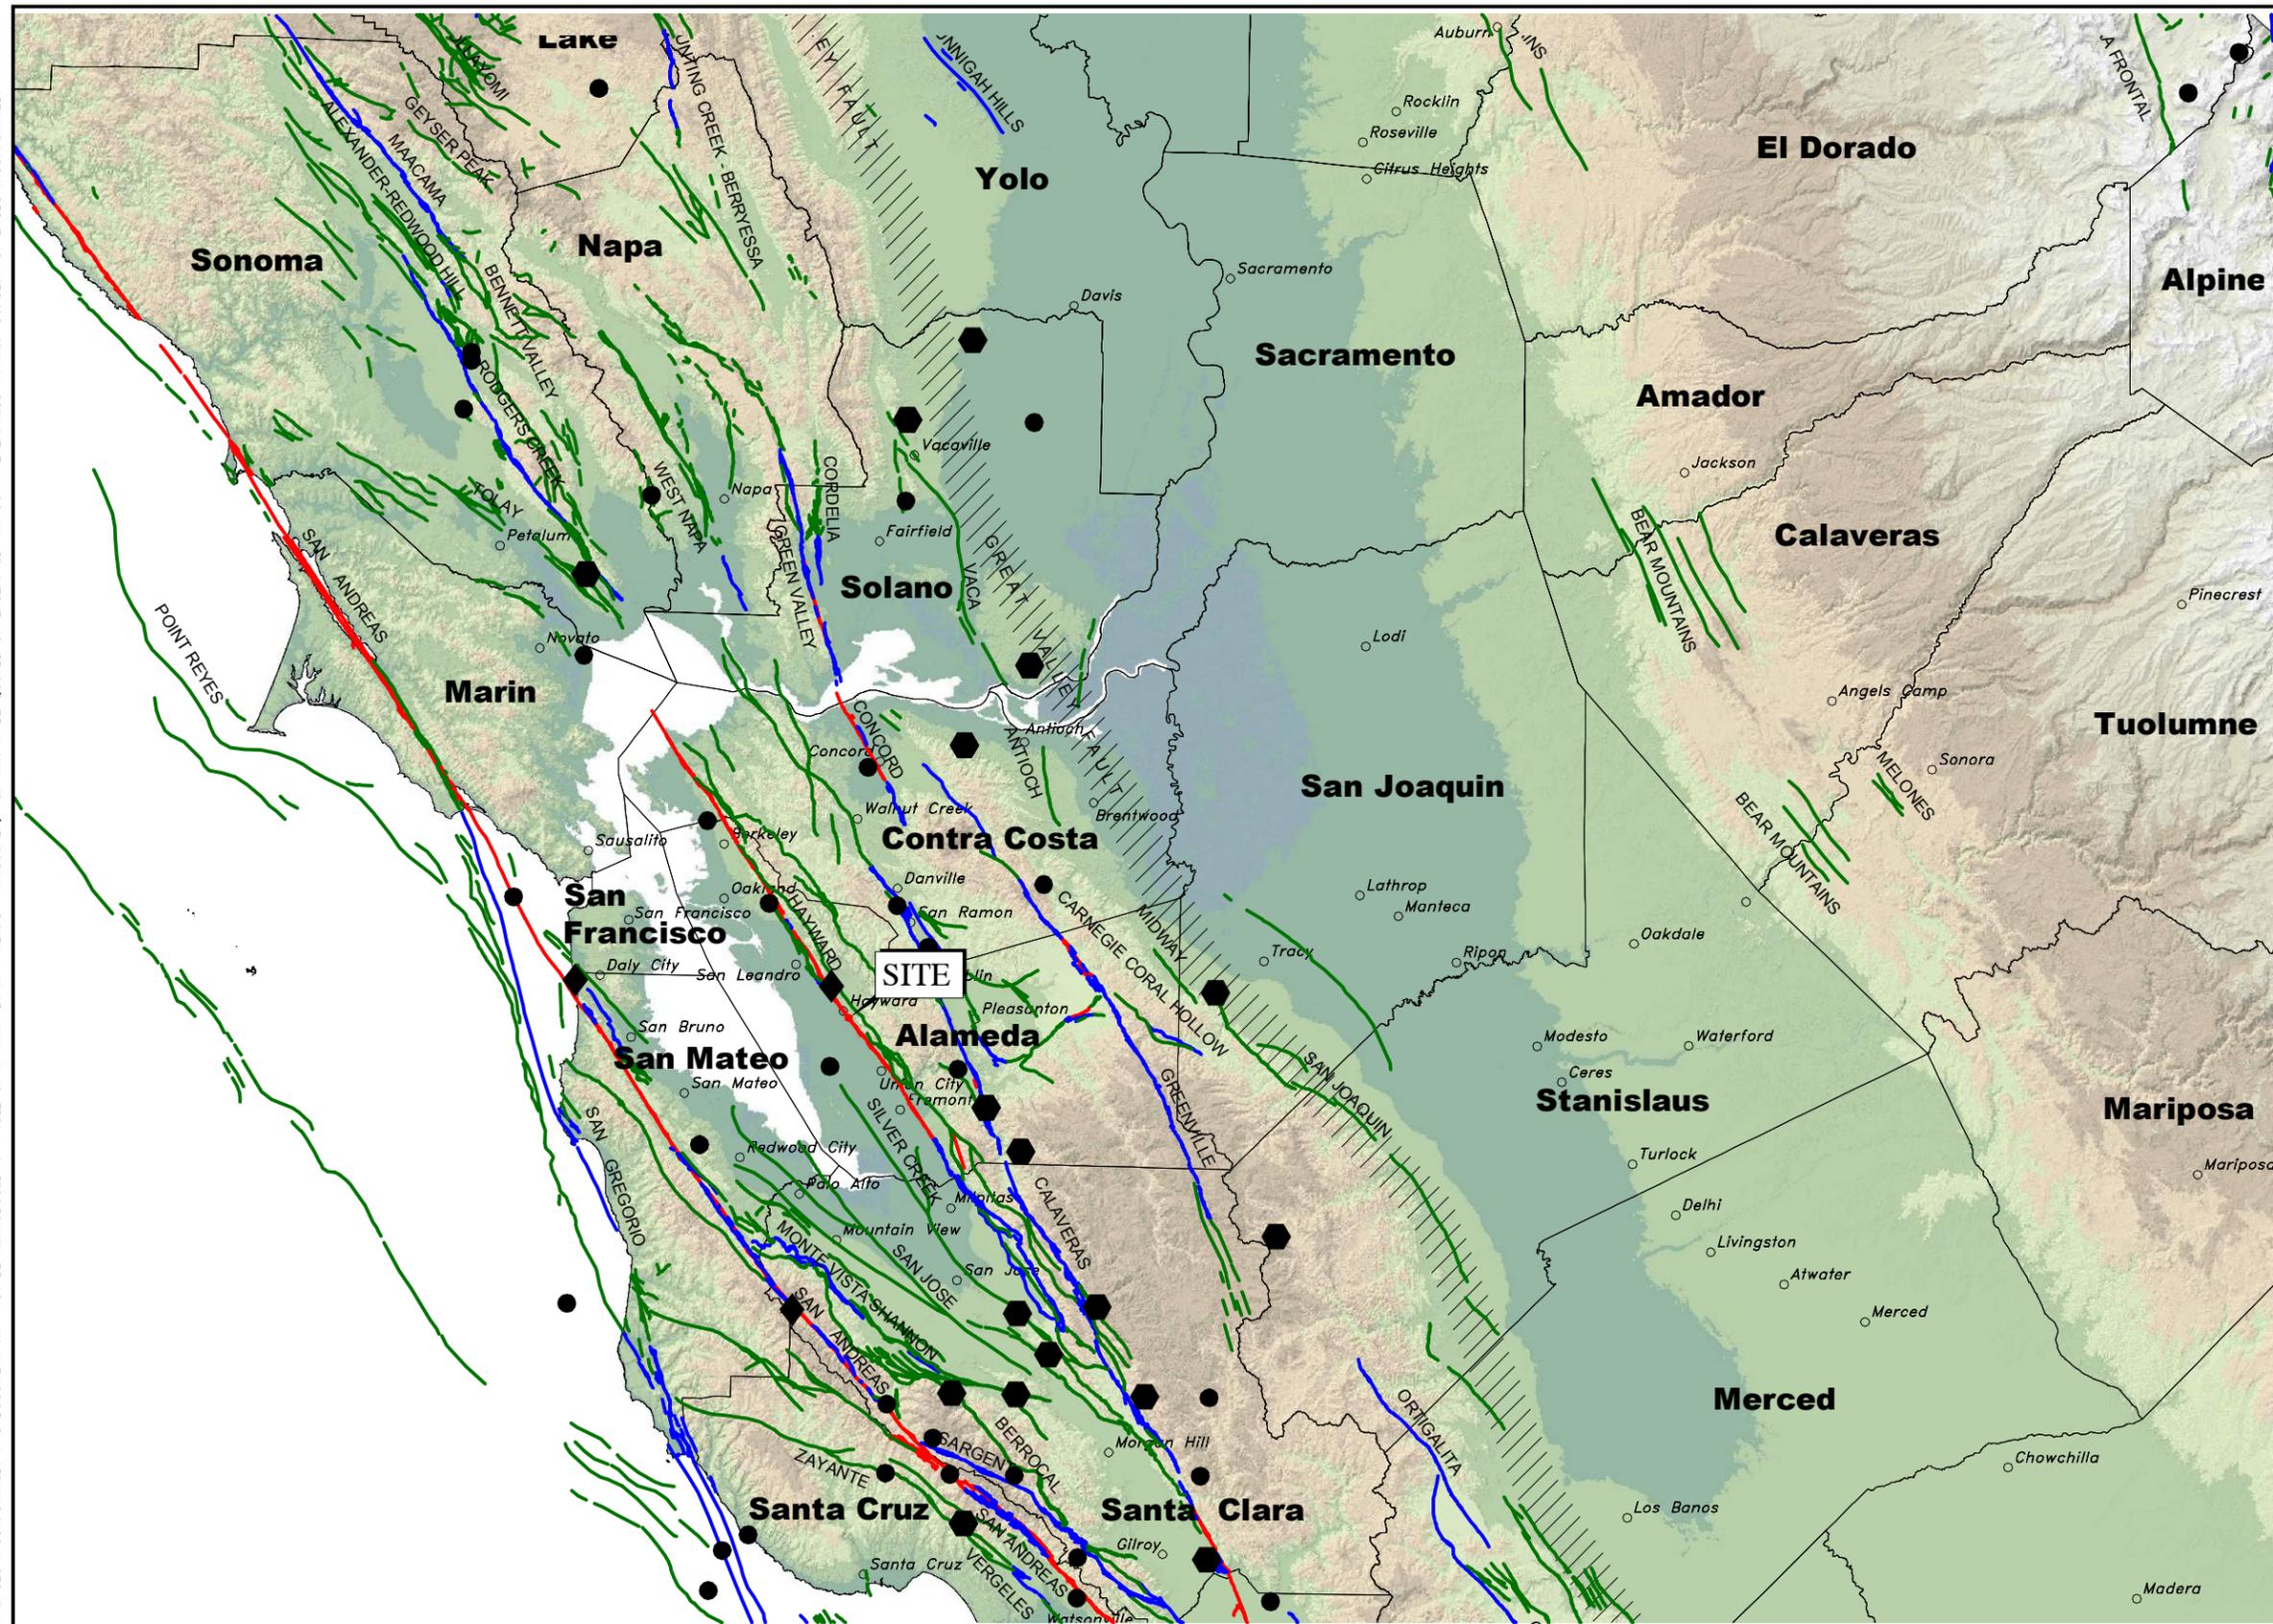
PROJECT NO.: 12843.000.000	FIGURE NO.
SCALE: AS SHOWN	7
DRAWN BY: LL

EXPLANATION	
◆	MAGNITUDE 7+
⬡	MAGNITUDE 6-7
●	MAGNITUDE 5-6
— (Red)	HISTORIC FAULT
— (Blue)	HOLOCENE FAULT
— (Green)	QUATERNARY FAULT
///	HISTORIC BLIND THRUST FAULT ZONE

future. Figure 7 shows the approximate location of active and potentially active faults and significant historic earthquake epicenters mapped within the San Francisco Bay Region. Based on the 2014 update of the national seismic hazards maps, the table below shows the nearest known active faults capable of producing significant ground shaking at the site.
