GEOTECHNICAL FEASIBILITY REPORT

ROUTE 238 BYPASS – GROUP 6
HAYWARD , CALIFORNIA

Project No:
12843.000.000

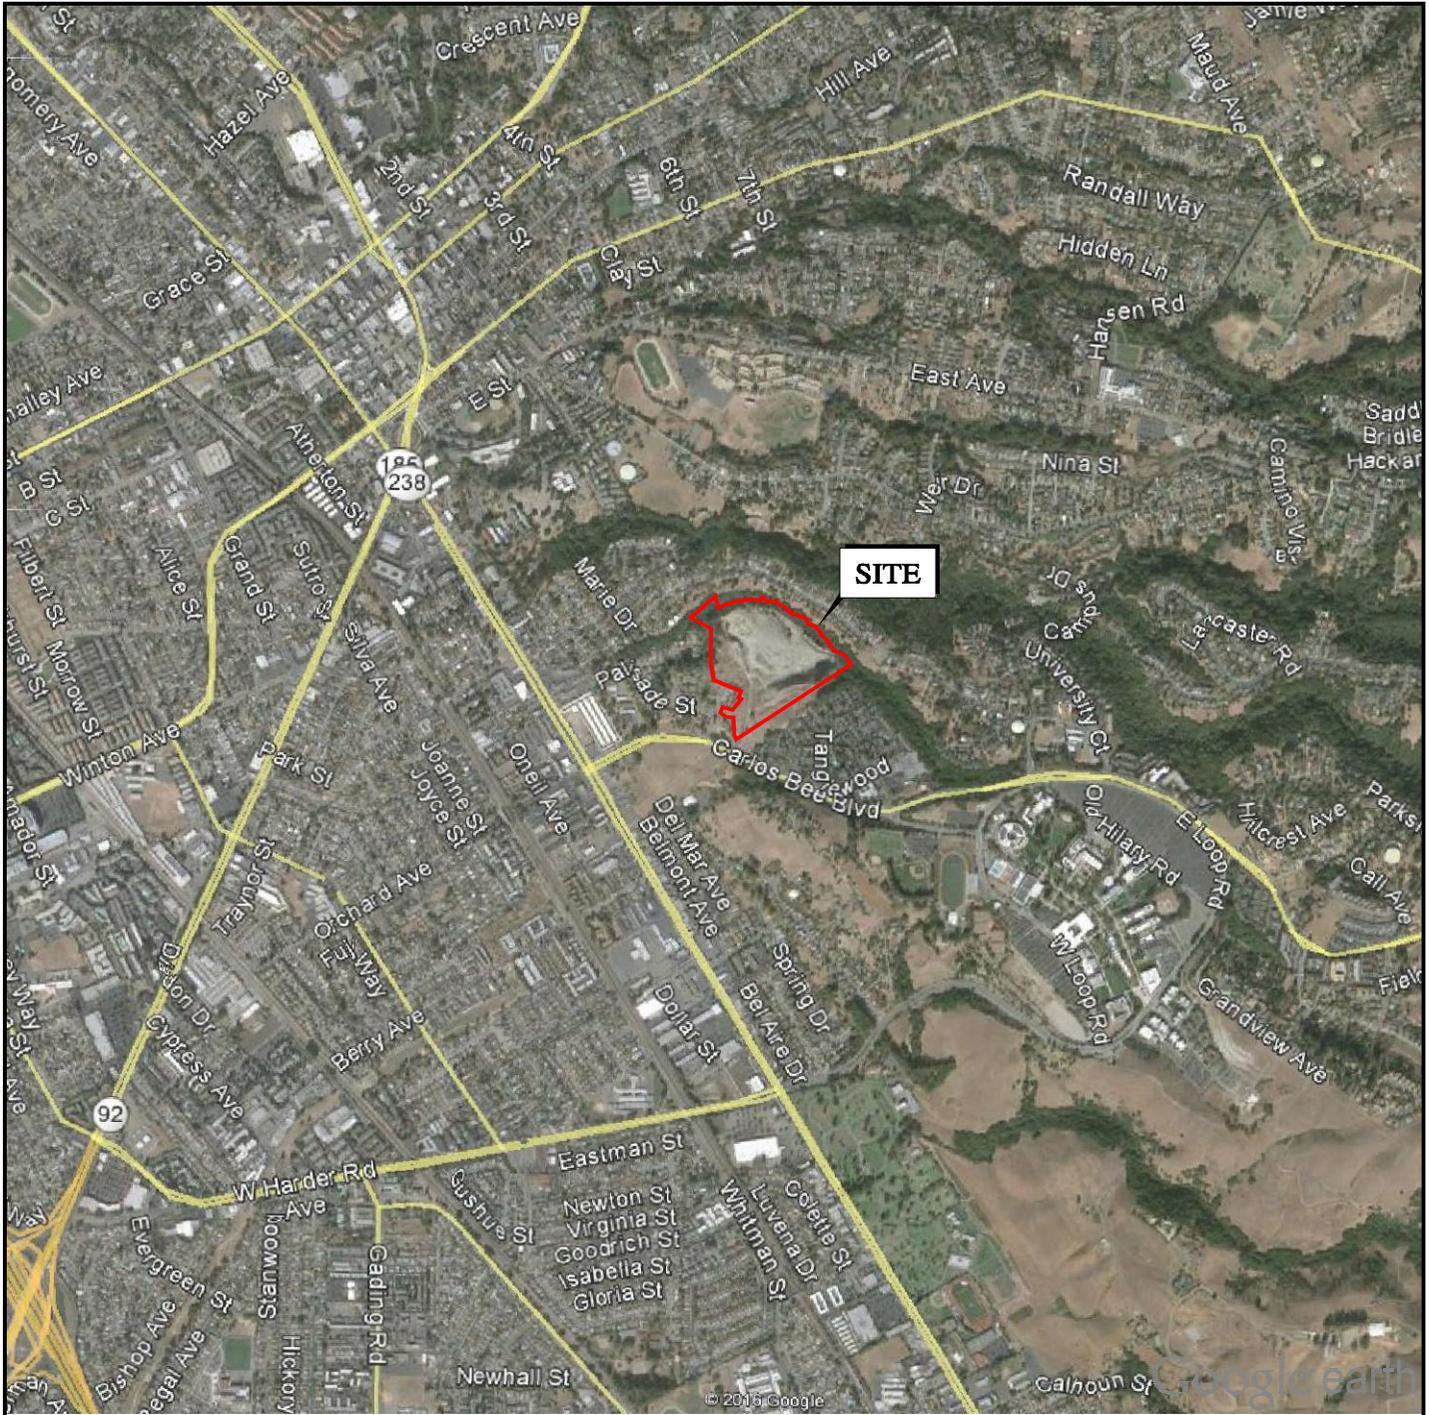
1

BASE MAP SOURCE: GOOGLE EARTH MAPPING SERVICE

The project site comprises approximately 30 acres of land currently utilized as open space and was a former quarry operation. The project site is located north of Carlos Bee Boulevard, south of Highland Boulevard and approximately 1,500 feet northeast of Route 238 (Mission Boulevard) and approximately 2,000 feet northwest of California State University, East Bay (Figure 1).

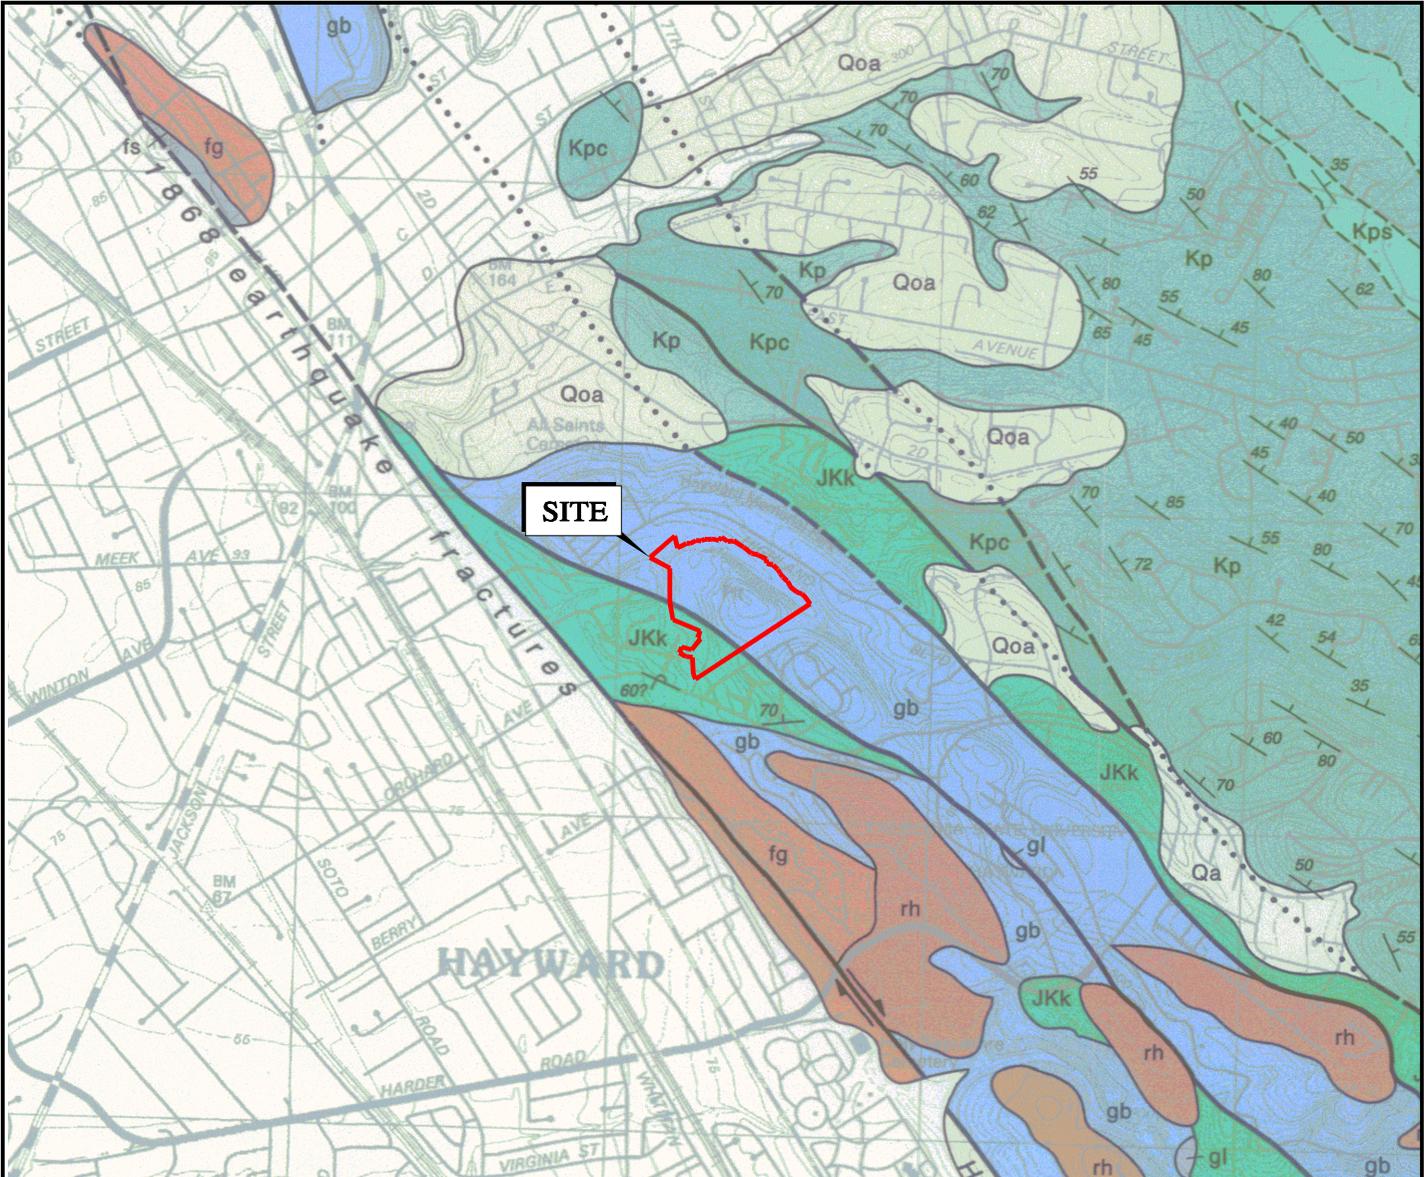
3

--- GEOLOGIC CONTACT-DASHED WHERE GRADATIONAL OR APPROXIMATELY LOCATED

According to published maps covering the site by Dibblee (2005), the site is primarily underlain by late Jurassic gabbro-d diabase associated with the Coast Range Ophiolite Complex and late Jurassic early Cretaceous Knoxville Formation (Figure 3). Dibblee (2005) maps the majority of the bedrock on site as gabbro-d diabase which underlies roughly the northern two-thirds of the property. The Coast Range Ophiolite Complex is an igneous complex that was scraped off the ocean floor during subduction from the late Jurassic to early Cretaceous.

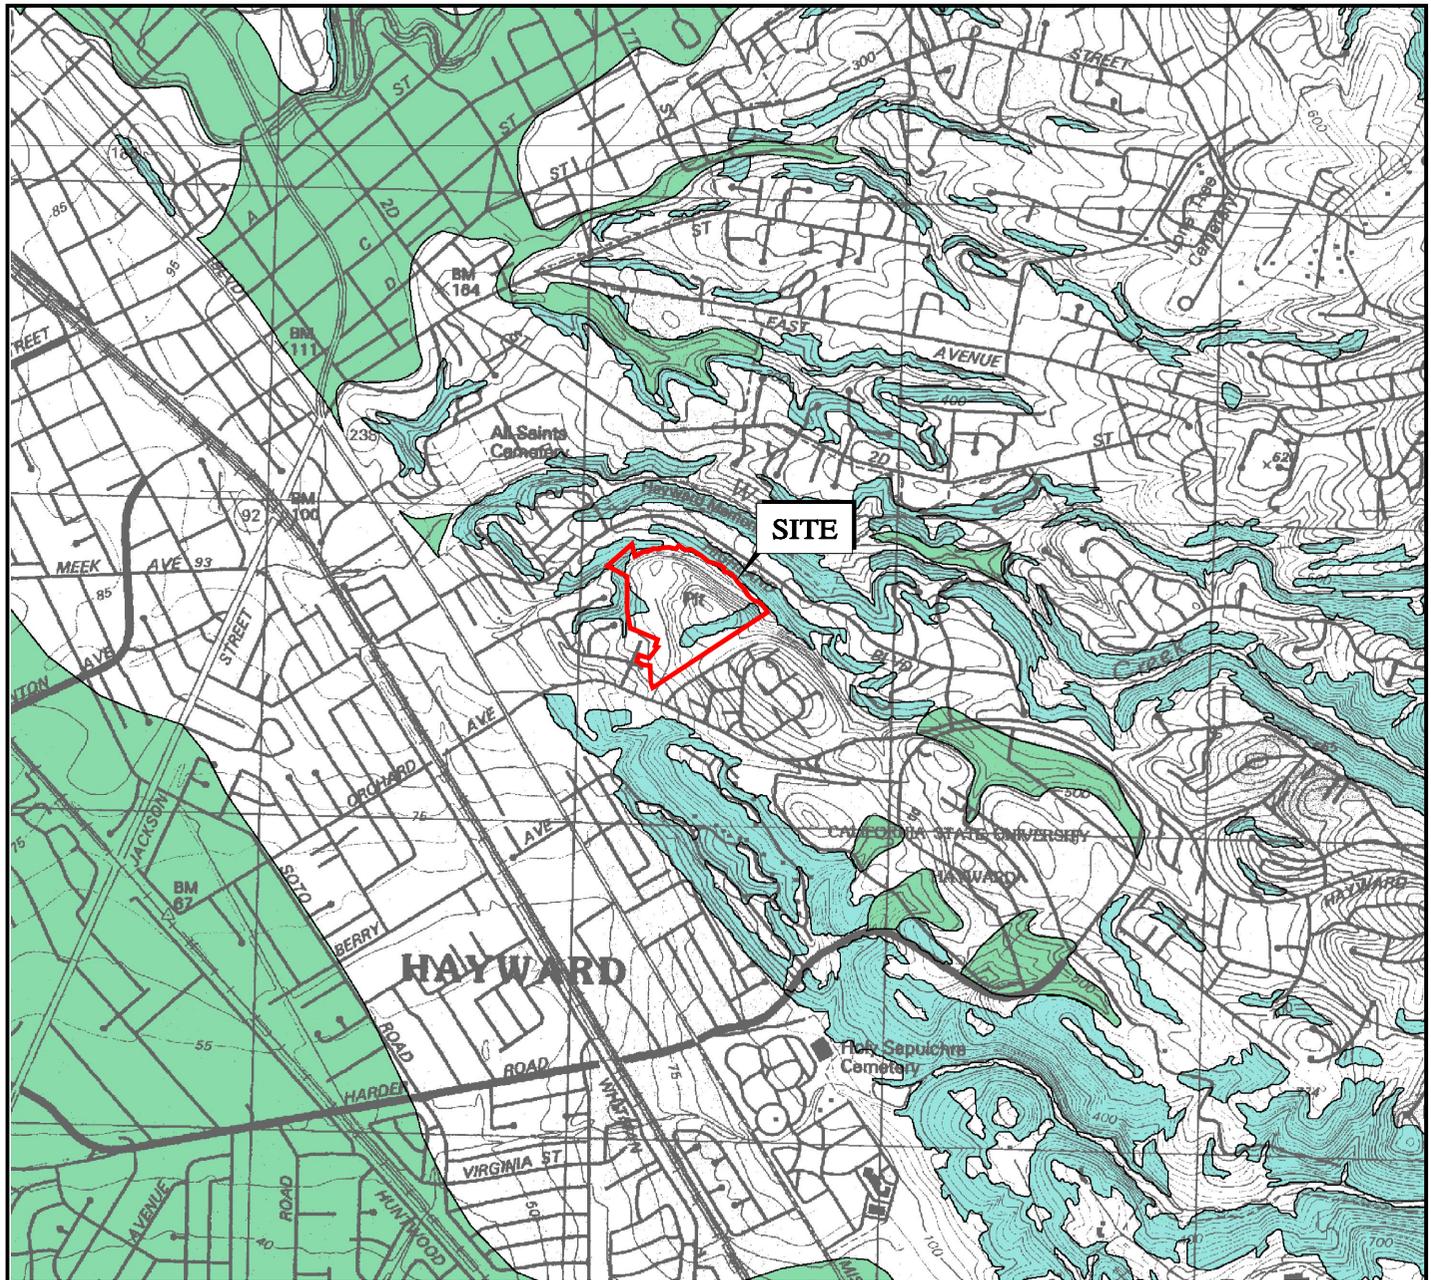
LIQUEFACTION

SEISMIC HAZARD ZONES MAP ROUTE 238 BYPASS - GROUP 6 HAYWARD, CALIFORNIA		PROJECT NO.: 12843.000.000	FIGURE NO. 6
			SCALE: AS SHOWN	
			DRAWN BY: SRP CHECKED BY: JJT

Liquefaction is a phenomenon in which saturated, loose or medium dense, cohesionless soils are subject to a temporary, but essentially total, loss of shear strength because of pore pressure build-up under the reversing cyclic shear stresses associated with earthquakes. The State of California Seismic Hazard Zones Map does not show areas susceptible to liquefaction within the property (Figure 6). However, the potential for liquefaction in the drainage portions of the property should be evaluated using subsequent subsurface exploration.

Ground shaking associated with earthquake events can trigger landslides in weak geologic materials, caused by a wide range of mechanisms. Due to the overall inclination of the subject slopes, the potential for earthquake-induced landslides is considered high. The site is designated in the State of California Seismic Hazard Zones Map as susceptible to earthquake-induced landslides (Figure 6). This geologic hazard can be mitigated by various methods including but not limited to removal of potentially unstable materials and replacement as engineered fill or construction of engineered fill buttresses, rock-nail walls, etc.

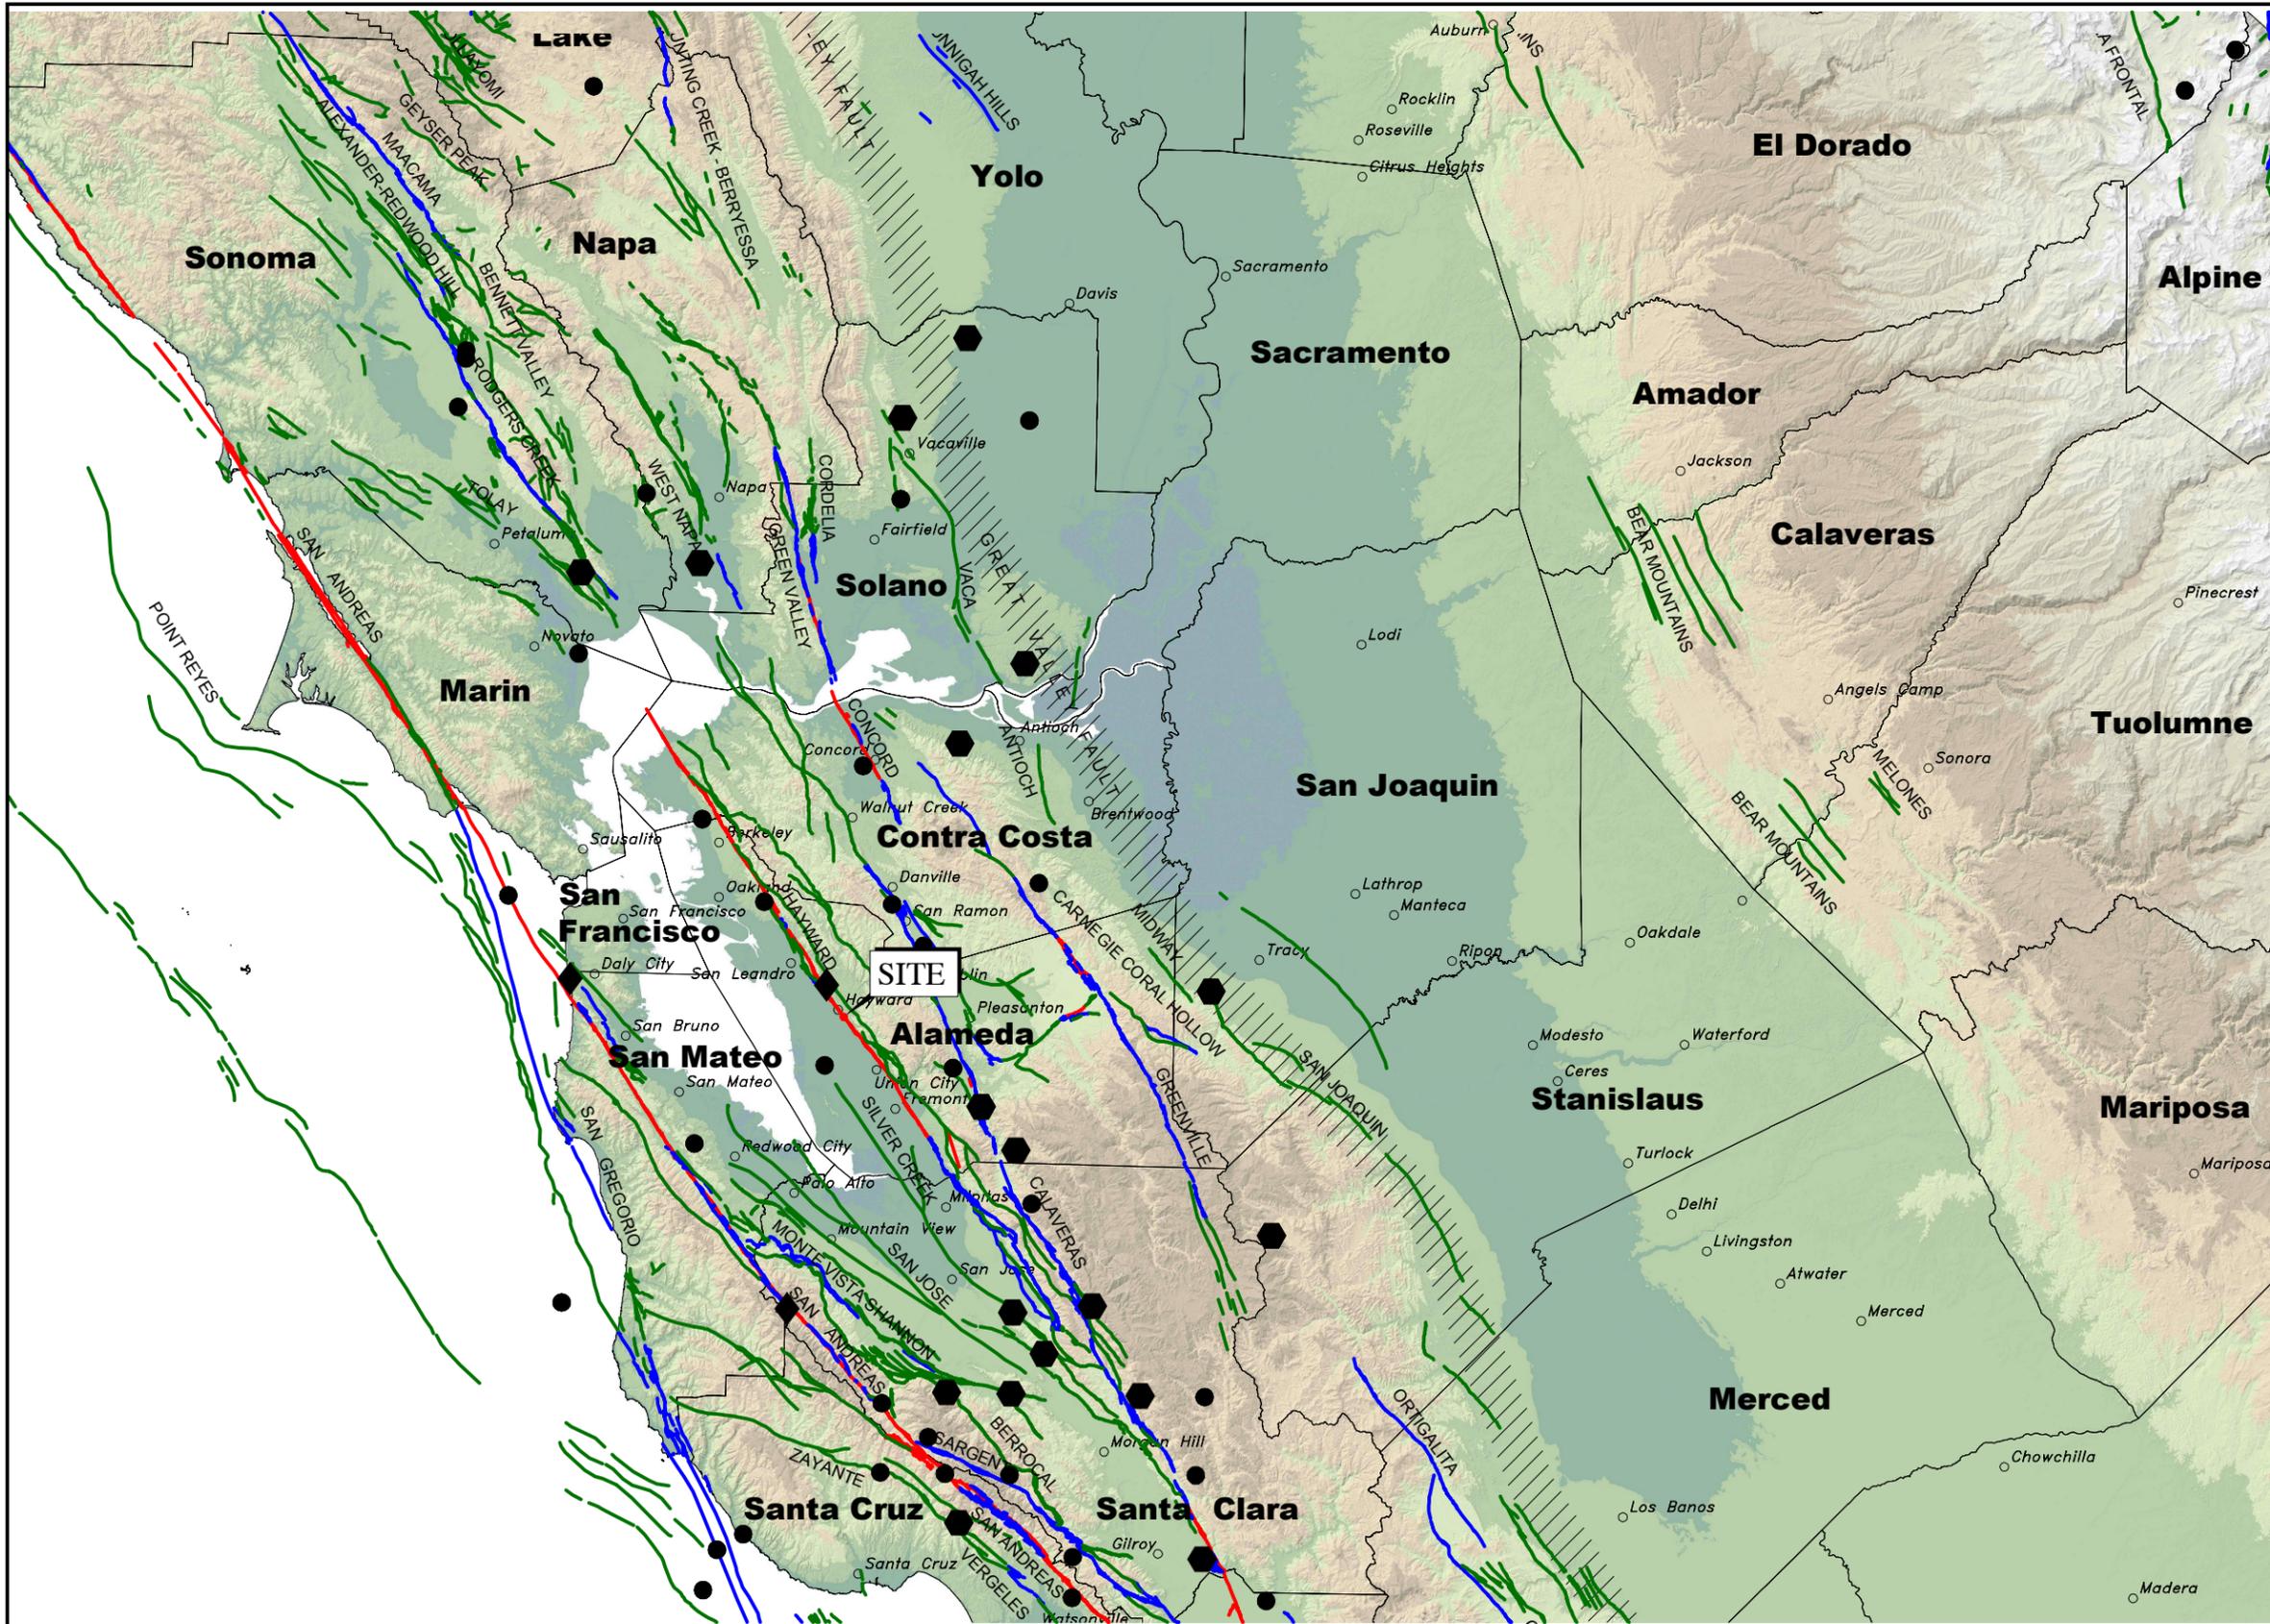
◆	MAGNITUDE 7+
⬠	MAGNITUDE 6-7
●	MAGNITUDE 5-6
— (Red)	HISTORIC FAULT
— (Blue)	HOLOCENE FAULT
— (Green)	QUATERNARY FAULT
///	HISTORIC BLIND THRUST FAULT ZONE

REGIONAL FAULTING AND SEISMICITY ROUTE 238 BYPASS - GROUP 6 HAYWARD, CALIFORNIA		PROJECT NO.: 12843.000.000 SCALE: AS SHOWN DRAWN BY: SRP CHECKED BY: JJT	FIGURE NO 7
				ORIGINAL FIGURE PRINTED IN COLOR

Moment Magnitude 7) earthquakes have been recorded and can be expected to occur in the future. Figure 7 shows the approximate location of active and potentially active faults and significant historic earthquake epicenters mapped within the San Francisco Bay Region. Based on the 2014 update of the national seismic hazards maps, the table below shows the nearest known active faults capable of producing significant ground shaking at the site.

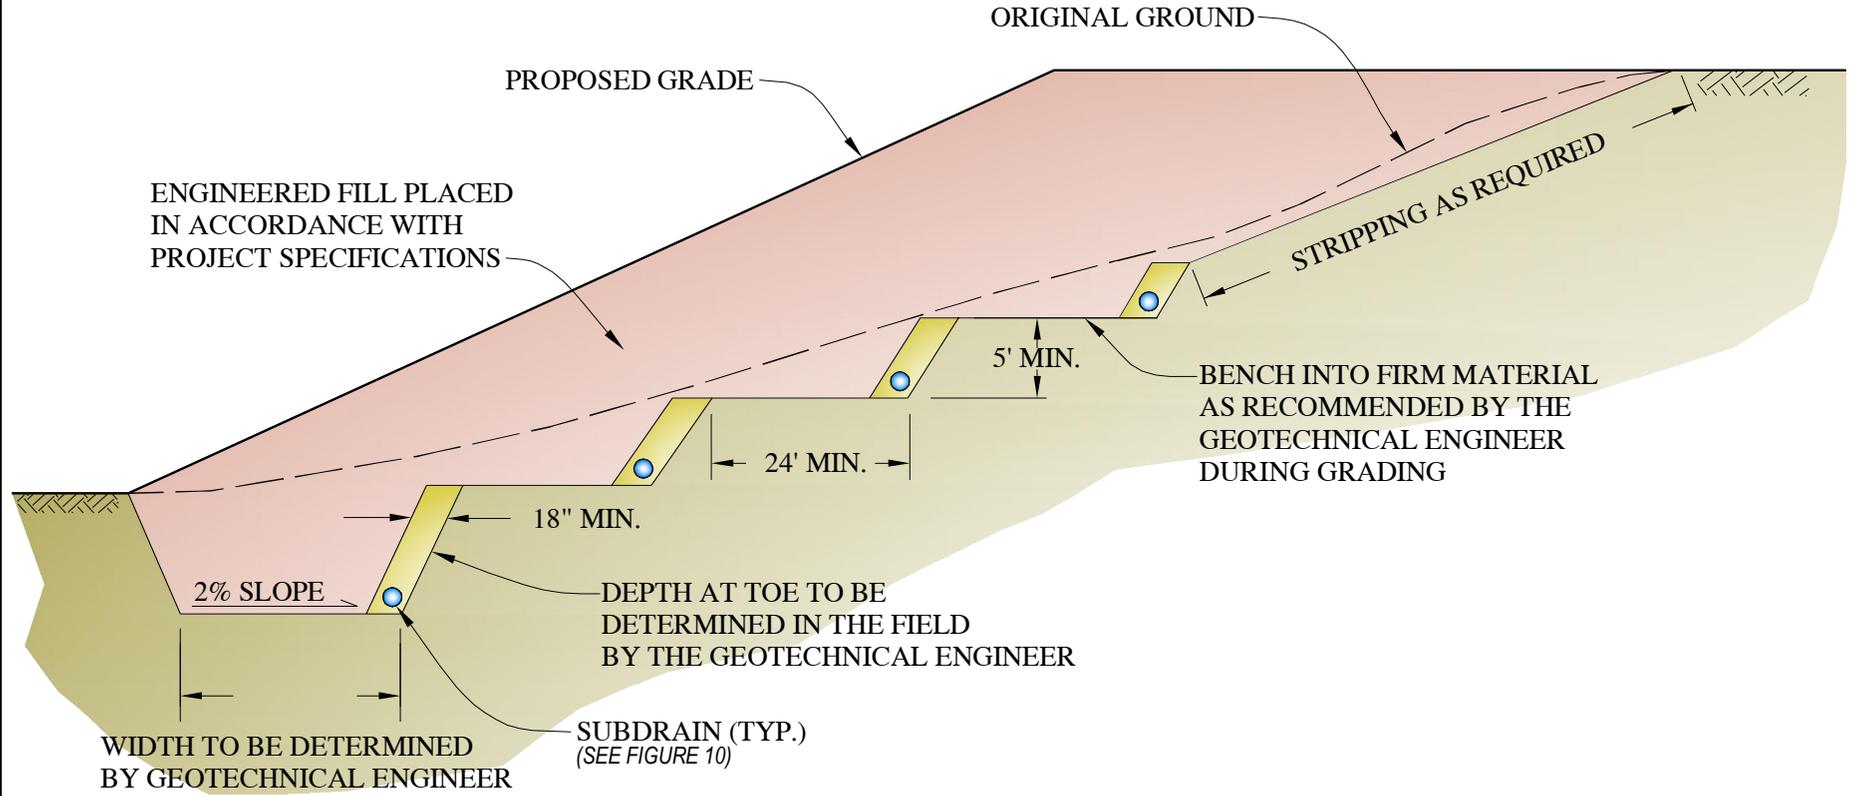
TYPICAL KEYWAY DETAIL
 ROUTE 238 BYPASS - GROUP 6
 HAYWARD, CALIFORNIA

PROJECT NO.: 12843.000.000	9
SCALE: NO SCALE	
DRAWN BY: SRP CHECKED BY: JJT

For planning purposes, a keyway should be constructed inward from the toe of the new fill slope. The keyways should extend below original grade into firm competent soil/rock, as determined by the Engineering Geologist/Geotechnical Engineer. Slope the keyway bottom at least 2 percent downward toward the heel of the keyway. Keyway dimensions should be evaluated by the Engineering Geologist/Geotechnical Engineer based on actual soil/rock conditions observed during construction. Typical keyway details are provided in Figure 9.

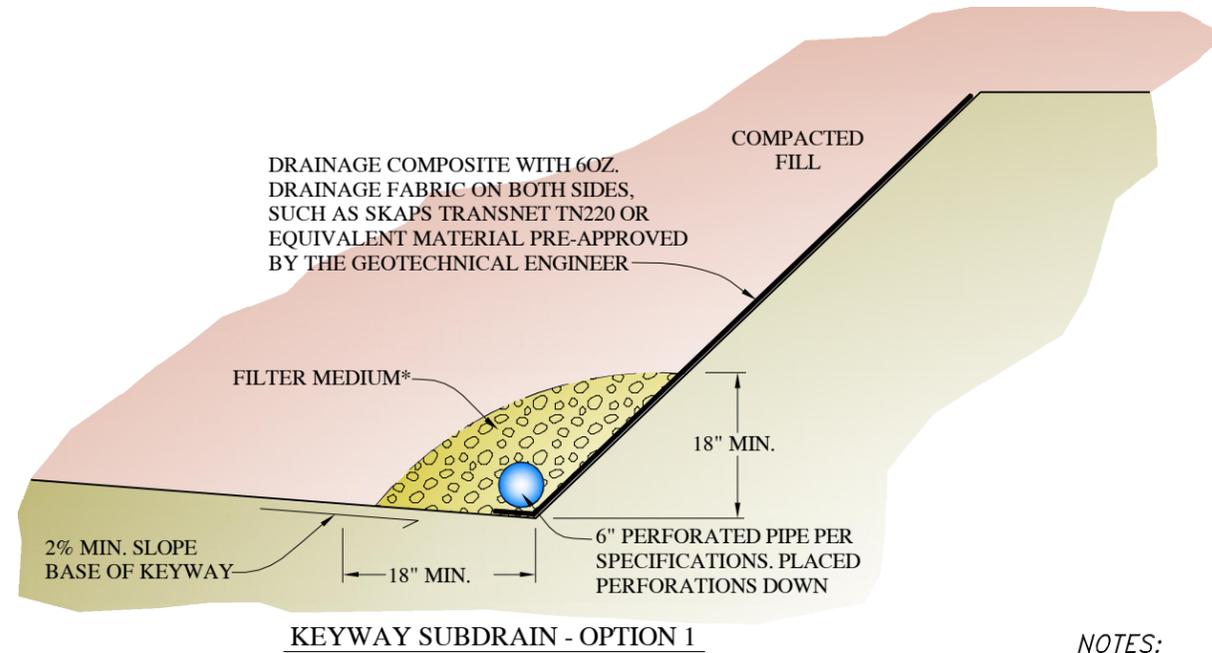
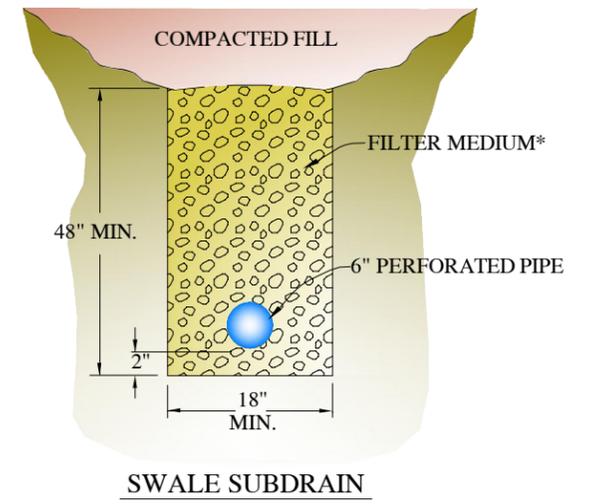
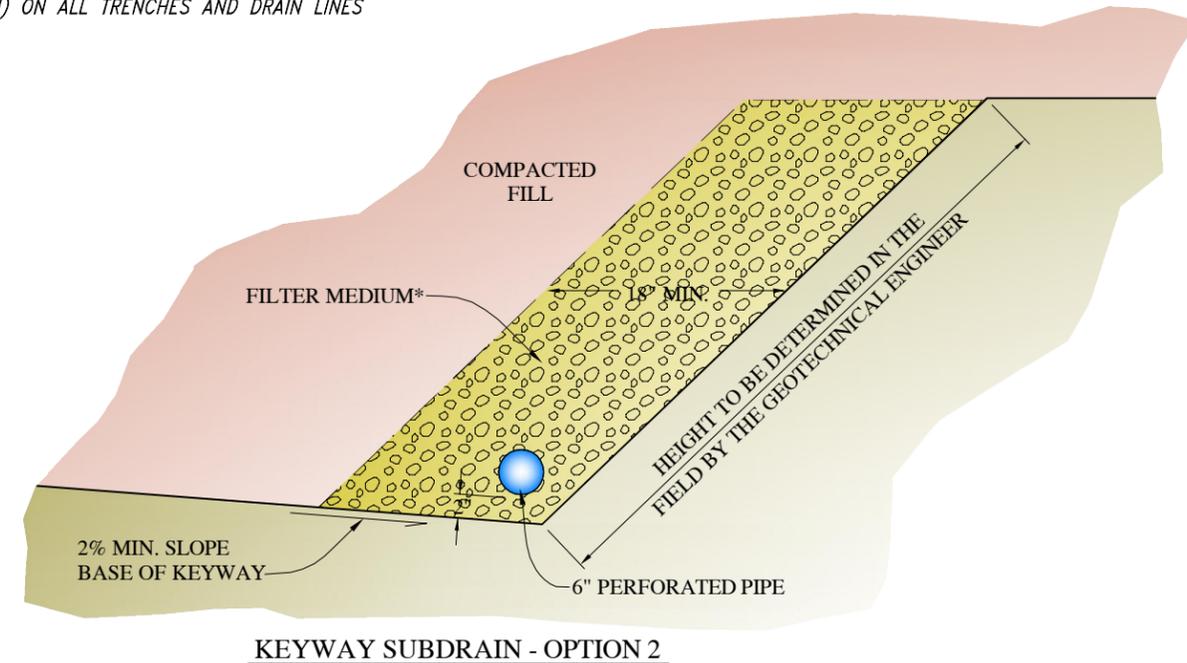
1. ALL PIPE JOINTS SHALL BE GLUED
2. ALL PERFORATED PIPE PLACED PERFORATIONS DOWN
3. 1% FALL (MINIMUM) ON ALL TRENCHES AND DRAIN LINES

GRAB STRENGTH (ASTM D-4632)	180 lbs
MASS PER UNIT AREA (ASTM D-4751)	6 oz/yd ²
APPARENT OPENING SIZE (ASTM D-4751)	70-100 U.S. STD. SIEVE
FLOW RATE (ASTM D-4491)	80 gal/min/ft
PUNCTURE STRENGTH (ASTM D-4833)	80 lbs

TYPICAL SUBDRAIN DETAILS
ROUTE 238 BYPASS - GROUP 6
HAYWARD, CALIFORNIA
