**INITIAL STUDY/
MITIGATED NEGATIVE DECLARATION**

**22422 ROCKAWAY LANE PROJECT
HAYWARD, CALIFORNIA**

November 2023

Project No. HAY2001.09

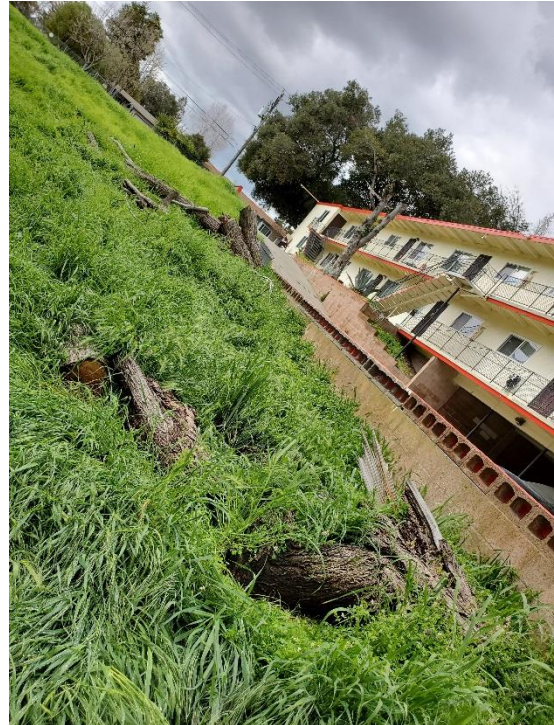
Figure 2. Portions of the trunk of tree #3 (background/top) were left in place, but not enough to directly measure the trunks. Both trunks of tree #4 (foreground) were on the ground right where they were felled, and diameter measurement where the trunk would be 54" above grade was possible.

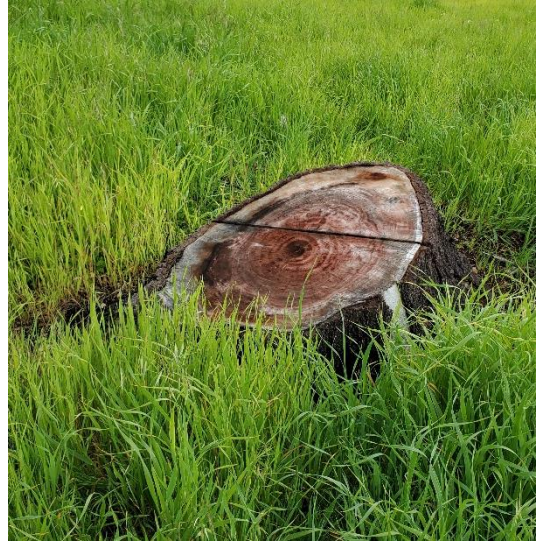
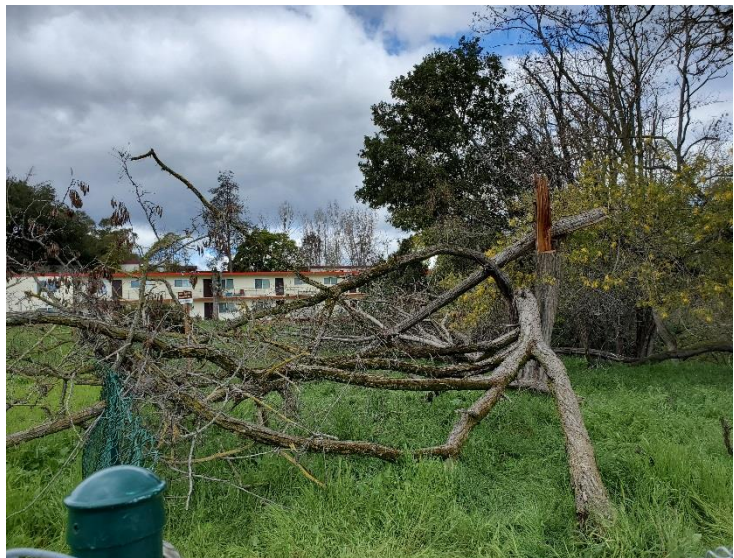
Figure 3. (top) The stump of tree #1 was oblong due to the trunk flare, much larger than the trunk above. I used the survey diameter for my appraisals.

(bottom) tree #5 was partially felled in place, so its health, structure, and diameter could be directly evaluated from the brush and wood.
